# PRELIMINARY INVESTIGATION REPORT

## Lake Forest, Sprinkler System Water Loss

Representing: Lake Forest HOA  
Location: 1620 Lakeview Terrace, Unit B304, Frisco, Colorado  
Date of Loss: November 27, 2023  
AEI Project No.: 16020

AEI Project No.: 16020

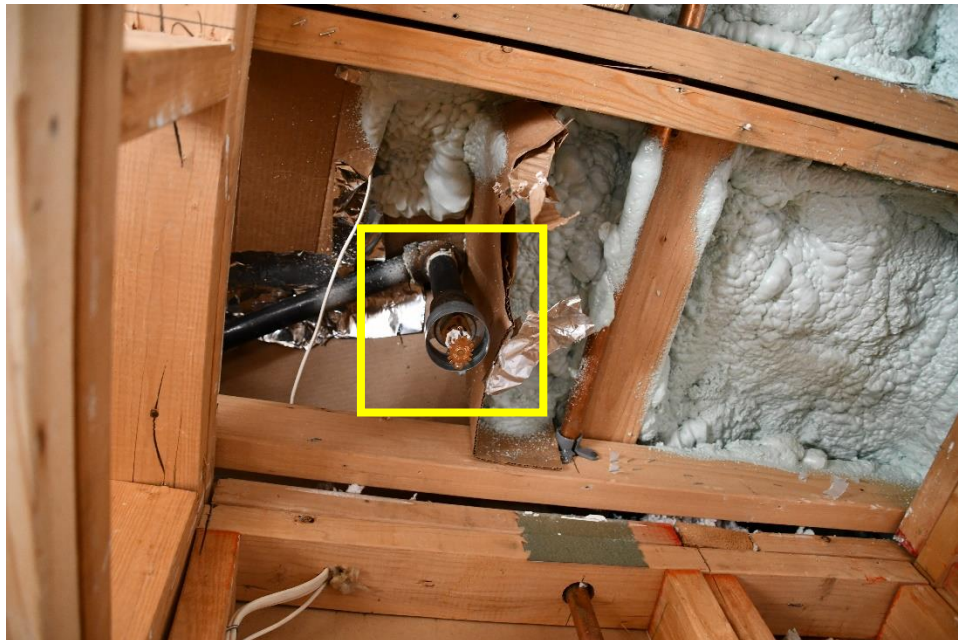
On November 27, 2023, the sprinkler system failed in Unit B304 proximate to the same location that the sprinkler system failed in 2022. It was determined by the property management/owners and the fire department that a sprinkler head failed and discharged water into the structure.

**Figure 6. Location of the failed sprinkler head (16020\_CBS\_1-020).**

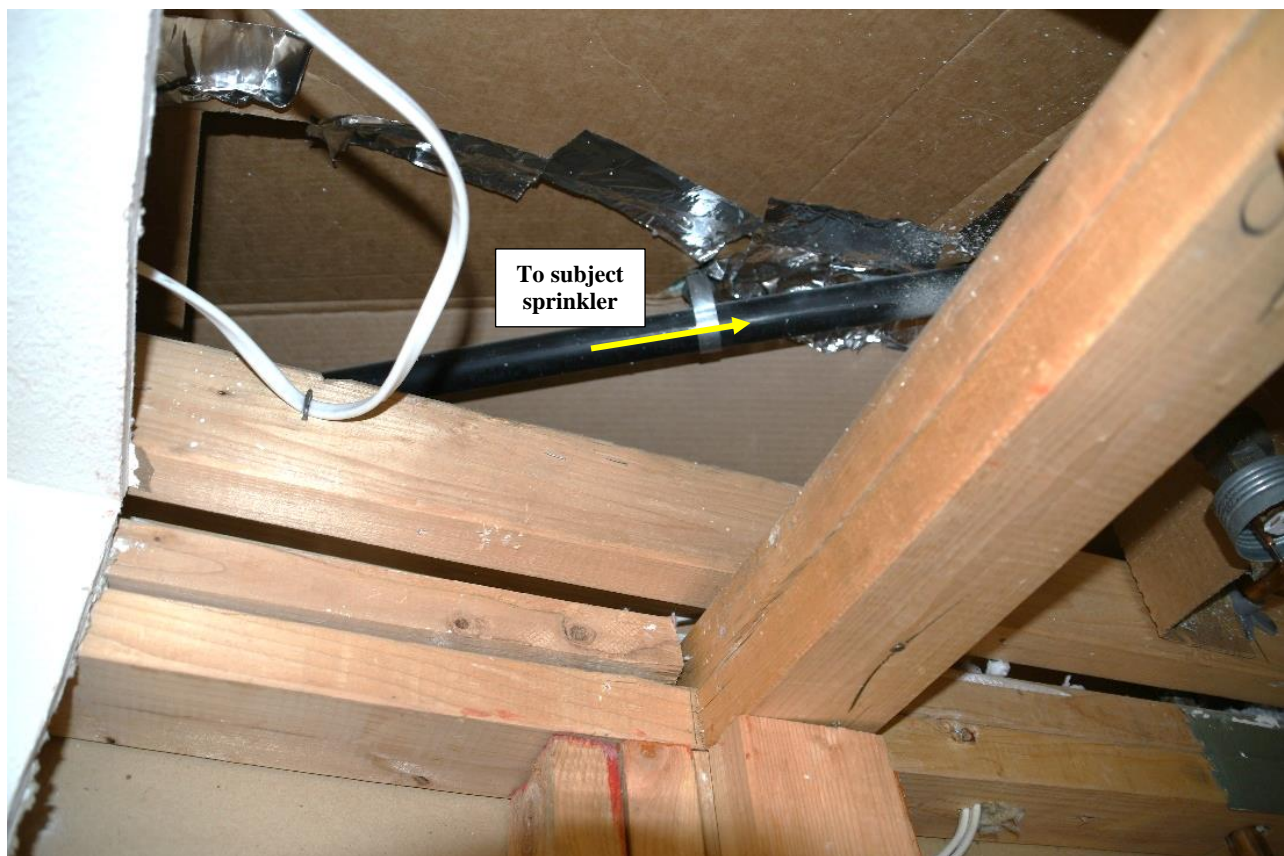
The black-steel sprinkler branch line for the subject sprinkler (i.e., the head that failed) was installed in the ceiling of the kitchen and extended from the attic over the west bedroom/master bathroom area of the unit, as shown in Figures 7 through 9. The sprinkler piping had cardboard tented over the pipe and expanding spray foam around the cardboard, also shown in Figures 7 through 9 and in Figure 10. The sprinkler piping for this portion of the unit was fed from the floor below through the vertical west wall between the kitchen and bedroom, then west into the attic over the bedroom. The piping had a drop for the sprinkler in the mechanical room, and then ran diagonally across into the ceiling between the upper level and the kitchen. The path of the piping can also be followed in Figures 7 through 9, and Figure 11.

**Figure 7. Sprinkler branch for the subject sprinkler head (16020\_CBS\_1-035).**

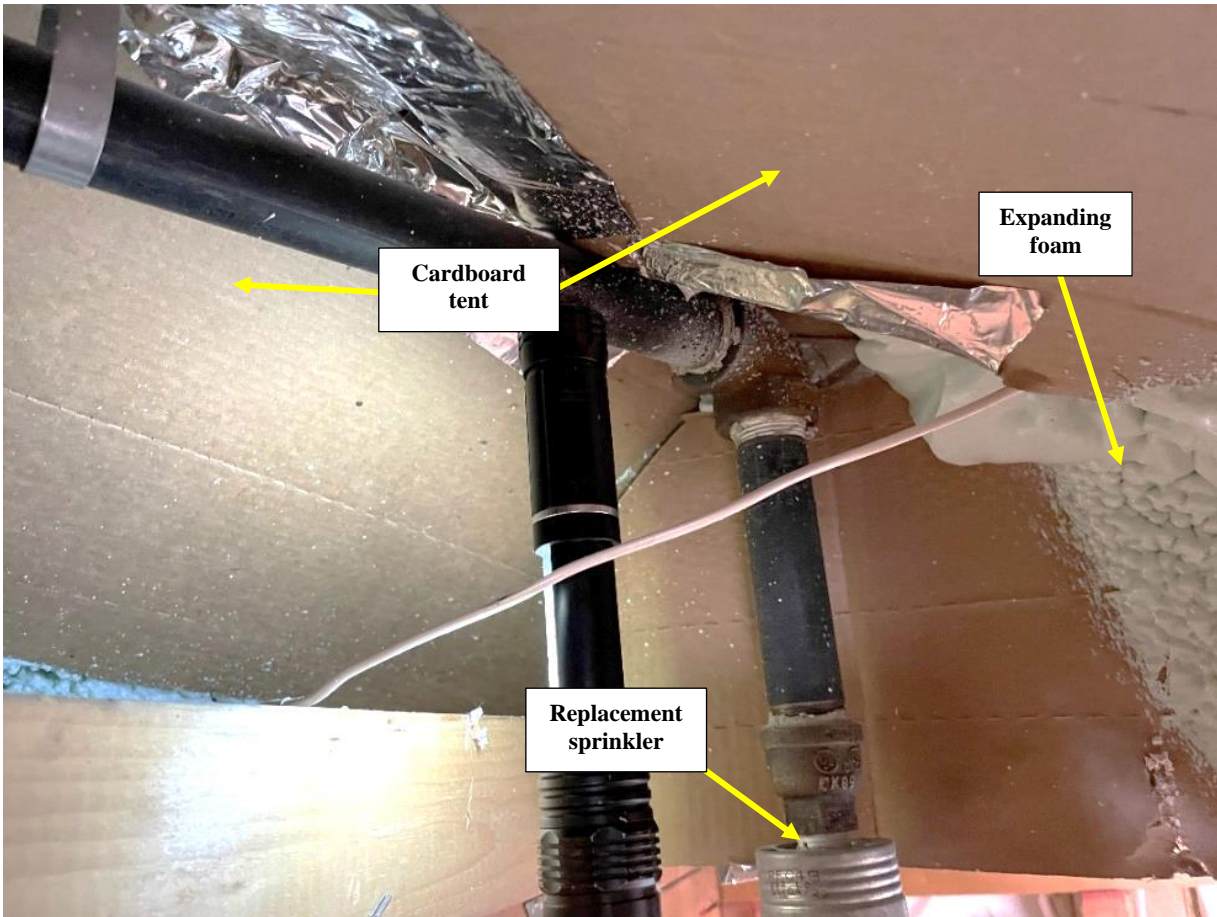
**Figure 8. Sprinkler branch line for the subject sprinkler (16020\_CBS\_2-037).**

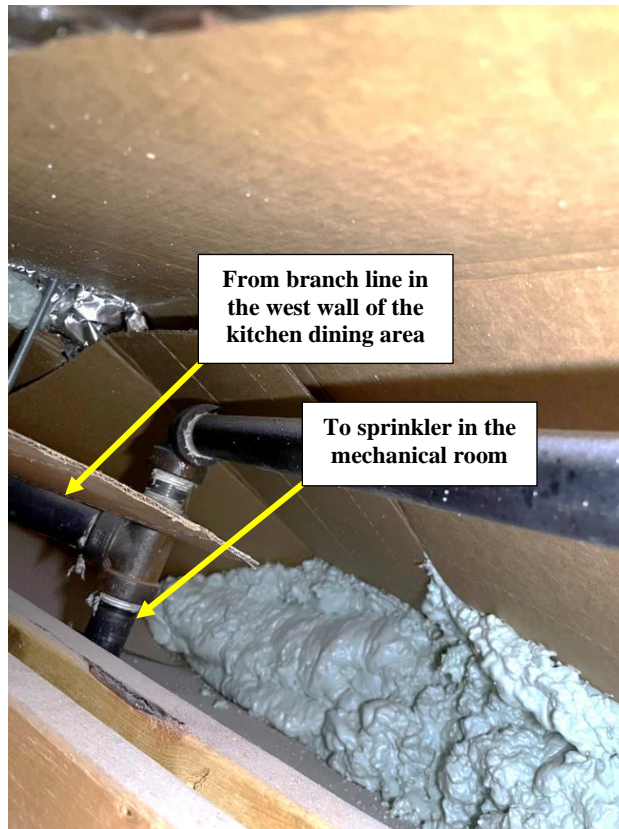
**Figure 9. Sprinkler branch for the subject sprinkler (16020\_CBS\_2-042).**

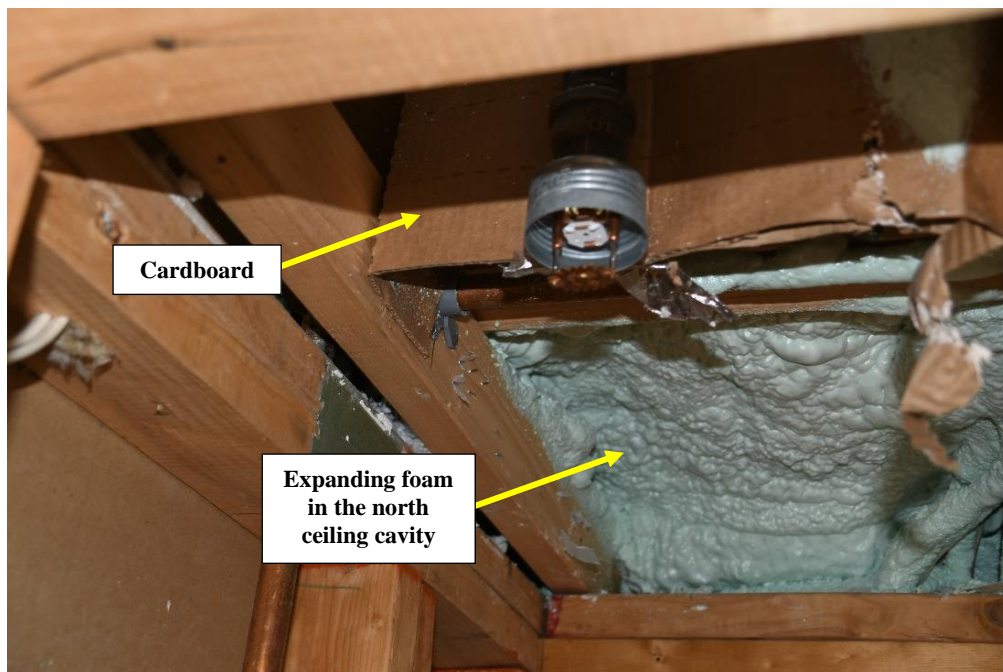
**Figure 10. Replacement sprinkler (16020\_CBS\_1-043).**

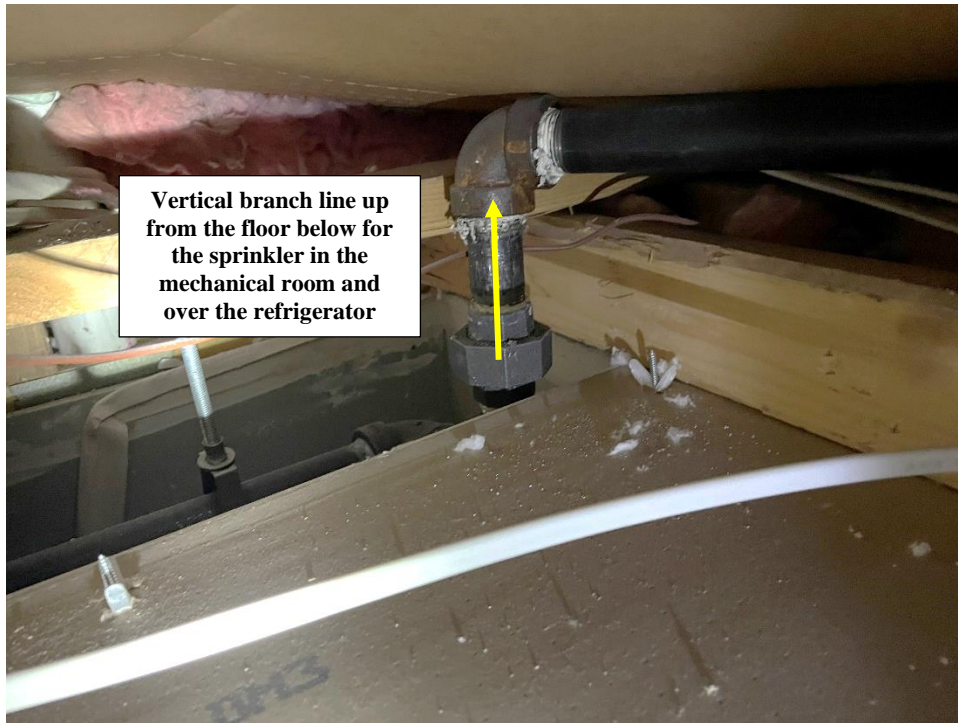
**Figure 11. Vertical branch line from the floor below (16020\_CBS\_2-047).**

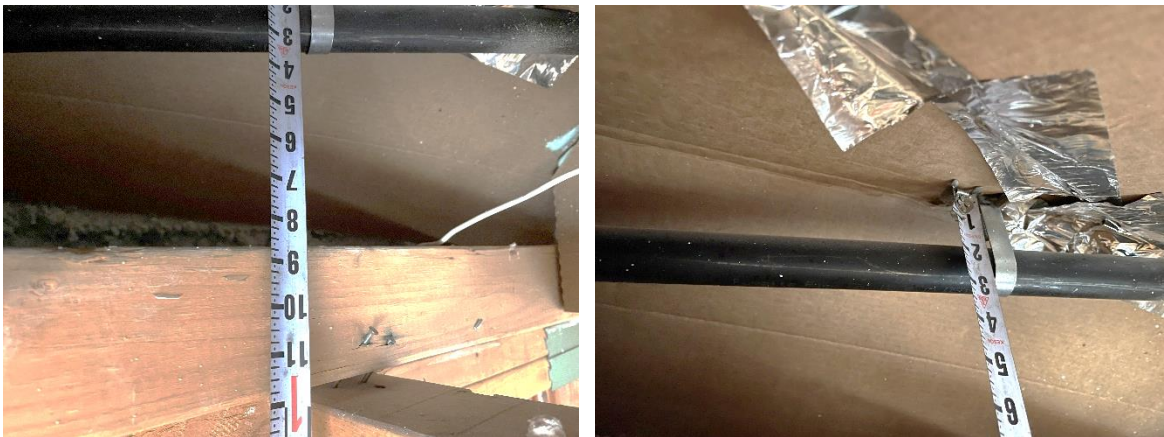
The high point of the cardboard tent was approximately 12-inches above the ceiling construction, as depicted in Figure 12. The sprinkler pipe was approximately 2-inches below the high point of the cardboard, also depicted in Figure 12.

**Figure 12. Measurements for the high point of the cardboard and distance of pipe from the cardboard (16020\_CBS\_2-054, 16020\_CBS\_2-055).**

The attempt to install a cardboard tent over the black-steel sprinkler pipe did not take into account the R-value of insulation needed to protect the pipe from freezing. The pipe was approximately 10-inches above the sheetrock ceiling. The cardboard tent was, at its highest point, approximately 12-inches above the sheetrock ceiling. The measured depth of the white loose-fill insulation in the attic was approximately 14-inches in depth throughout the attic. Based on these measurements and observed conditions in the

attic, there were approximately 2-inches of insulation covering the peak of the cardboard tent. Considerably more insulation, depth-wise, was needed to protect the subject pipe from freezing. The subject sprinkler piping was inadequately protected from freezing, which likely resulted in the formation of an ice block within the pipe, leading to the failure of the sprinkler pipe.

1. Add additional insulation over the cardboard tent installed in the attic over the kitchen, as well as installing a small louver in the ceiling to allow warm air to enter the cavity created by the cardboard tent. This method would only be effective if additional insulation were installed over the cardboard tent.
2. Bring the black-steel pipe into the heated envelope of the unit. Although NFPA 13R indicates that pipe installed under insulation is considered to be below the ceiling, improper insulation depth negates the thermal protection of the pipe. The sprinkler pipe could be relocated into the unit and installed where the ceiling and the wall meet. A small soffit could be constructed around the pipe, concealing the pipe, as it follows a path to the area over the refrigerator. A side wall sprinkler could be installed for the mechanical room from the same run of pipe.

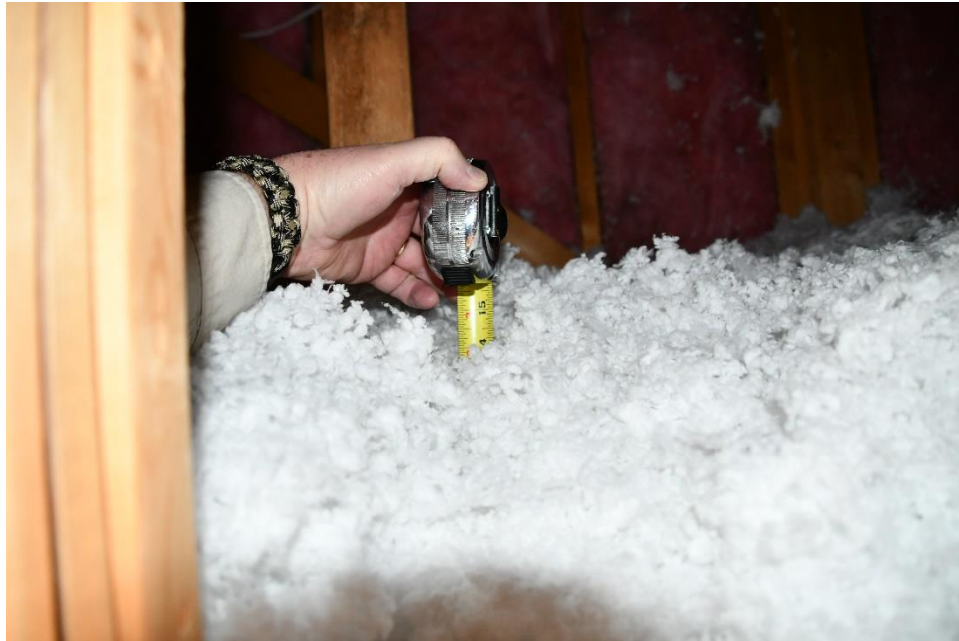
insulation was approximately 14-inches, as depicted in Figures 15 and 16. Based on measurements, there would have been approximately 2-inches of insulation over the cardboard tent covering the sprinkler piping.

**Figure 15. Insulation depth (16020\_CBS\_1-080).**

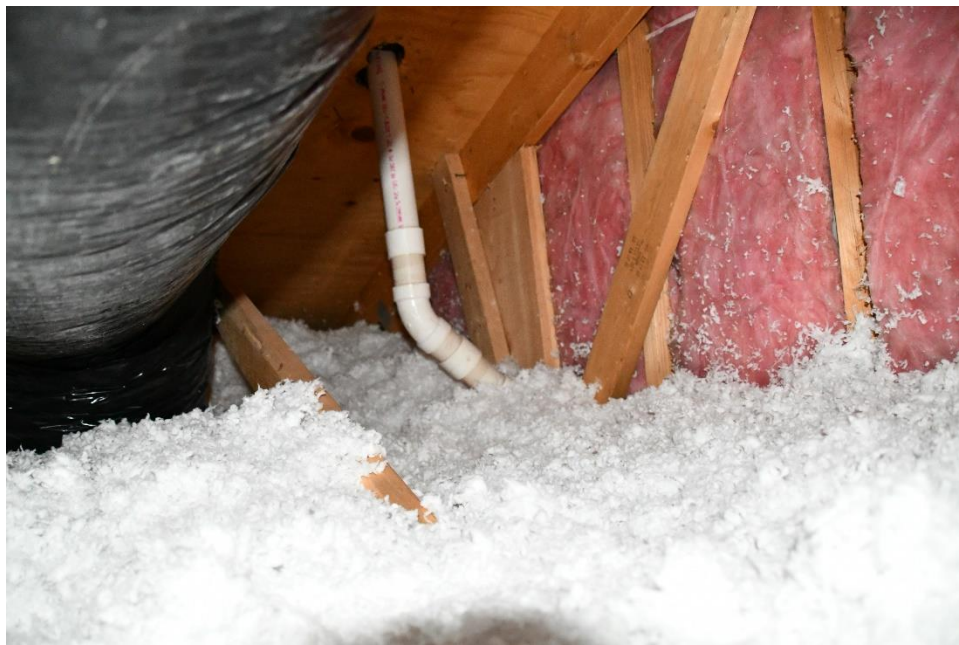
**Figure 16. View over the area where the sprinkler branch piping for the subject sprinkler was installed (16020\_CBS\_1-081).**

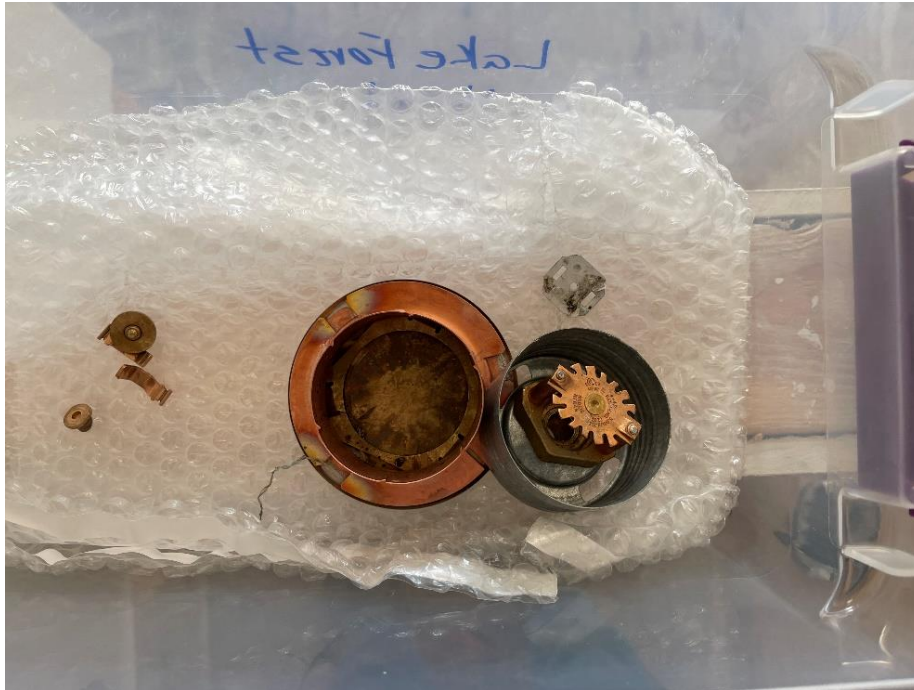
The sprinkler head that failed was and has been in possession of the properties' HOA since the date it was removed, as illustrated in Figure 17. All of the components of the sprinkler were recovered after the loss, also illustrated in Figure 17. The sprinkler deflector, arms, orifice, and other surfaces exhibited no damage

**Figure 17. Subject sprinkler and components of the sprinkler (16020\_CBS\_2-001).**

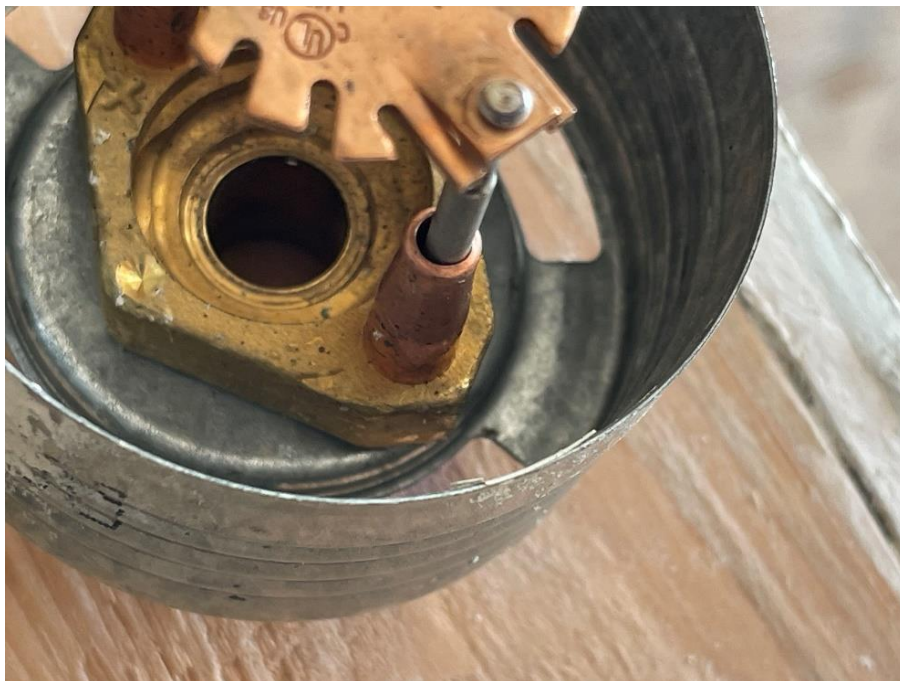
and/or witness marks, as shown in Figure 18. The cup for the concealed cover plate was observed to be damaged, as depicted in Figure 19. The components were documented and non-destructively examined.

**Figure 18. Subject sprinkler, typical of the deflector arms and orifice (16020\_CBS\_2-023).**

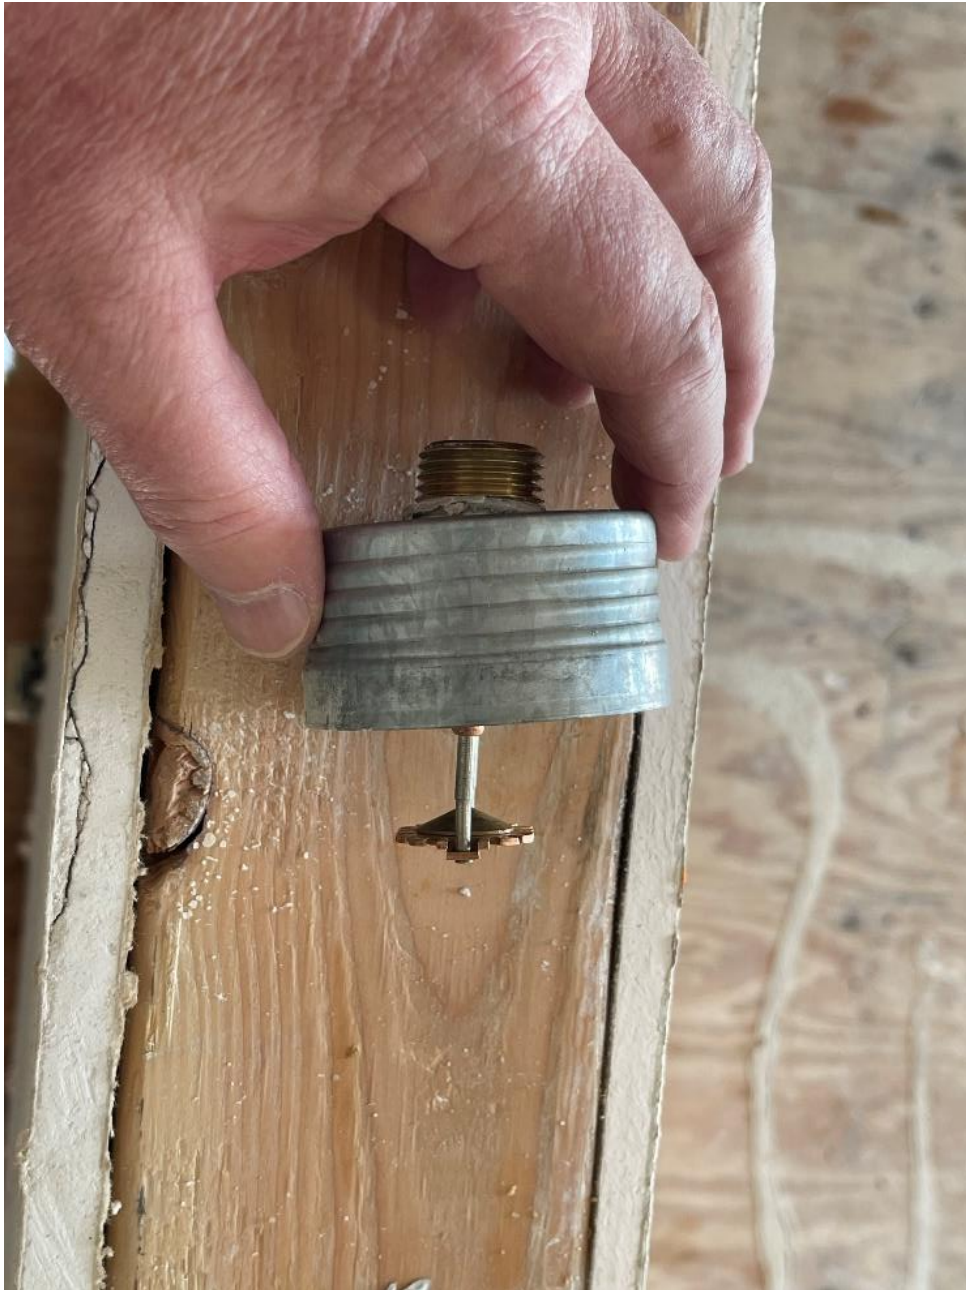
**Figure 19. Cup on the subject sprinkler, to which the concealed plate would be assembled (16020\_CBS\_2-021).**

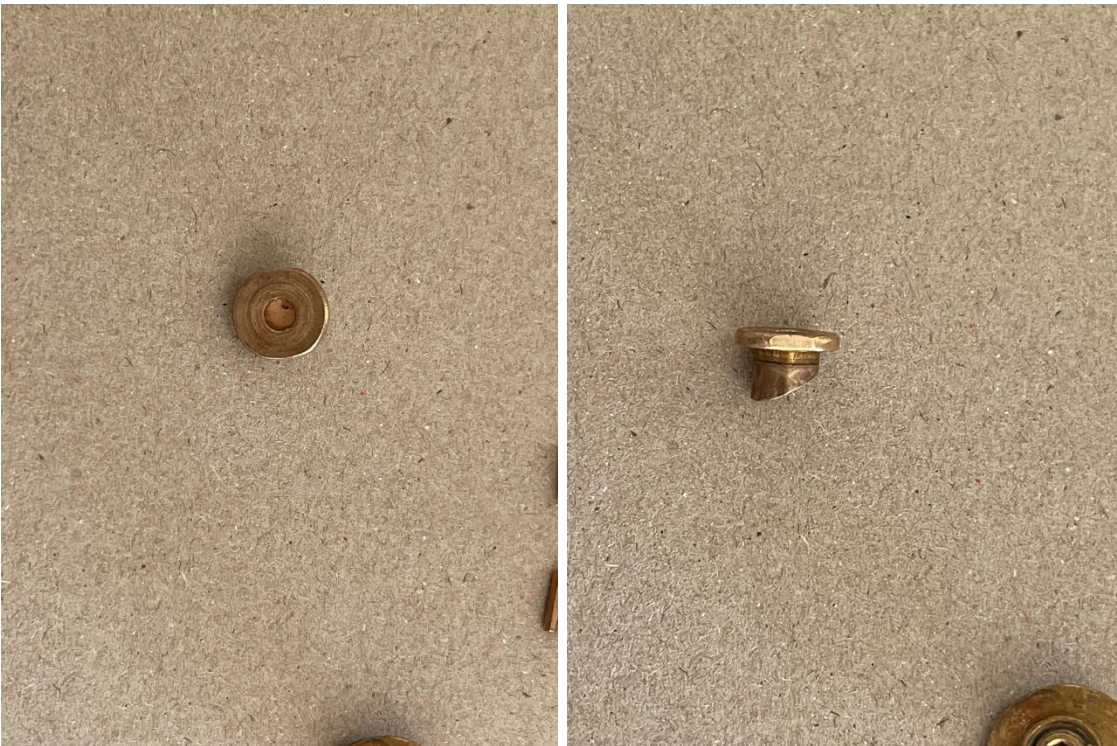
The fusible element for the sprinkler was intact and was not separated, as illustrated in Figure 20. The components of the sprinkler seat/plug were undamaged and exhibited no witness marks indicative of physical damage, as shown in Figures 21 and 22. The tension arms from the sprinkler exhibited no witness marks indicating damage, as depicted in Figure 23. When the inspection concluded, the subject sprinkler and the sprinkler components were left with Sally DeLong.

**Figure 21. Component of the sprinkler seat/plug (16020\_CBS\_2-029, 16020\_CBS\_2-030).**

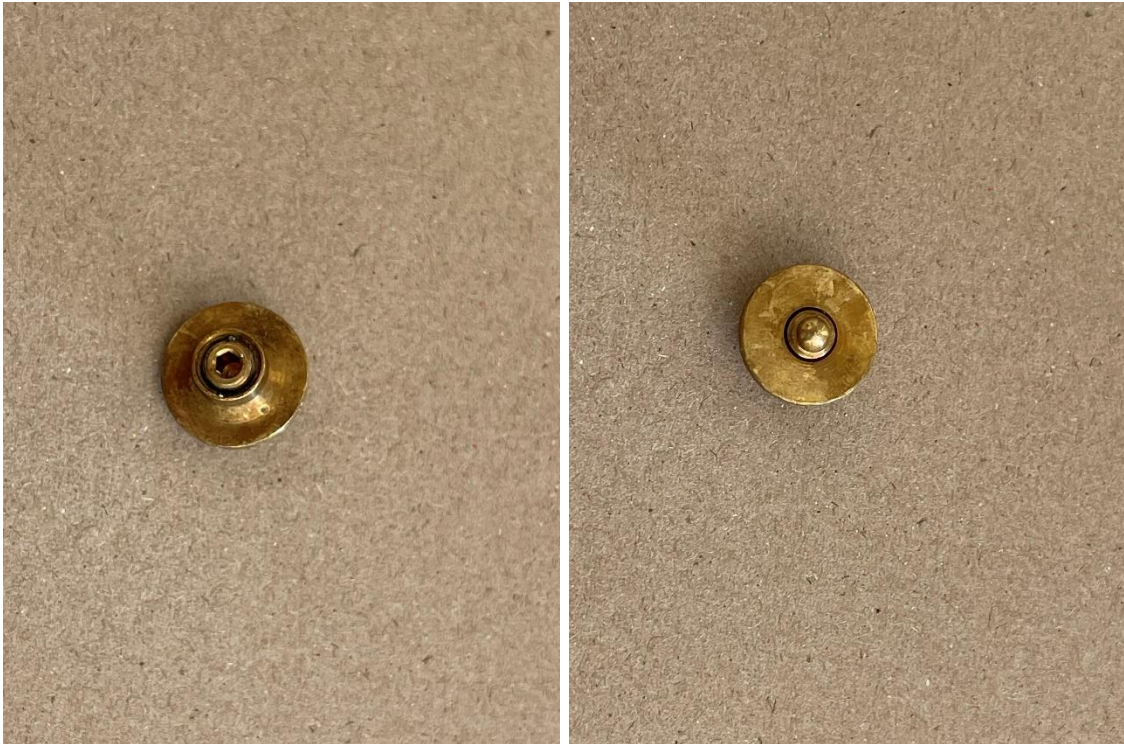
**Figure 22. Component of the sprinkler seat/plug (16020\_CBS\_2-031, 16020\_CBS\_2-032).**

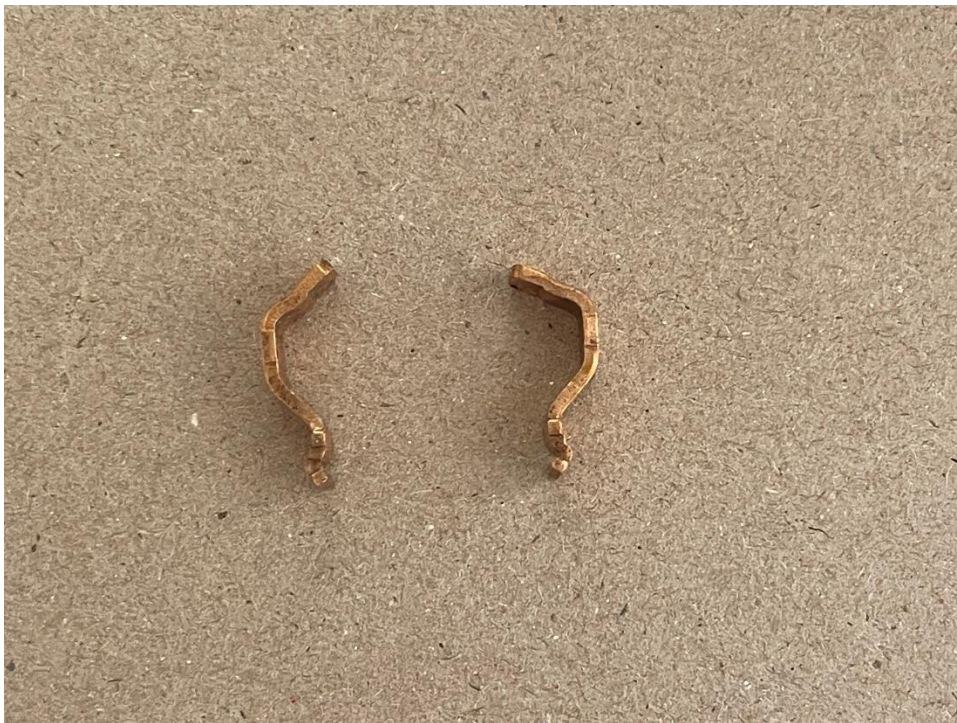
**Figure 23. Tension arms from the subject sprinkler (16020\_CBS\_2-035).**

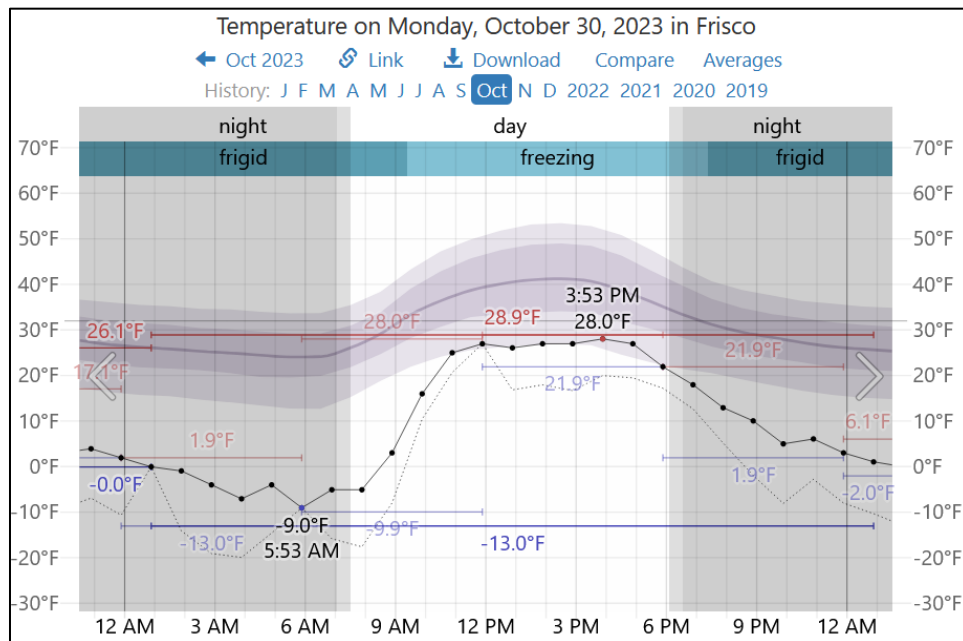
The weather history for Frisco, Colorado was reviewed for dates between October 28, 2023, and November 23, 2023. The weather data was acquired from Weatherspark.com. The low temperature during the reviewed time period was -13°F recorded on October 30, 2023, as illustrated in Figure 24. The high and low temperatures on November 23, 2023, i.e., the date of loss, were 37°F and 16°F respectively, as exhibited in Figure 25.

Figure 24. Excerpts of the weather history extracted from Weatherspark.com for October 30, 2023.

Based on available information and observations during the site inspection, the subject sprinkler more likely than not failed as the result of freezing temperatures leading up to the date of the loss. Temperatures in Frisco, Colorado, dropped to a low of -13°F on October 30, 2023. Additionally, although temperatures were moderate through the date of the loss, they were below freezing each night, and the sprinkler that failed was located on a wet pipe sprinkler system that passed through the north-facing attic of the structure.

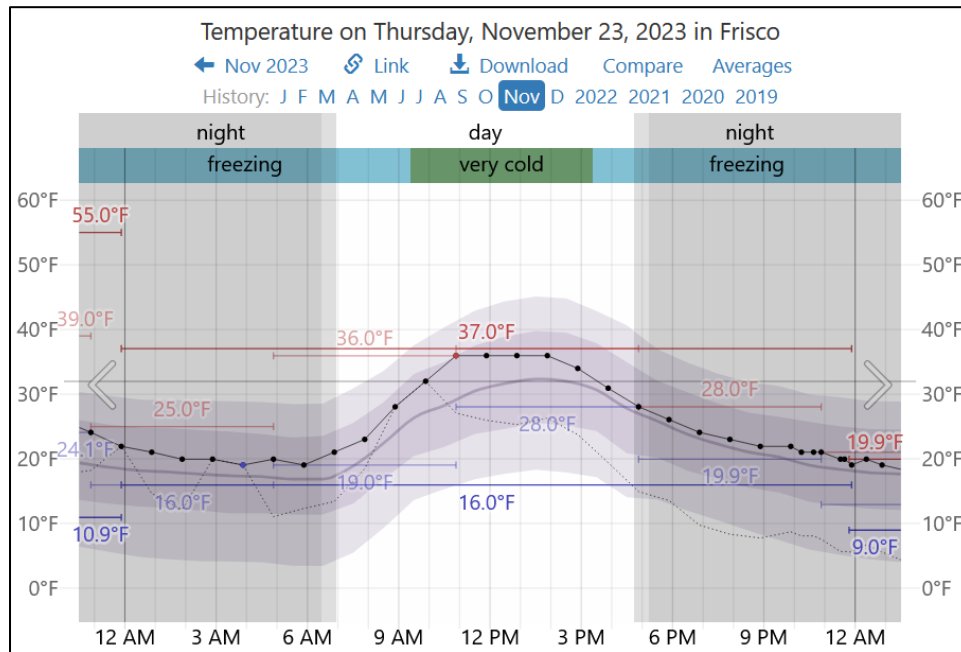
Figure 25. Excerpts of the weather history extracted from Weatherspark.com for November 23, 2023.
