ROOF CONDITION REPORT 6-25-25

CROSS CREEK HOA-FRISCO, CO

Criterion-Cona Engineers

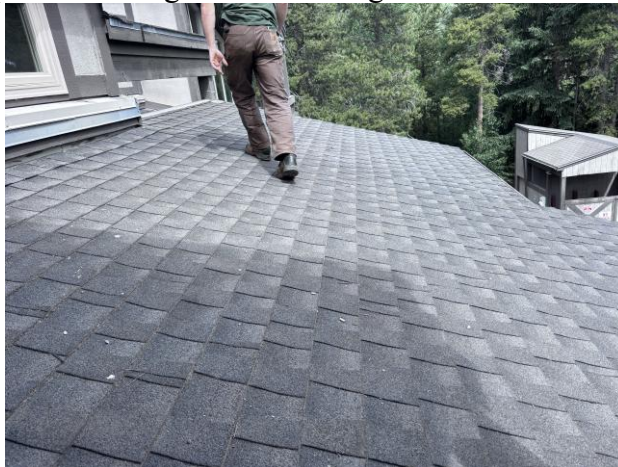
1. Roofs have drip and rake edge metal flashing.

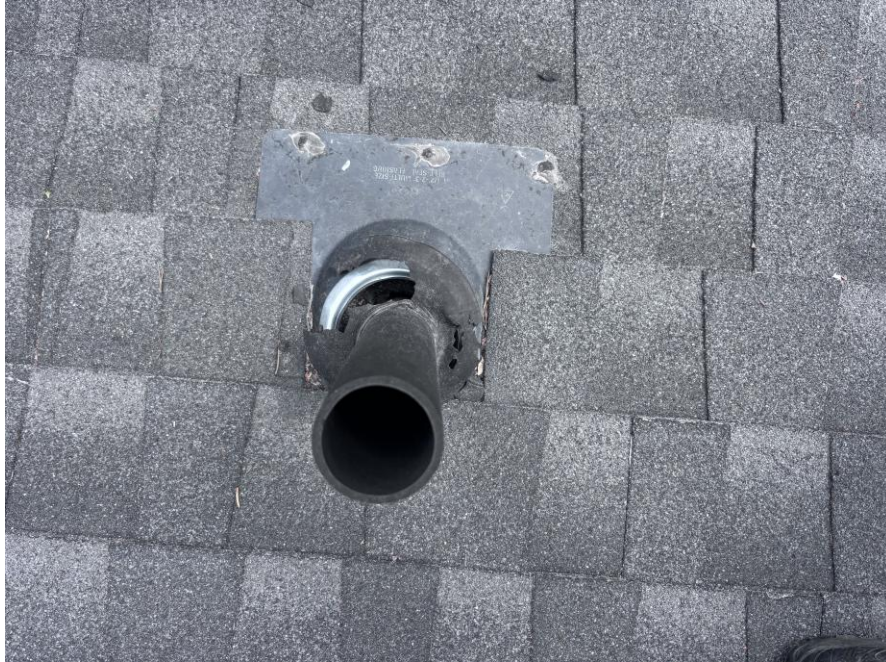
2. Gutters and downspouts on the front and rear with heat tape.
3. One plumbing stack was significantly deteriorated and likely to cause water infiltration into unit #201? (Actual unit # may be different)

1. **Remove and replace asphalt shingle roof down to the roof substrate in 2026.**
(Note- roof replacement may be pushed to 2027- some risk of leakage is possible if replacement is delayed to 2027)
2. **Repair damaged plumbing stack surround in 2025.**
3. Start bidding process with vendors third quarter of 2025.
4. Release vendor contract around March 2026.
5. Modify trim to allow for 12” of underlayment up the vertical surfaces during the rebuild. Install angle flashing and counterflash 12” up head and end walls and at chimneys.

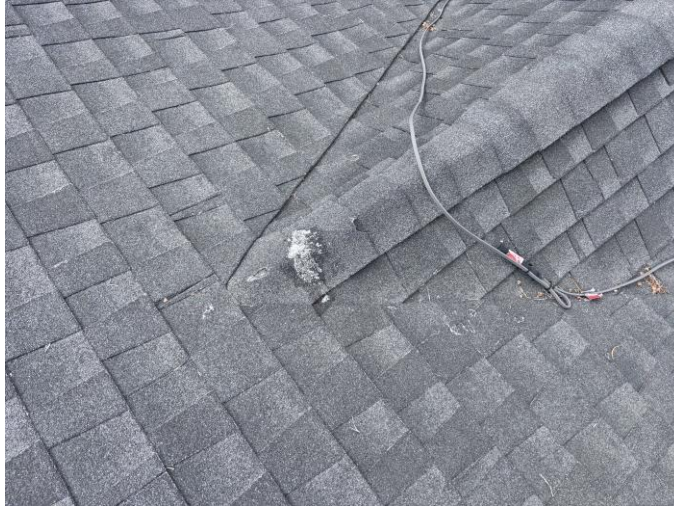
4. No snow guards were observed.
5. Significant leading-edge deterioration of shingles was observed.
6. Significant ridge shingle damage was observed.

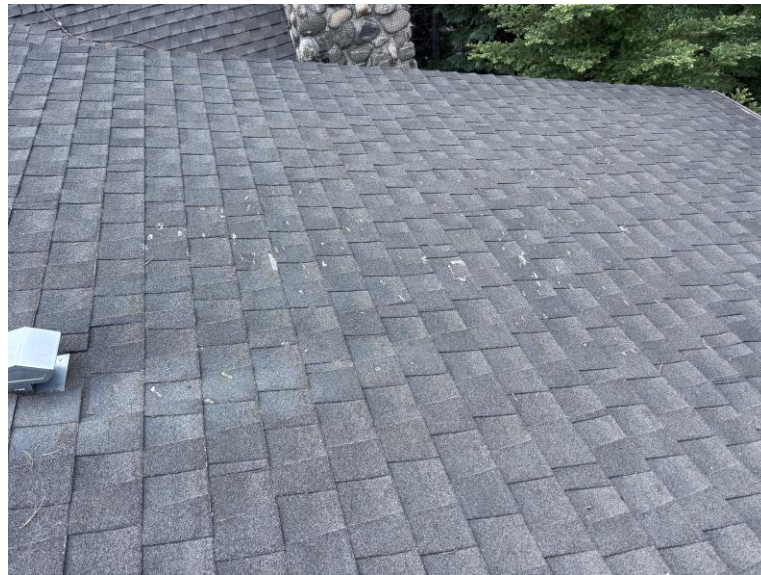
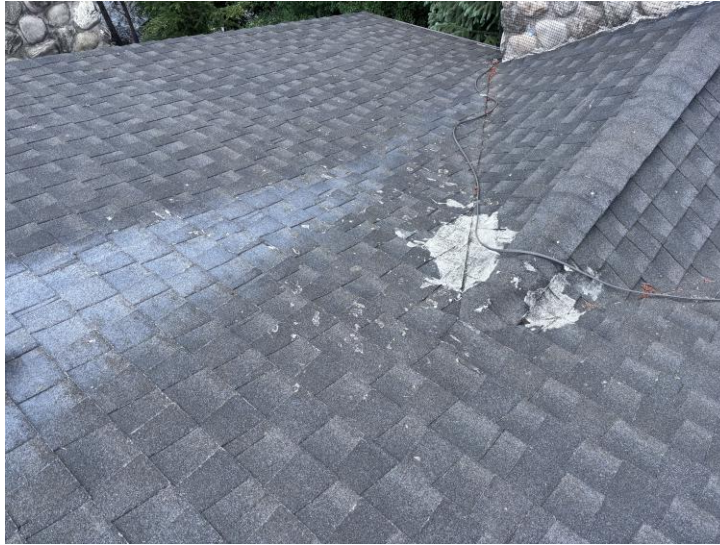
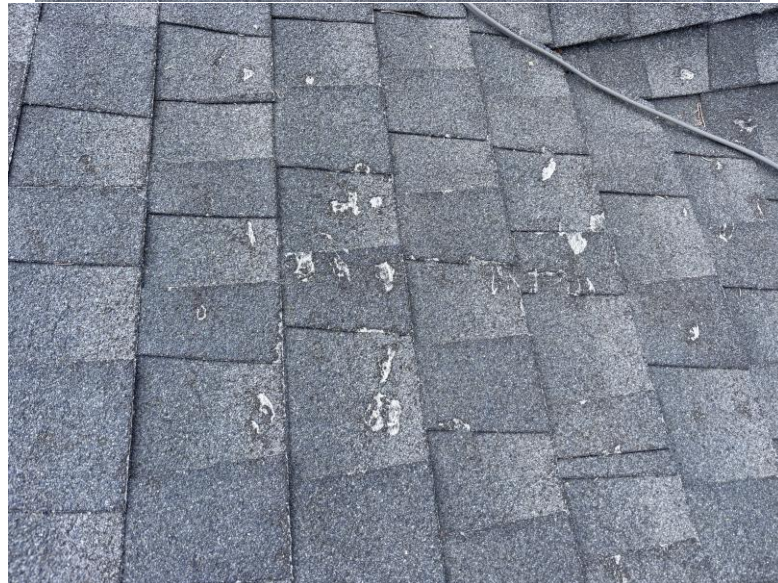
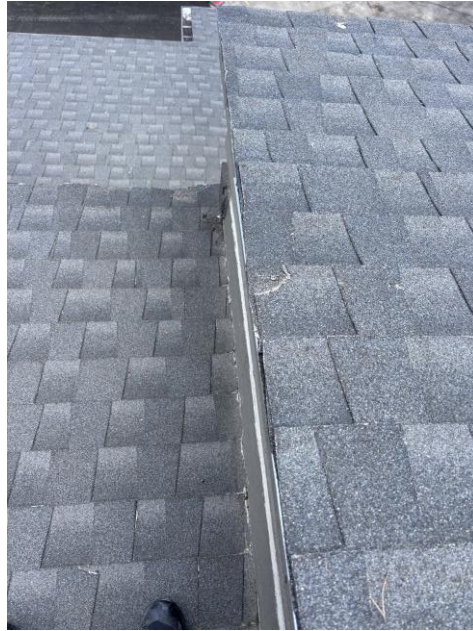
7. Significant damage to the asphalt shingles from ice removal and environmental age was observed.

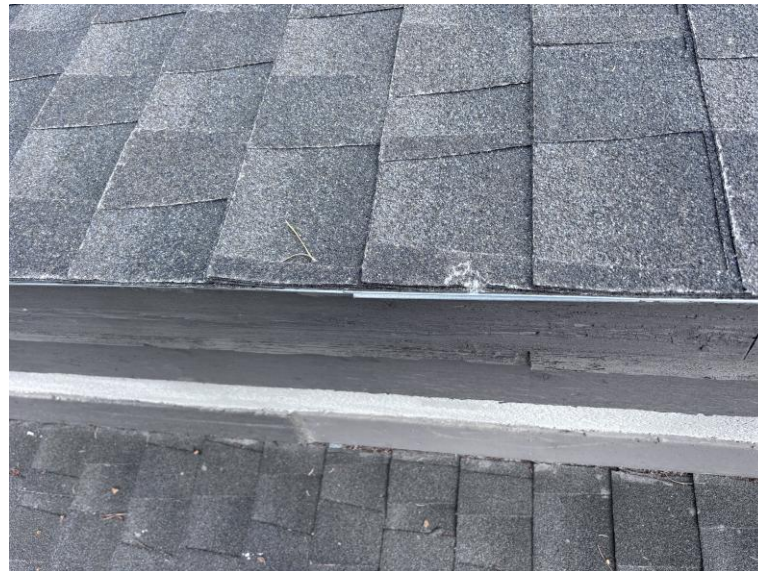
8. Wood trim was in contact with the asphalt shingles leading to some deterioration of the trim.

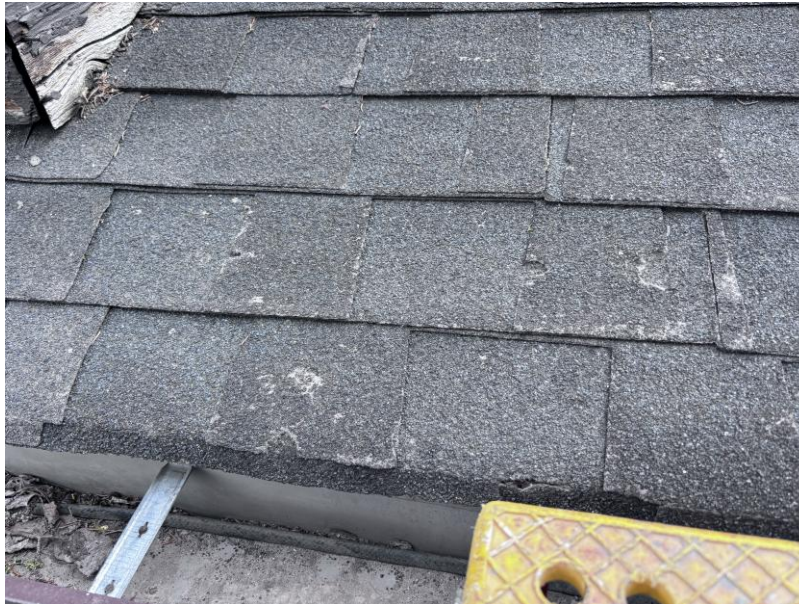
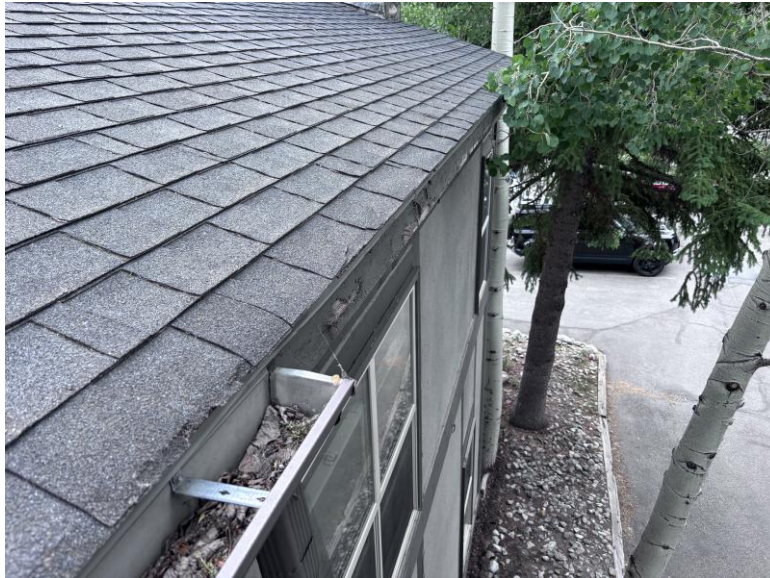
1. Roofs have drip and rake edge metal flashing.
2. No snow guards were observed.
3. Significant leading-edge deterioration of shingles was observed.
4. Significant damage to the asphalt shingles from ice removal and environmental wear was observed.

1. **Remove and replace asphalt shingle roof down to the roof substrate in 2026. The condition of the clubhouse roof is similar to #200-300. (Note- roof replacement may be pushed to 2027- some risk of leakage is possible if replacement is delayed to 2027)**

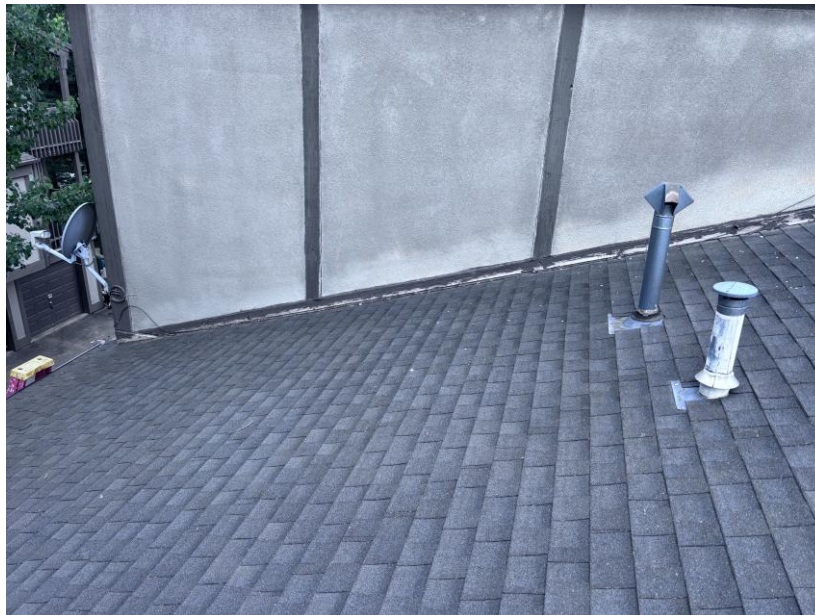
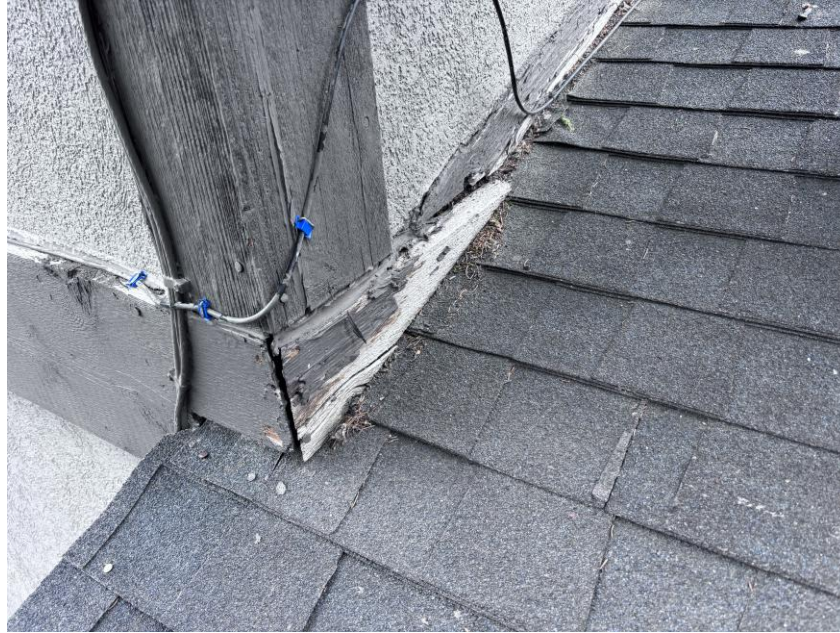
5. Wood trim was in contact with the asphalt shingles leading to some deterioration of the trim.

2. Start bidding process with vendors third quarter of 2025.
3. Release vendor contract around March 2026.
4. Modify trim to allow for 12” of underlayment up the vertical surfaces during the rebuild. Install angle flashing and counterflash 12” up head and end walls and at chimneys.

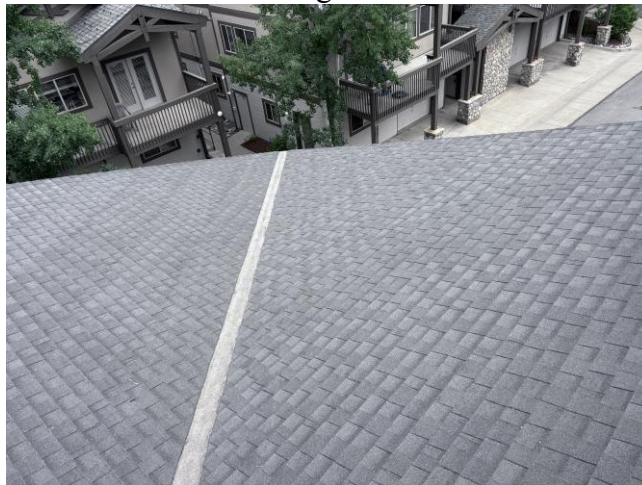
6. Open valleys do not have metal flashing.

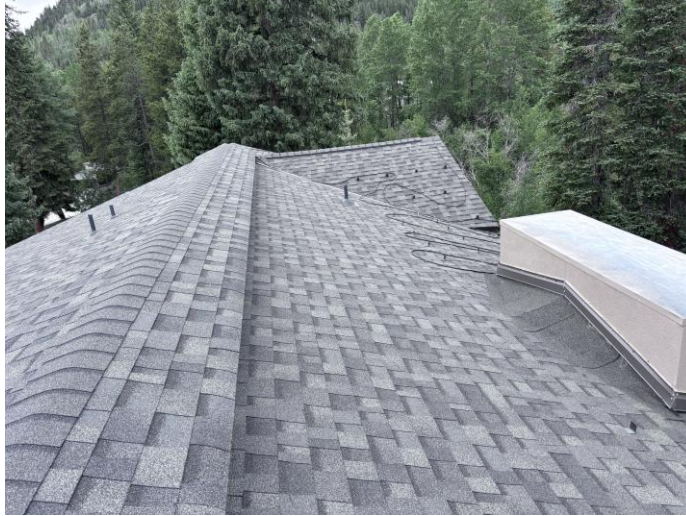
1. Roofs have drip and rake edge metal flashing.
2. Gutters and downspouts on the front and rear with heat tape.
3. Snow guards were observed with S-type heat tape at roof eaves.

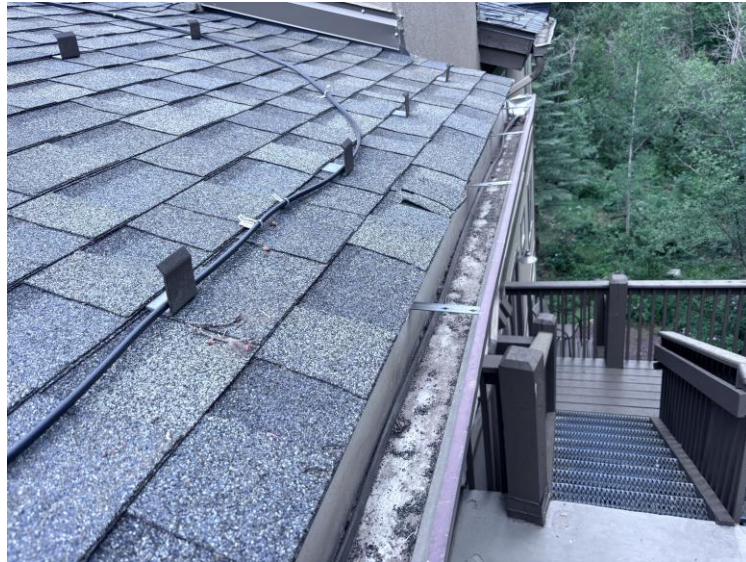
4. No significant deterioration of shingles was observed. Some minor mechanical shingle damage was observed at eaves.

1. **Remove and replace asphalt shingle roof down to the roof substrate in year 8-10.**

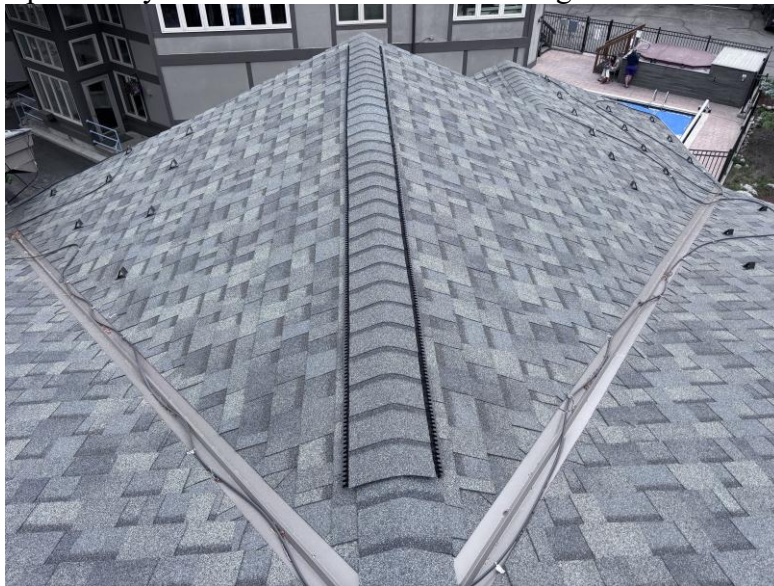
5. W-type open valley metal installed with vented ridge.

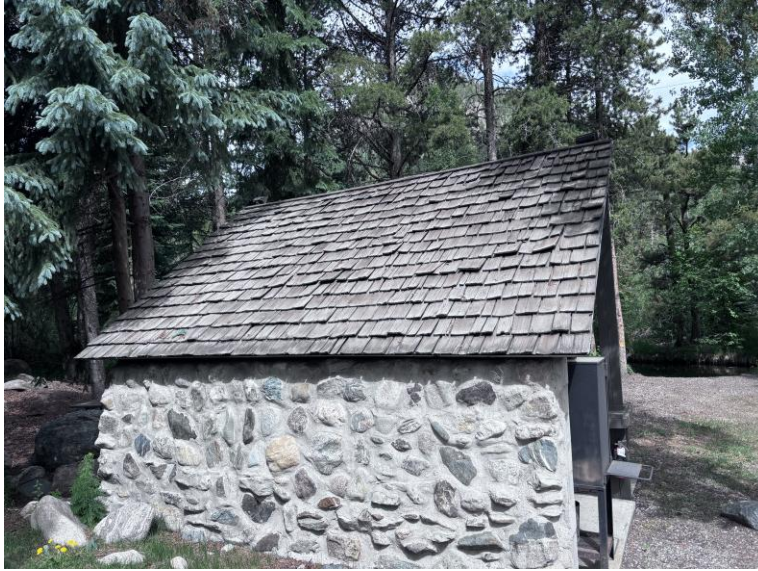
6.0 Observations Picnic -shed roof

1. Cedar shake shingles- should replace when #100 building roofs are replaced.

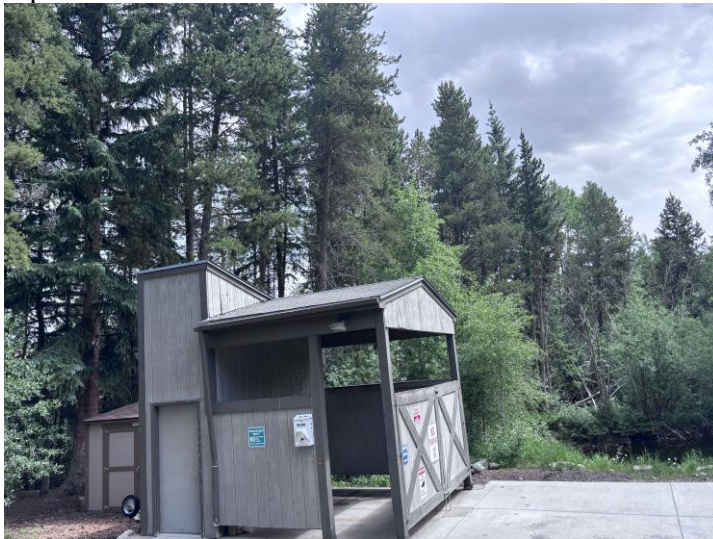
6.1 Trash enclosure roof

1. Trash enclosure asphalt shingle roof- should replace when #100 roofs are replaced.
