Property: Lake Forest
Lake View Terrace-Frisco, CO

Service: Full Reserve Study

FRISCO, COLORADO

Site Inspection 5/25/21
INITIAL DRAFT submitted: 6/8/21
FINAL REPORT Submitted 6/21/21

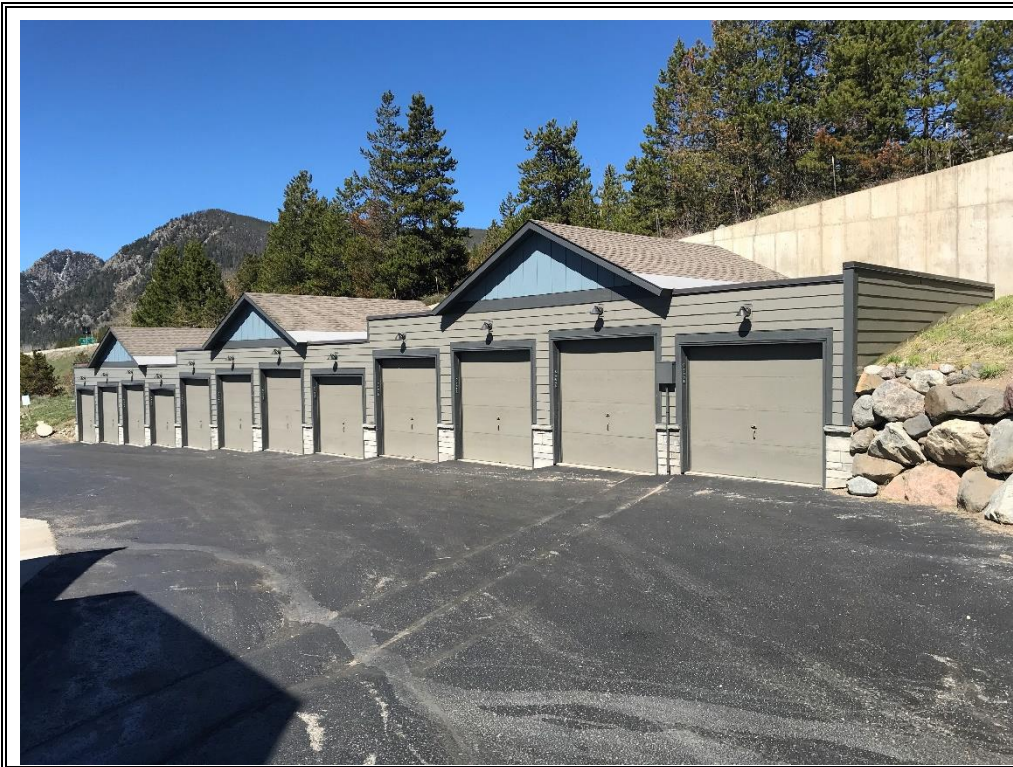
PHOTOGRAPH 1

Description:
EUL-25 years asphalt
RUL- 4 years asphalt replacement with 3” cut and overlay.
Crack seal and seal coat every 4 years.
SUMMARY- Asphalt parking surface showing cracks and deterioration.
REPAIRS- Cut and 2” overlay of complete parking lot with new striping.

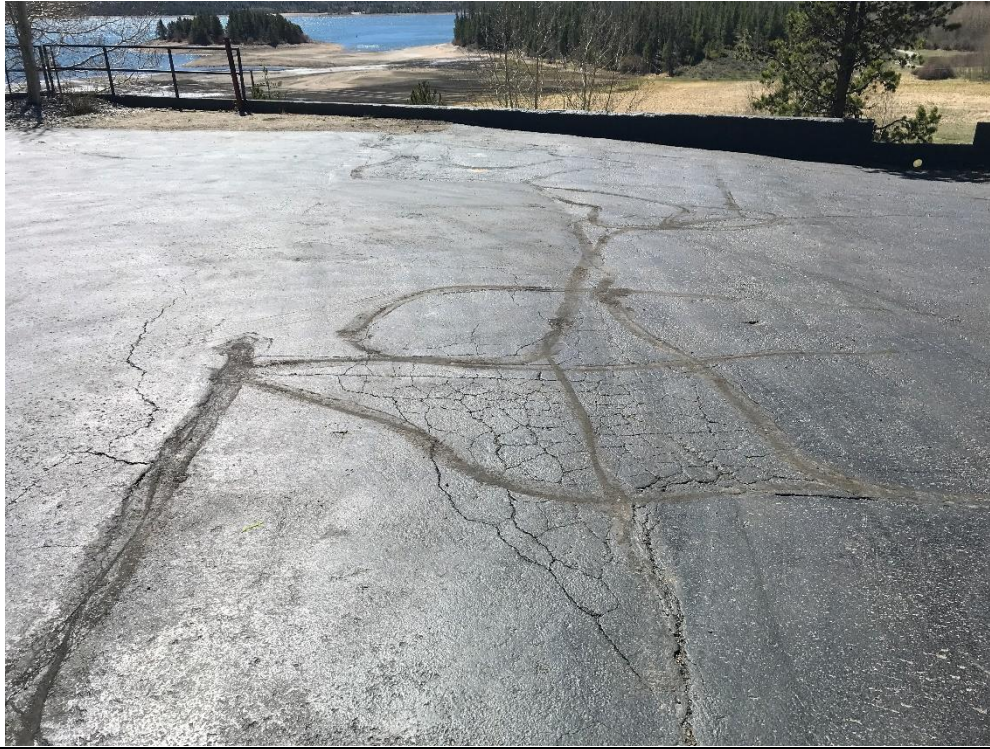
PHOTOGRAPH 2

Asphalt parking area- used for snow storage in the winter.

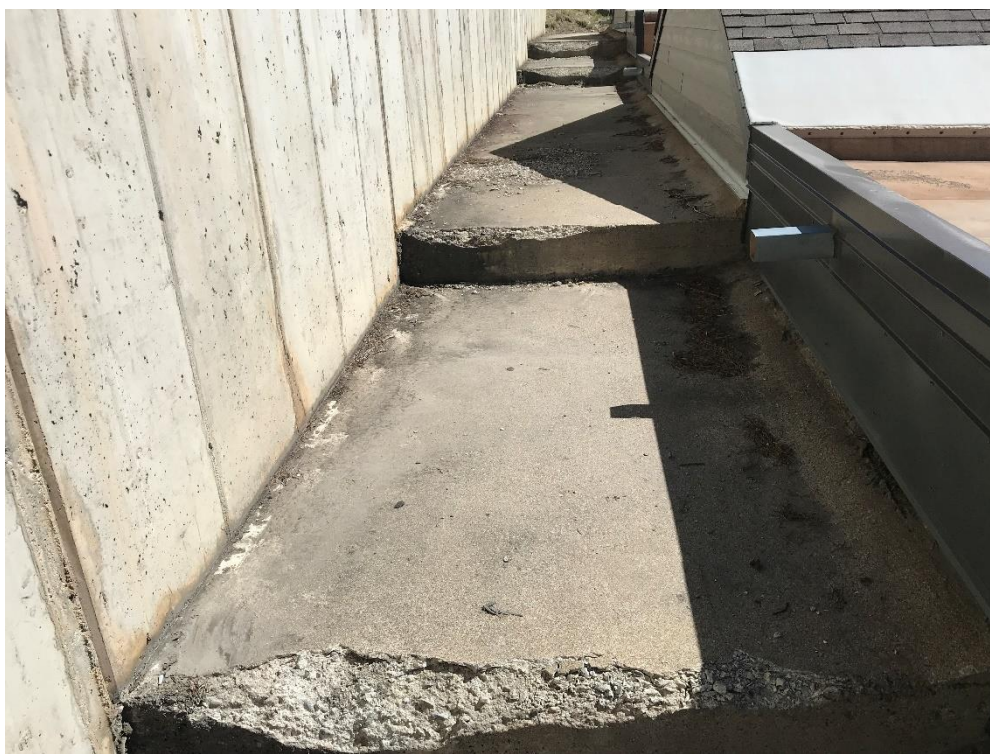
PHOTOGRAPH 3

Location: Behind West
garages
EUL-30 years
RUL- 2 years
SUMMARY- concrete damage
due to environmental wear

REPAIRS- Remove and
replace with new steps.

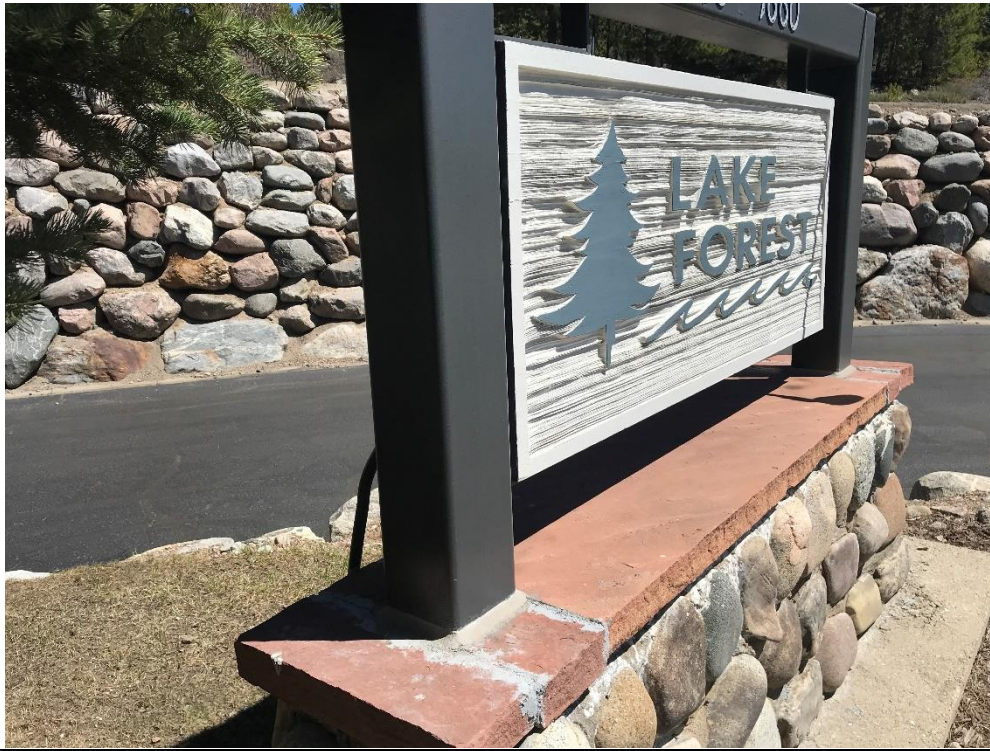
PHOTOGRAPH 4

Location: Parking entrance
 EUL-18 years
 RUL- 2 years
 SUMMARY- Sign portion is newer, base support has some internal rot of framing structures.
 REPAIRS- Remove and replace base sign support.

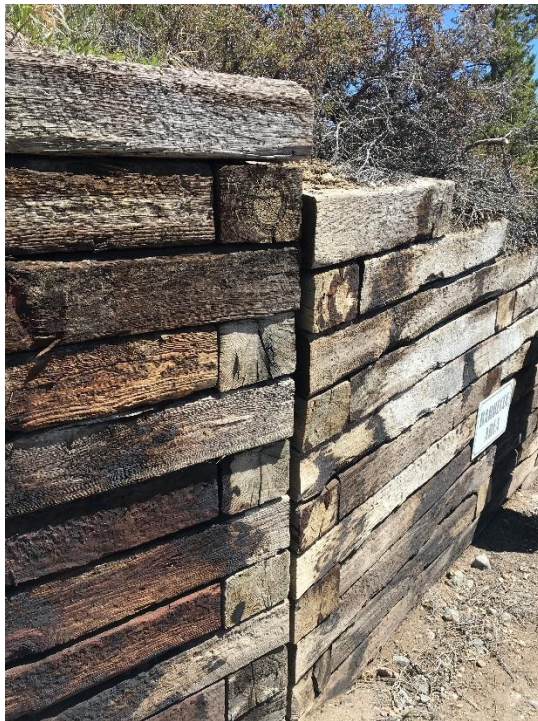
PHOTOGRAPH 5

Location: North side of property behind E & F buildings
 EUL-35 years
 RUL- 3 years
 SUMMARY- Wall has not shifted significantly since 2017. FEZ is monitoring wall movement in multiple locations with horizontal measurements to the building wall.
 REPAIRS- Year 3 -major repair and stabilization. Year 10 50% wall replacement.

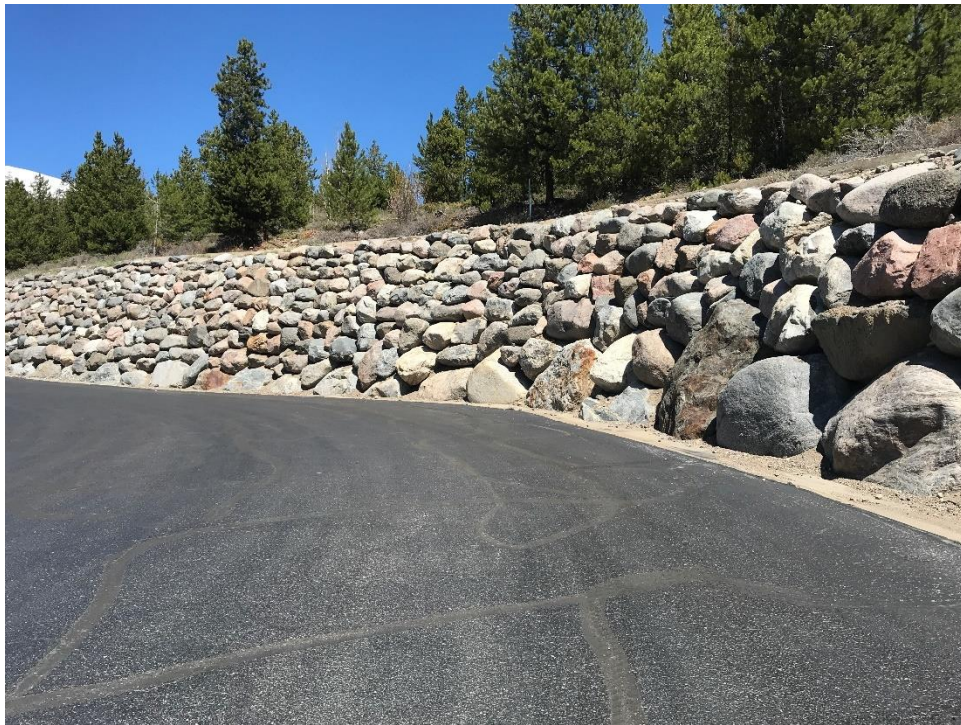
SUMMARY- Rock wall is stable and in good condition. Work was completed to improve gutter flow at top of wall.

REPAIR: Major repair shown in Year 10. Maintenance of top gutter flow will extend wall life.

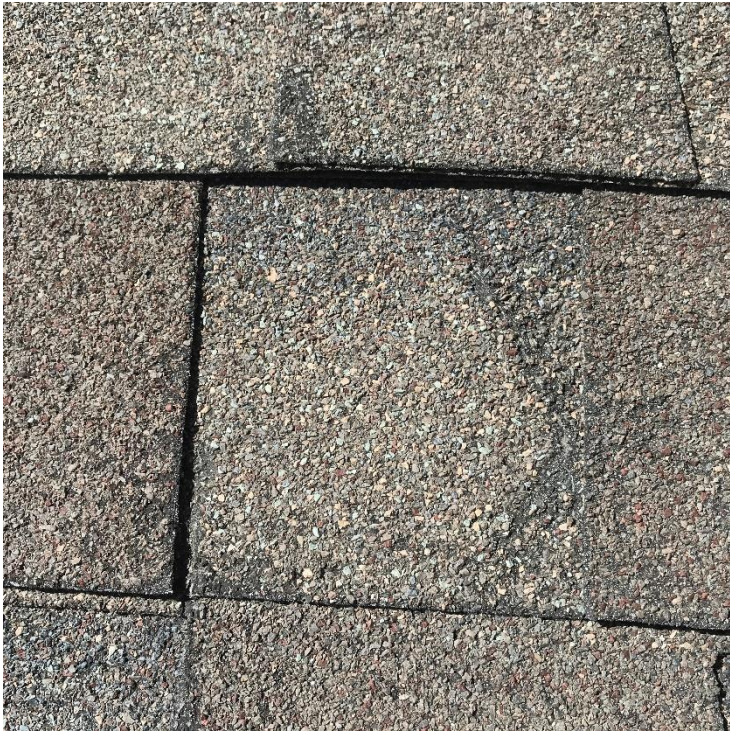
<p><u>Description:</u></p> <p>Location: Garage, clubhouse and trash enclosure EUL-22 years RUL- 0 years SUMMARY- Asphalt shingles are showing loss of granules, cracking and scrim is visible in some locations. Appears to be environmental deterioration and not hail damage.</p> <p>REPAIR: Replace with new asphalt shingles.</p> <p>PHOTOGRAPH 7</p>
---	--

The sloped asphalt shingle roofs on the garages, trash enclosure and the clubhouse are showing deterioration and will need replacement in 2021. The roofs are missing granules and showing advanced wear.

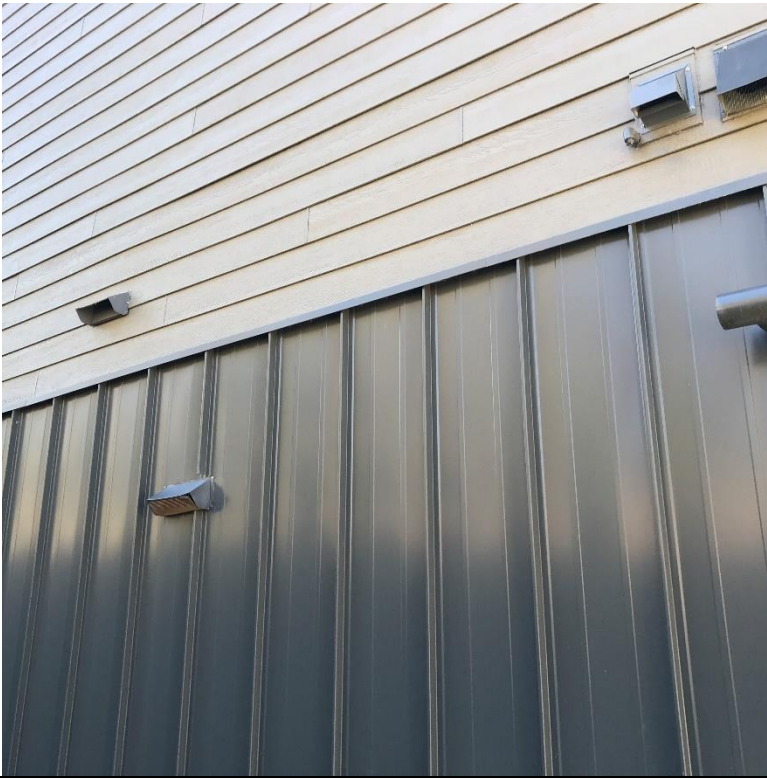
PHOTOGRAPH 9

EUL-35 years
 RUL- 34 years
 SUMMARY- 2020 installed
 lapped DiamondKote upper
 siding and standing seam metal
 lower wall.
 REPAIR: None.

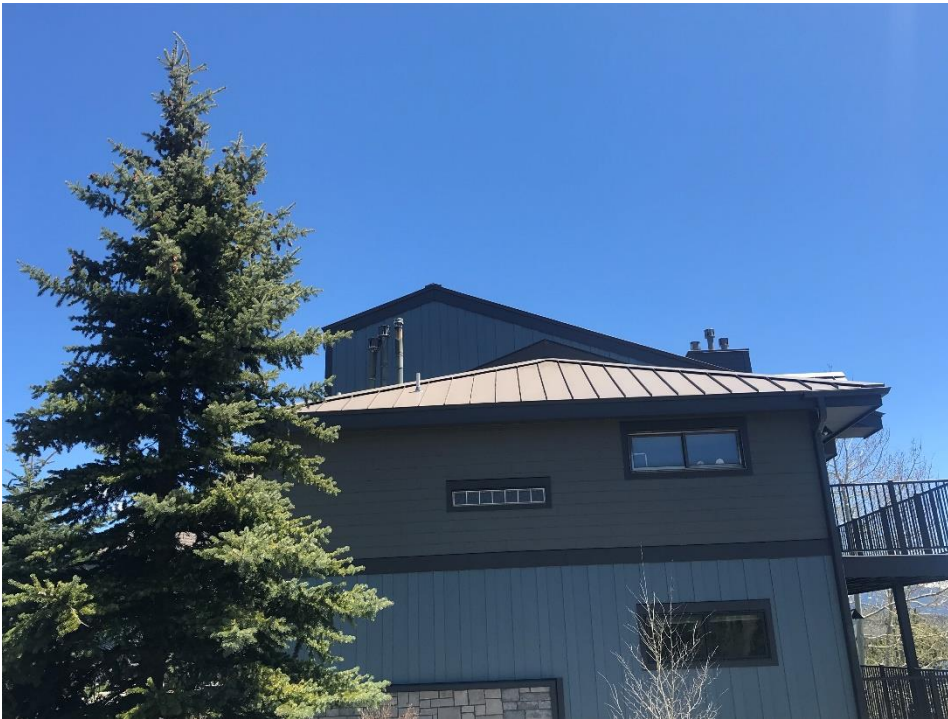
PHOTOGRAPH 10

EUL-40 years
 RUL- 20 years
 SUMMARY- Standing seam
 metal roof on all condo
 buildings is in good condition.
 REPAIR: Replace with
 equivalent product.

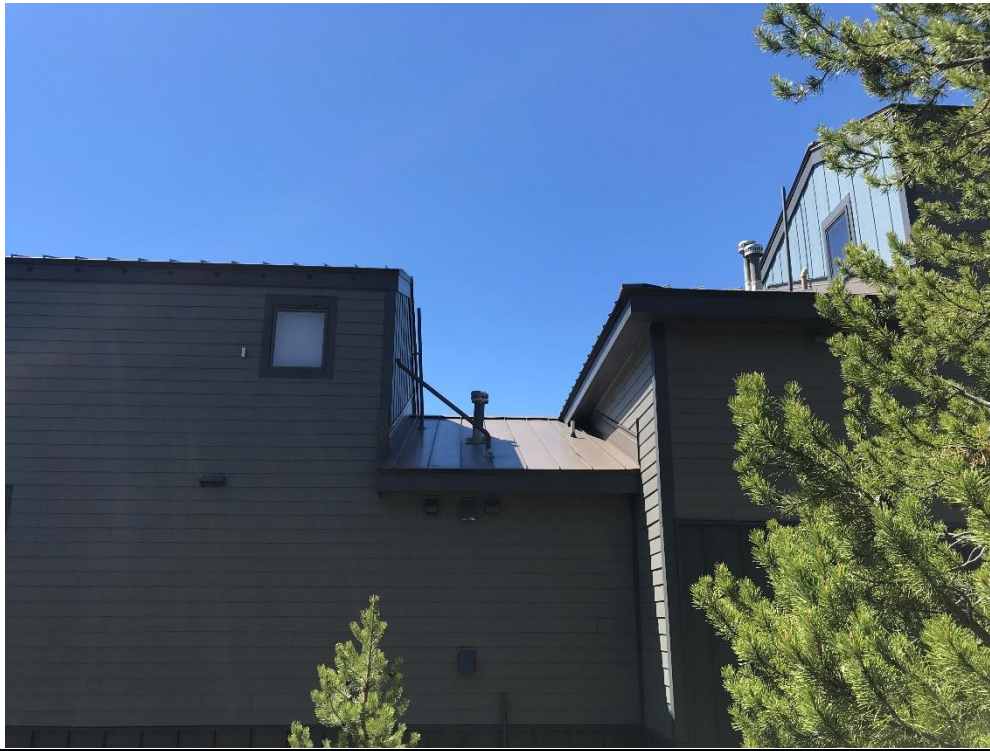
Roof vents are in fair condition and shown for replacement/repair.

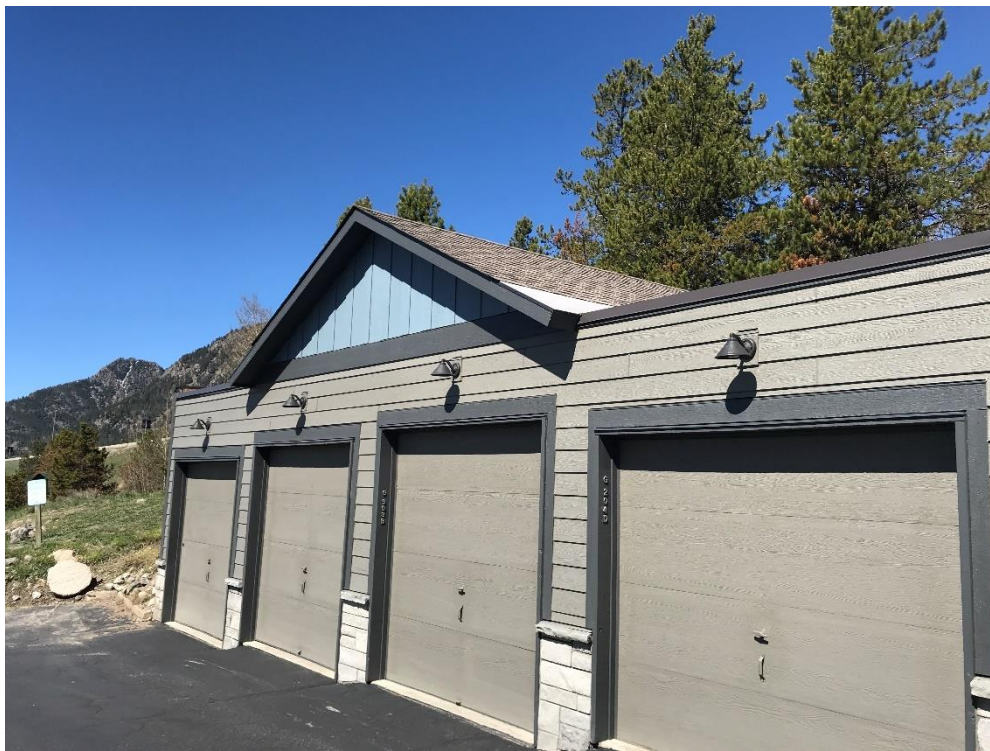
PHOTOGRAPH 11

EUL-25 years
RUL- 24 years
SUMMARY- Garage and entry lights replaced in 2020. Breezeway lighting not replaced at that time.
REPAIR: Replace as needed with energy efficient fixtures.

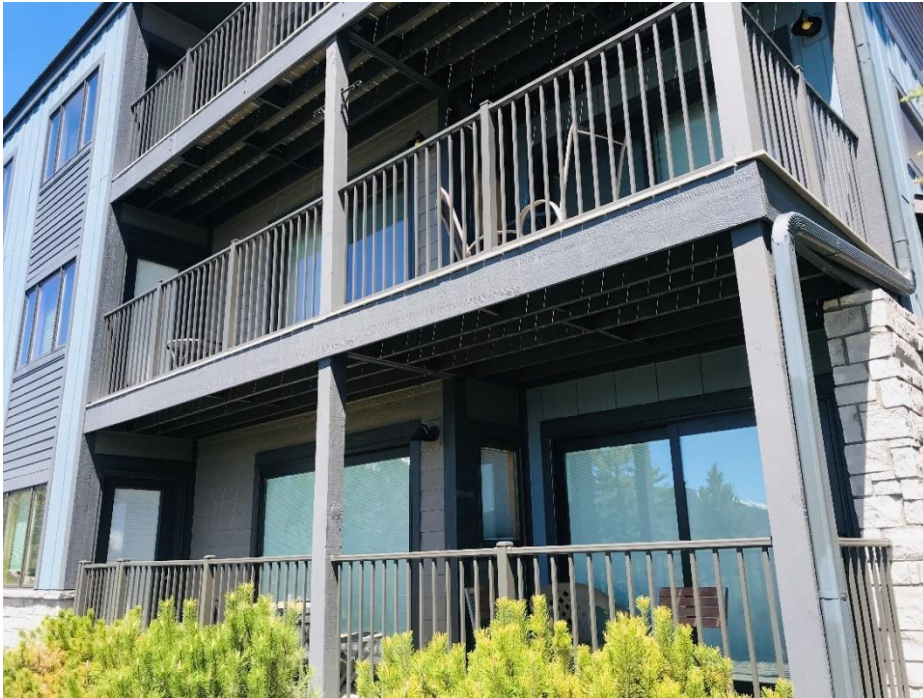
EUL-30 years
RUL- 30 years
SUMMARY- Railings are iFence Integrity and installed in 2020 at the same time the deck boards were installed.
REPAIR: Remove and replace the Envision Evergreen decking in Year 20 with equivalent product.

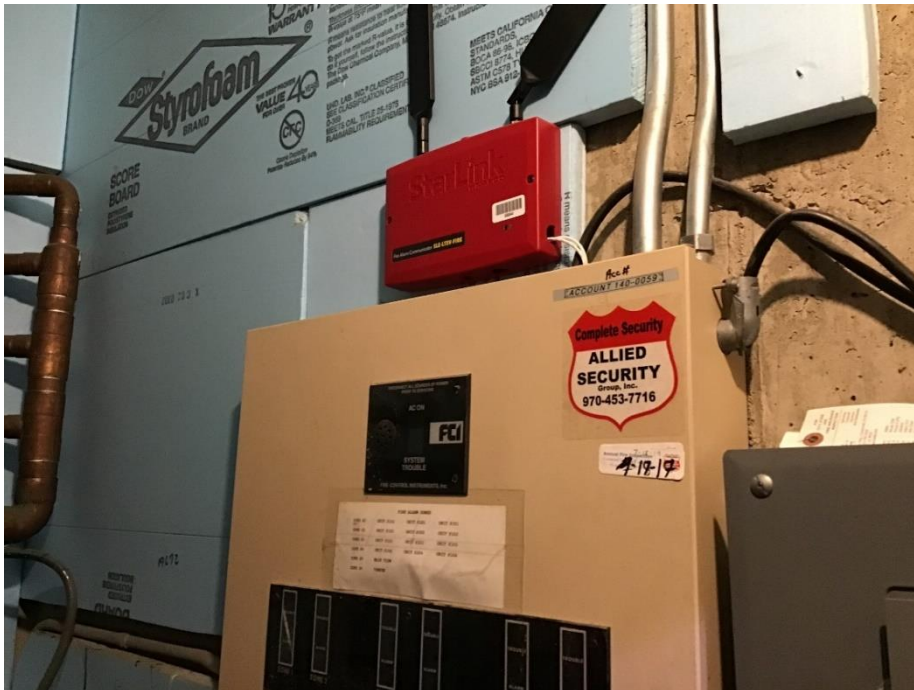
PHOTOGRAPH 13

EUL-20 years
RUL- 2 years
SUMMARY- One fire control has been upgraded to RF unit. 5 additional fire control systems are shown for upgrade in Year 2.
REPAIR: Remove and replace with current technology and RF communication.

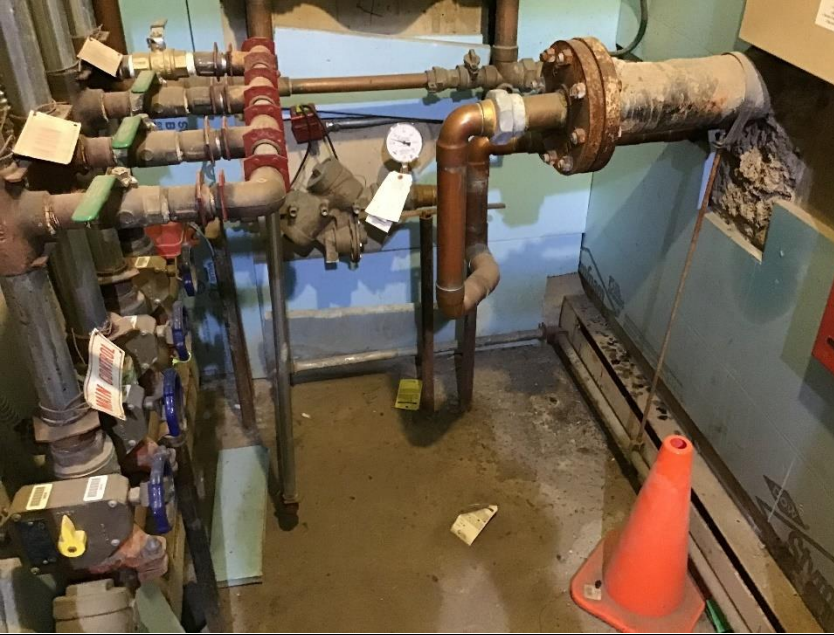
Fire hydrants and fire alarm control panels were observed in each building on the property. Fire alarm panel is monitored and located in lower level stairwells. The supply piping to individual units is the POZ-LOK system in A, B, E and F building that has been recalled by the manufacturer. This system has not developed any problems to date, but there is a lawsuit in progress.

SUMMARY- Poz-lok system has been the subject of a recall but is not leaking at this time.

REPAIR: Poz-Lok connections are throughout the sprinkler system that extends from the fire control room into each unit. When replacement is required, the entire fire piping system would be considered for upgrade.

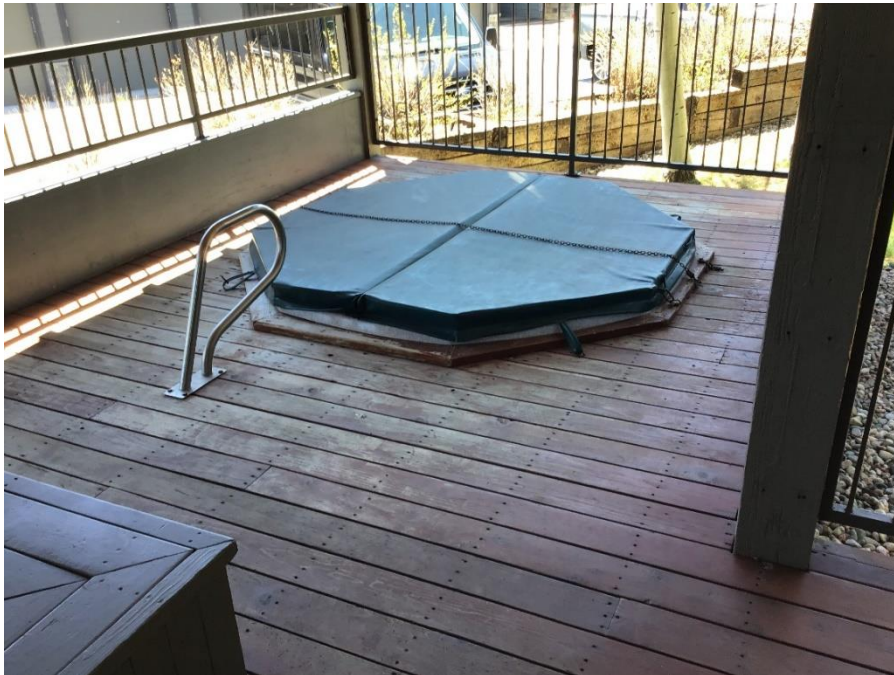
PHOTOGRAPH 15

SUMMARY- Tubs and covers are currently in good condition.

REPAIR: Remove and replace as units age.

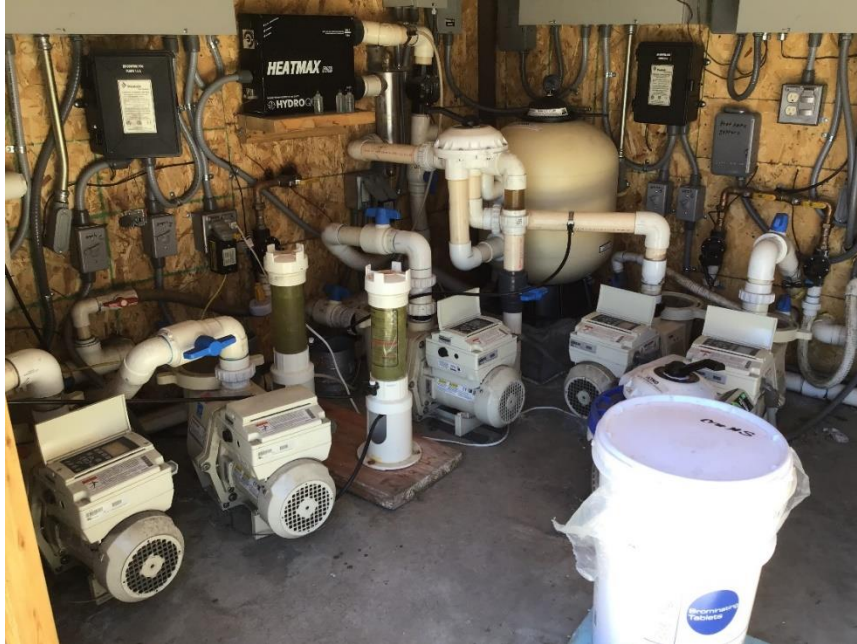
PHOTOGRAPH 16

SUMMARY- 6 pumps were replaced in 2017 with VFD controlled pumps with pressure cutouts.

REPAIR: Remove and replace typically when pumps can no longer be rebuilt. Some motor replacement possible as an operating expense.

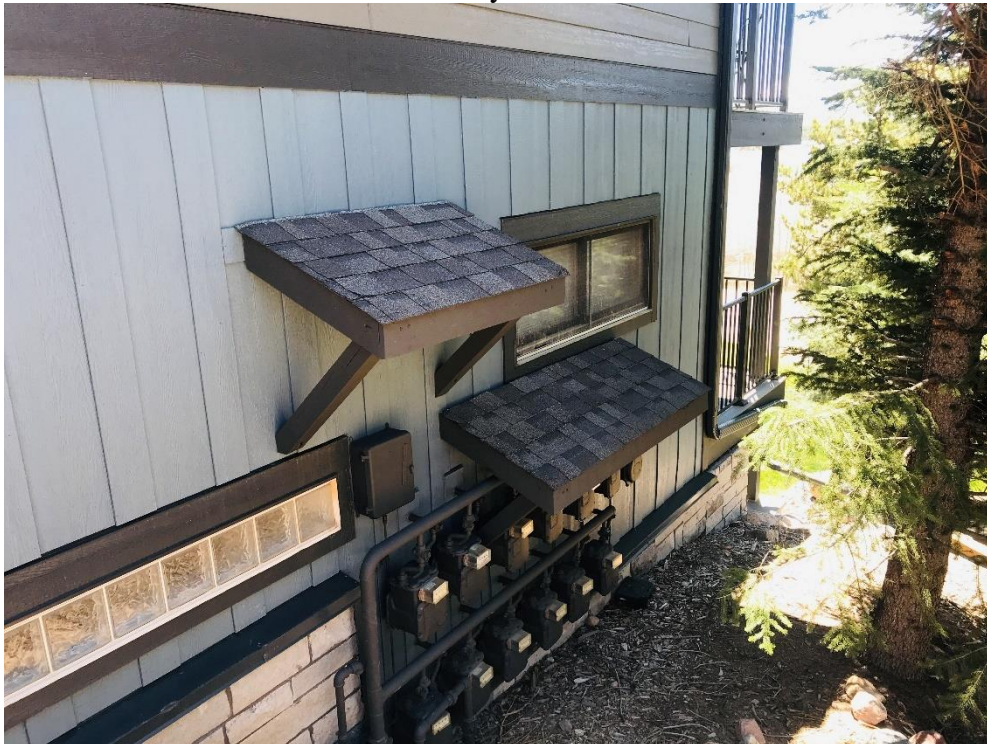
PHOTOGRAPH 17

SUMMARY- Small roofs are installed to protect utilities from weather.

REPAIR: Not properly flashed. Flashing should be installed behind the siding and extend over asphalt shingle.

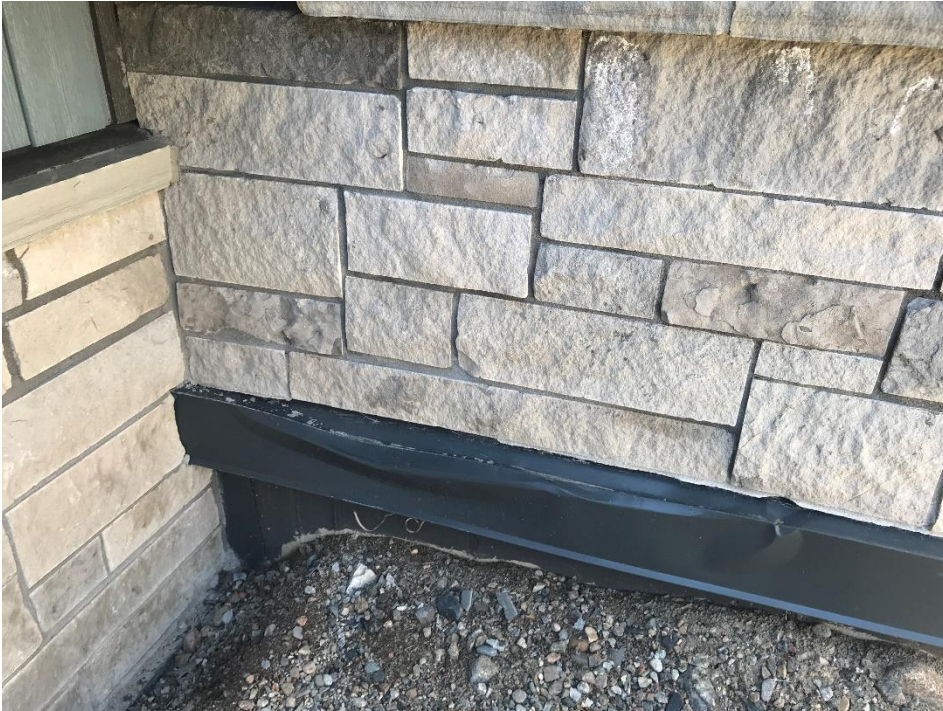
PHOTOGRAPH 18

SUMMARY- Efflorescence is salts (white powder) that is left on the surface of the stone as water evaporates.

REPAIR: Control water release from the stone.

Remove visible stains with Vanatrol or equiv.

Remove grout at base of stone wall to allow for water removal at the base without weep holes.

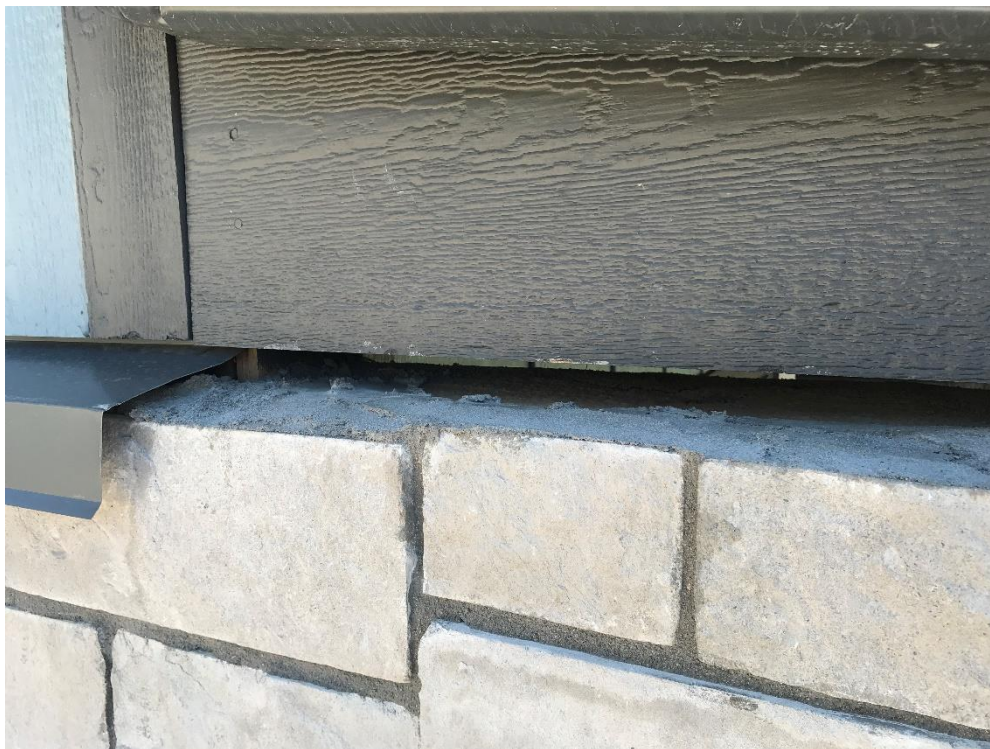
PHOTOGRAPH 19

SUMMARY- Stone veneer missing cap.

REPAIR: Two locations where cap is missing and could allow water penetration.

B & C building.

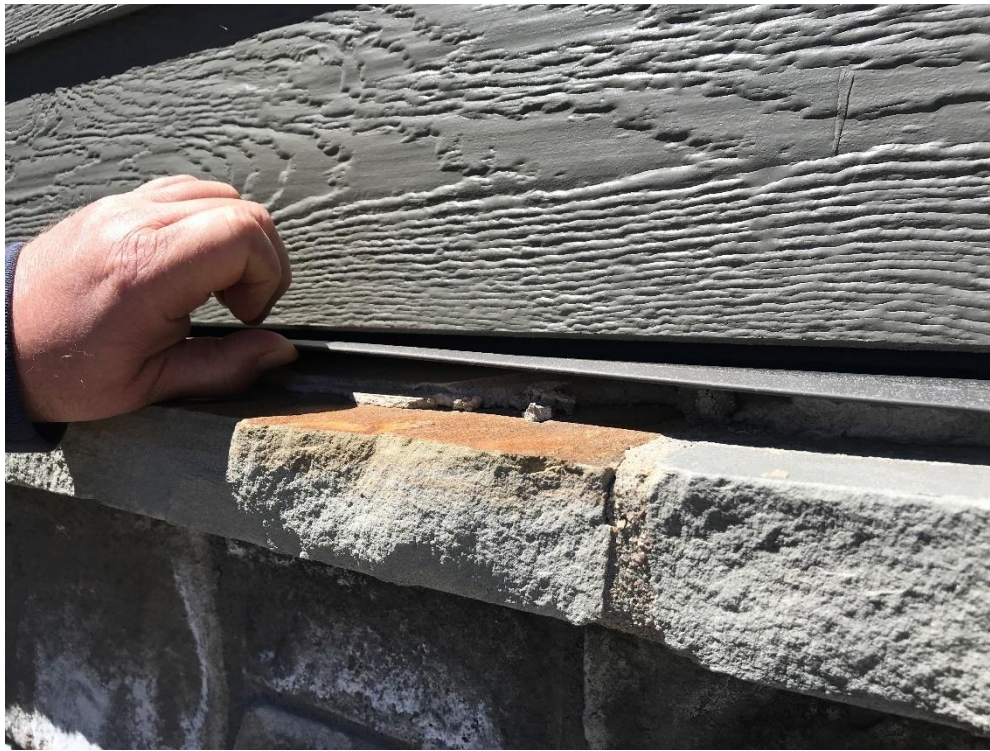
SUMMARY- Grout installed on top of stone cap and allowing water to pass behind stone veneer at cap.

REPAIR: Remove grout and seal flashing with caulk.
