# **PRELIMINARY INVESTIGATION REPORT**

## **Sprinkler System Freeze Loss**

Rep/Ins: Lake Forest Condo Association  
Location: 1630 Lake View Terrace, Building B,  
Unit 304B, Frisco, Colorado  
Claim No.: 115884-1  
Date of Loss: 02/23/22  
AEI Project No.: 15092

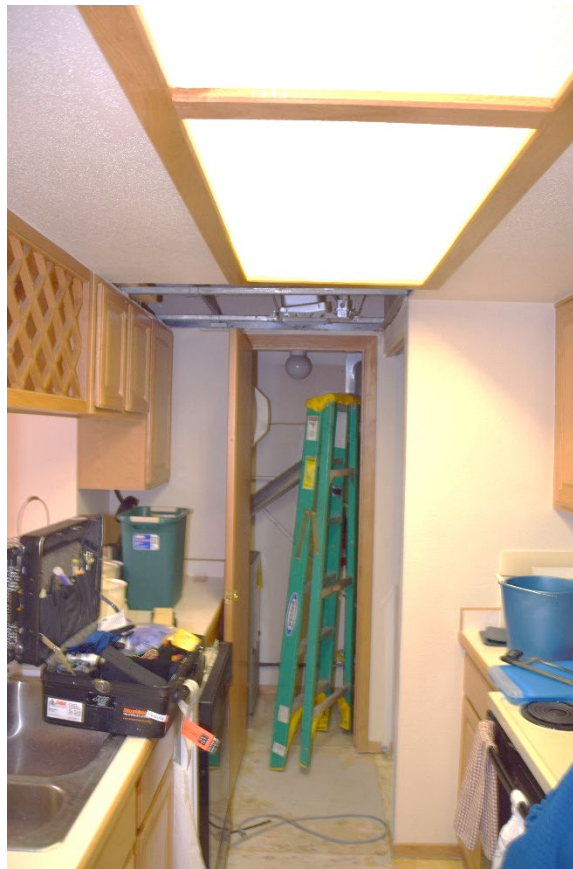
This writer attended a site inspection on March 14, 2022. John Iverson of McMillan and Keith McBreathy from Summit Resort Group (Summit) were also in attendance. The kitchen area of Unit 304B was accessed (Figure 1), and it was observed that the ceiling had been opened to locate the leak (Figure 2). There were two levels of gypsum board, a main ceiling, and an additional fire barrier approximately 15-inches above the main ceiling, also shown in Figure 2. The water damage observed was limited to the kitchen of the subject unit. It was determined by Summit that a sprinkler line had separated, resulting in the discharge of water into the unit. The subject sprinkler line was determined to be comprised of  $\frac{3}{4}$ -inch Poz-Lok tubing and a  $\frac{3}{4}$ -inch Poz-Lok 90° elbow, as shown in Figure 3.

**Figure 1. Kitchen in Unit 304B (15092 CBS 1-007).**

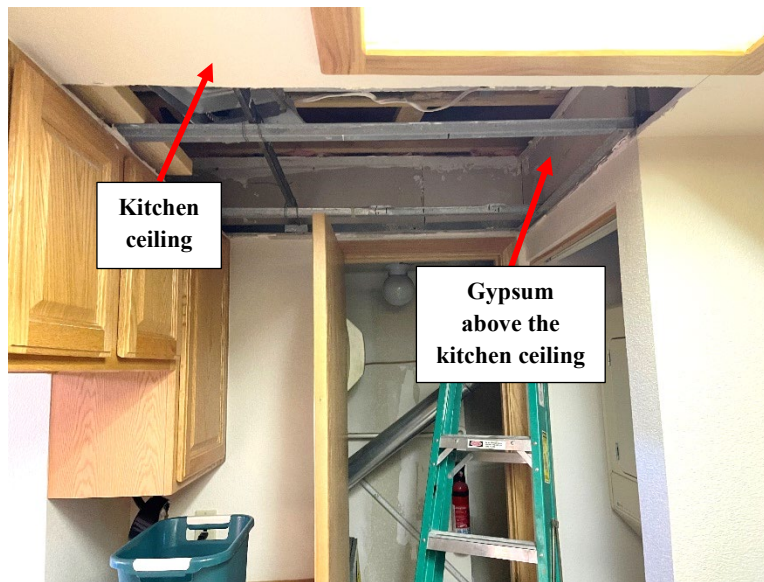
On February 23, 2022, the sprinkler system in Building B, Unit 304B, was observed leaking in the kitchen from the west ceiling in proximity to the mechanical room. The maintenance staff opened the ceiling to determine where the leak was located and concluded a sprinkler line in the attic was the source of the water.

**Figure 2. Removed ceiling in kitchen of Unit 304B (15092 CBS 2-006).**

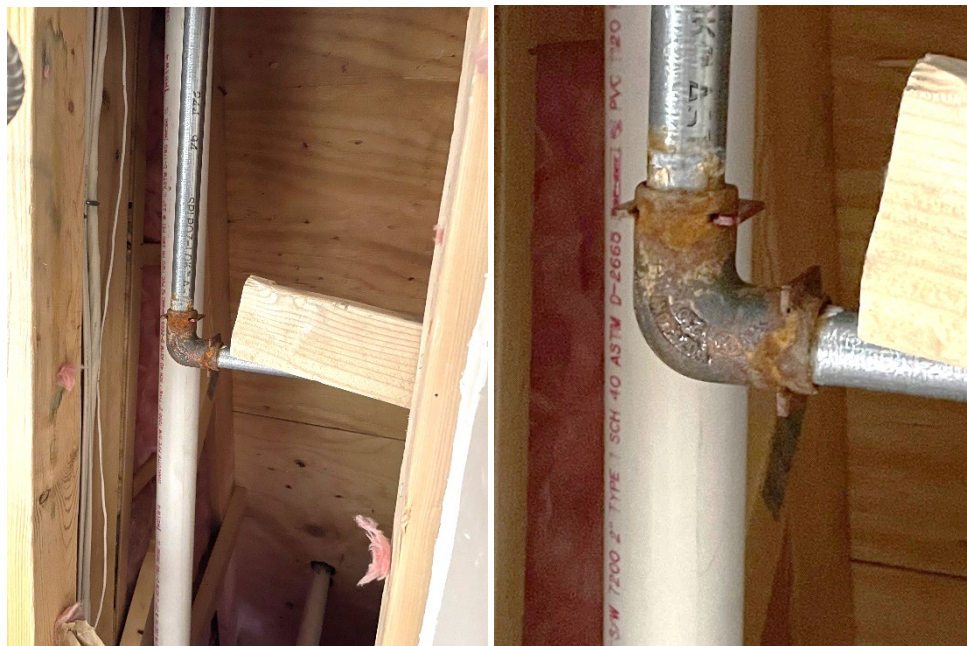
**Figure 3. Subject sprinkler pipe and fitting (15092 CBS 2-001, CBS 2-002).**

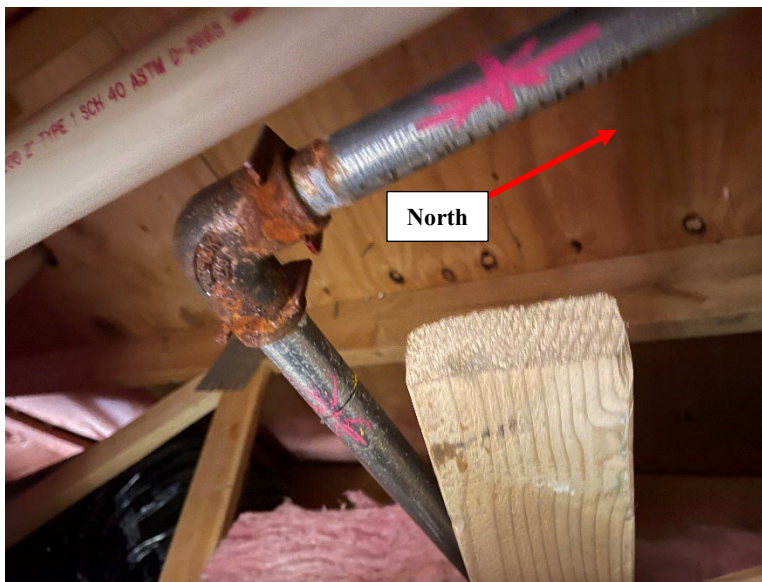
The area of the leak was documented and the tubing was marked for removal, as depicted in Figure 4. The tubing was cut and removed, as illustrated in Figure 5. Corrosion products were observed and the tubing was separating from the north side of the fitting, as shown in Figure 6. The tubing had moved approximately ½-inch from its assembled location. The key, used to lock the tubing to fitting, was still in place and the tubing could not be moved by hand, as depicted in Figures 6, 7, and 8. When installed, Poz-Lok tubing is inserted into a Poz-Lok fitting through an O-ring until it bottoms out. The fitting has two slots that a key slides into and is then knocked into place with a hammer to lock the fitting onto the tubing.

**Figure 4. Tubing marked for removal (15092 CBS 2-015).**

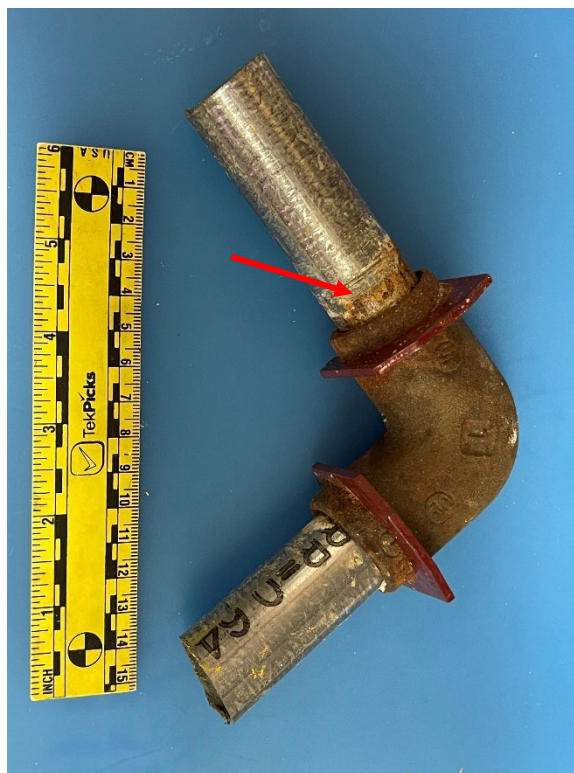
**Figure 5. Poz-Lok tubing and fitting after removal. Tubing can be observed starting to separate from the fitting (15092 CVBS 2-019).**

The sprinkler tubing was installed in the enclosed attic space above the kitchen of Unit 304B. The tubing and elbow were examined in place and removed after the examination. A subsequent visual examination of the pipe was completed at AEI. It was noted that the tubing was partially dislodged from the Poz-Lok fitting but could not be moved by hand. Based on the reviewed weather data and the witness marks on the tubing, the failure was the result of water freezing in the tubing. The tubing likely began to dislodge from the elbow in early February and started leaking water when the ice thawed around the date of the loss.

1. The water loss was the result of Poz-Lok tubing partially dislodging from a Poz-Lok elbow fitting when water in the tubing froze.
2. Parts to repair the Poz-Lok sprinkler system can no longer be obtained, and replacement of the sprinkler system will be required.

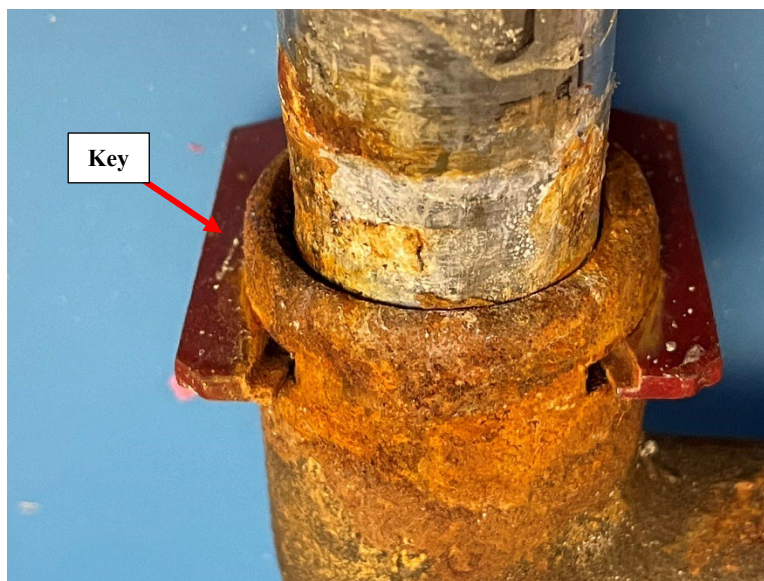
**Figure 6. Key used to hold tubing in place in the elbow fitting. Tubing separation from fitting is visible (15092 CBS 2-025).**

Corrosion was observed at the juncture of the tubing and fitting. However, based on the witness marks, the corrosion did not contribute to the tubing separating from the fitting. The welded seam on the tubing was not damaged and/or leaking, and there were no conditions observed with the tubing and fitting that would indicate any failure mechanism other than freezing.

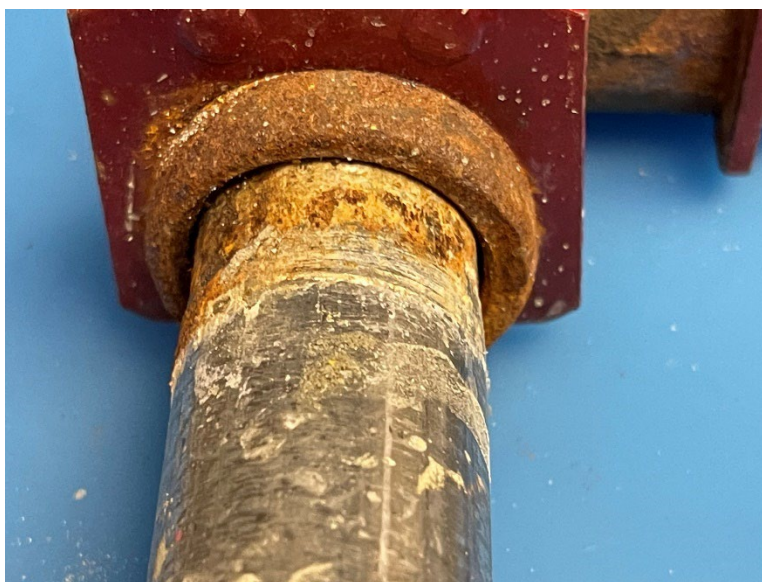
**Figure 7. Tubing separating from the elbow fitting (15092 CBS 2-027).**

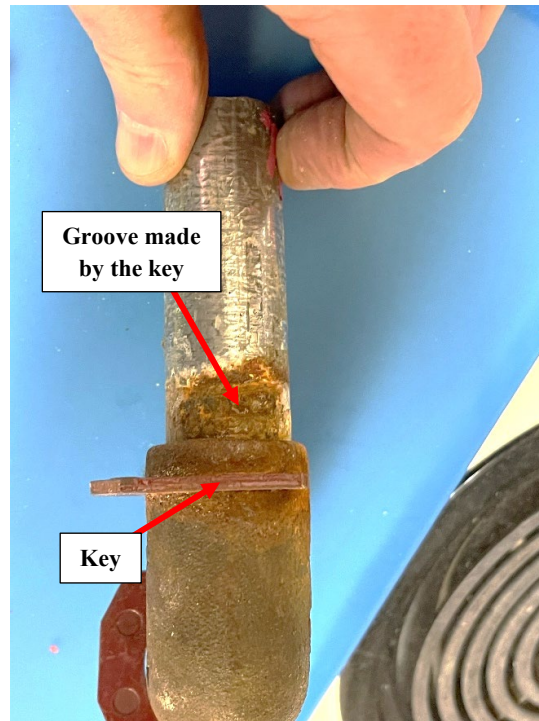
**Figure 8. Groove from the key in the tubing wall (15092 CBS 2-023).**

When installed, Poz-Lok tubing is inserted into a Poz-Lok fitting through an O-ring until it bottoms out. The fitting has two slots that a key slides into and is then knocked into place with a hammer to lock the fitting onto the tubing. The deformity in the tubing created by the key was clearly visible on the subject tubing, and witness marks were observed where the key was dragged over the tubing when it was dislodged from the fitting.

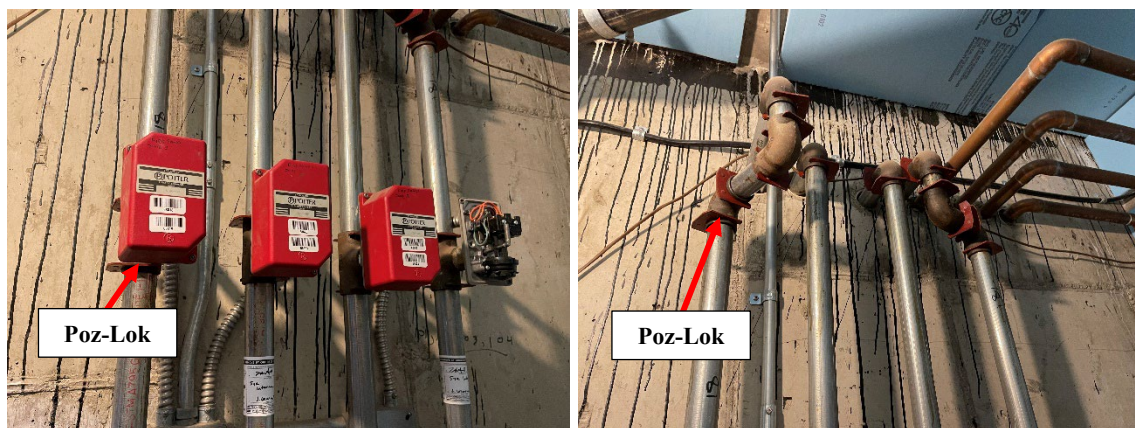
The sprinkler riser room on the lower level was inspected. The incoming water line was a combination line for the domestic and sprinkler systems. The incoming water line branched off to a 1 ½-inch supply for the sprinkler systems. The sprinkler manifold consisted of steel pipe and tees that supplied four sprinkler risers. The risers transitioned to 1 ½-inch Poz-Lok components and tubing, as illustrated in Figure 9. There were Western inspection tags on the system, as shown in Figure 10. The fire alarm system, an FCI fire alarm control panel, was in the riser room and the panel was in alarm, as depicted in Figure 11.

**Figure 9. Typical of the Poz-Lok components used for the sprinkler risers (15092 CBS 2-073, CBS 2-074).**

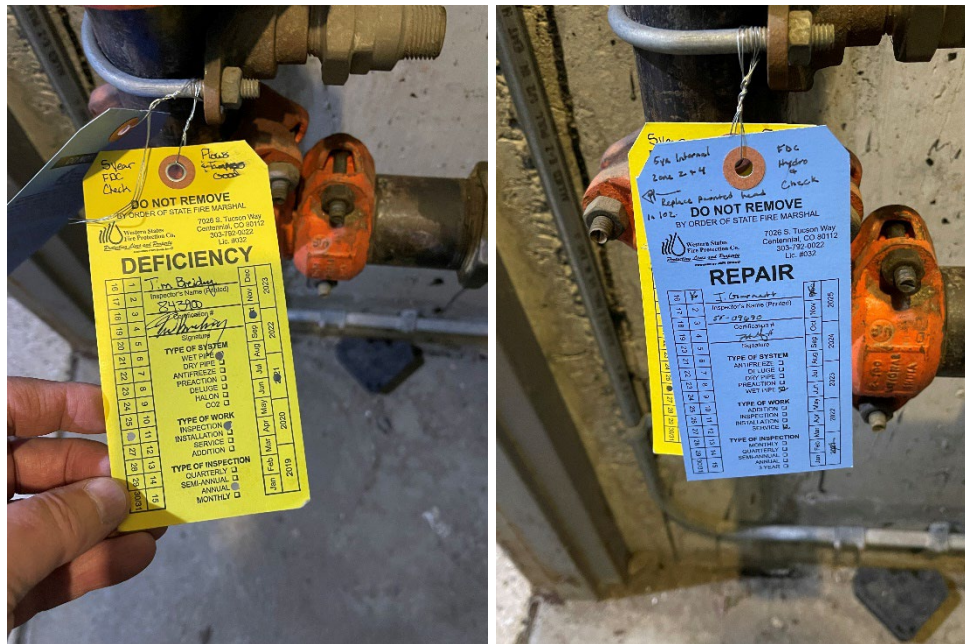
Figure 10. Western inspection tags (15092 CBS 2-040, CBS 2-038).

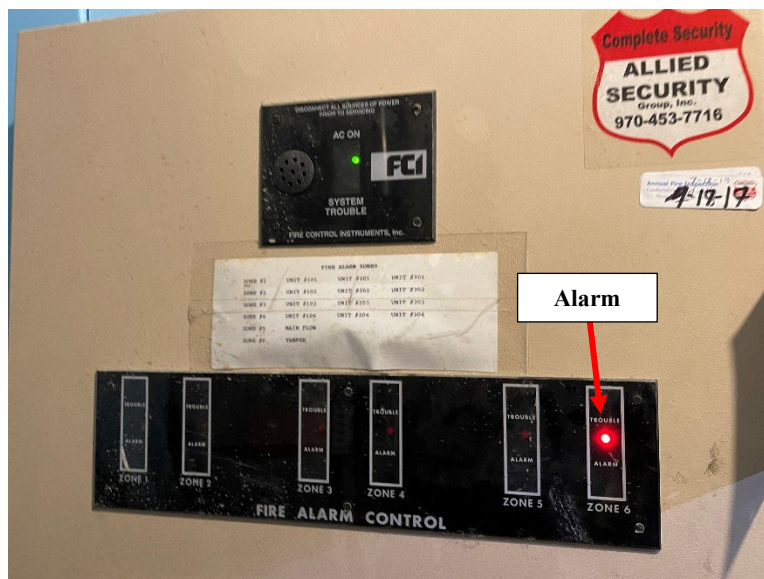
Figure 11. Fire alarm system (15092 CBS 2-091).
