Regarding: Reserve Study Final Version

# Yacht Club Condominiums, Inc. 144 Gold Run Cir. Dillon, CO. 80435

## FINAL VERSION

Report Period – 05/01/23 – 04/30/24

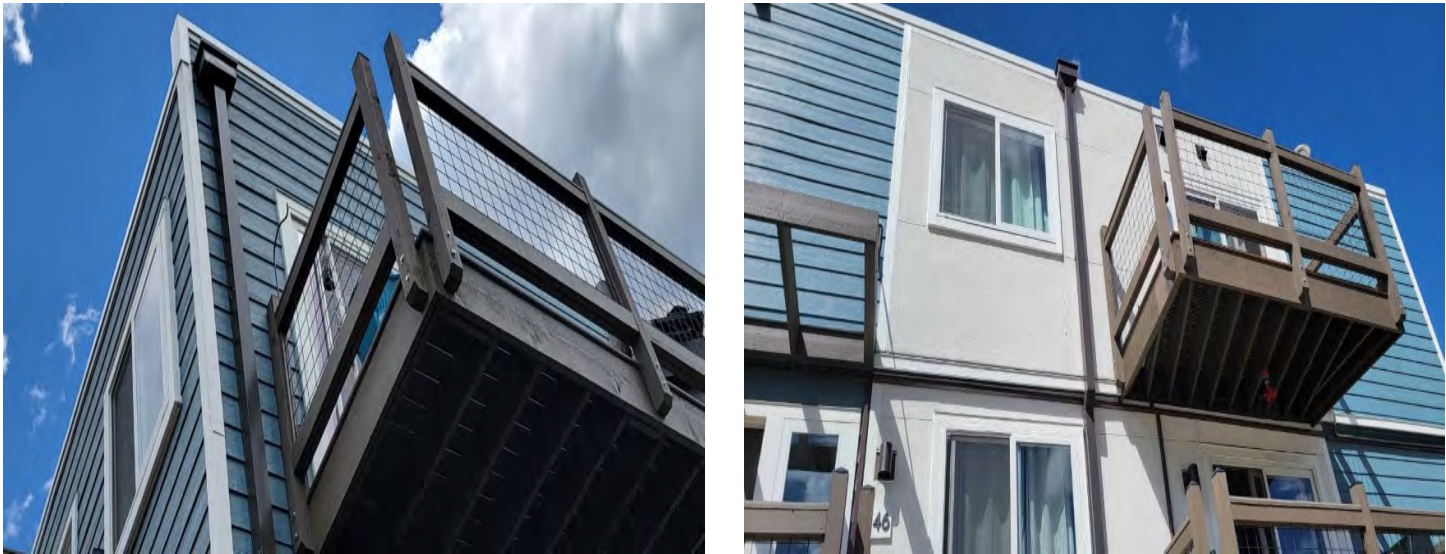
Comp #: 120

- No unusual conditions noted at time of site visit. Lines were replaced at the same time as the building reconstruction in 2019.
- In our experience, we see this type of downspout to have an extended life expectancy.
- Lines are heat taped, so any damage as a result of freezing should be minimal at most.
- Reserve to replace downspouts every other roof coating cycle (every 30 years)

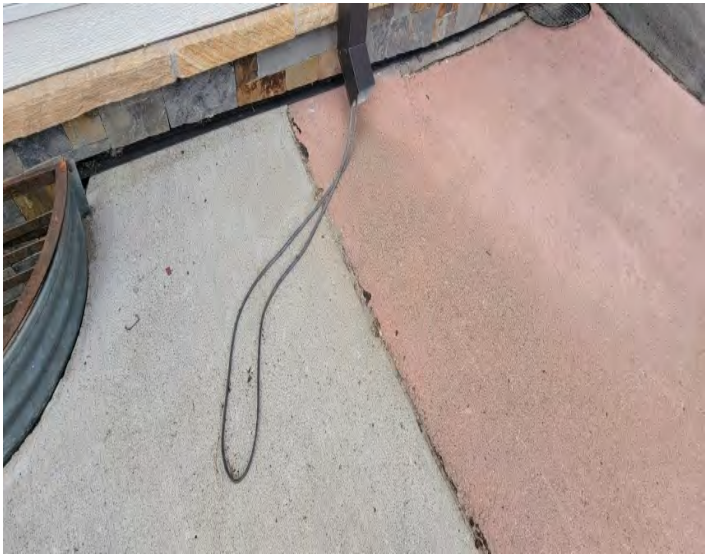
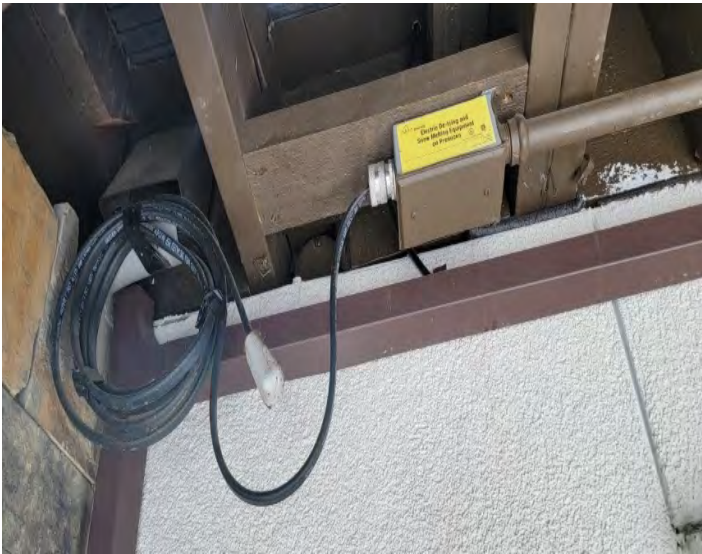
Heat Tape - Replace

- No reported problems at time of site visit. Site visit took place during summer months, so unable to visually observe the system in working conditions.
- The useful life of heat tape varies based on working time, exposure, damage, etc.
- On average, we recommend replacing every 10 years
- In between replacement cycles, repairs should be handled as needed with operating funds.

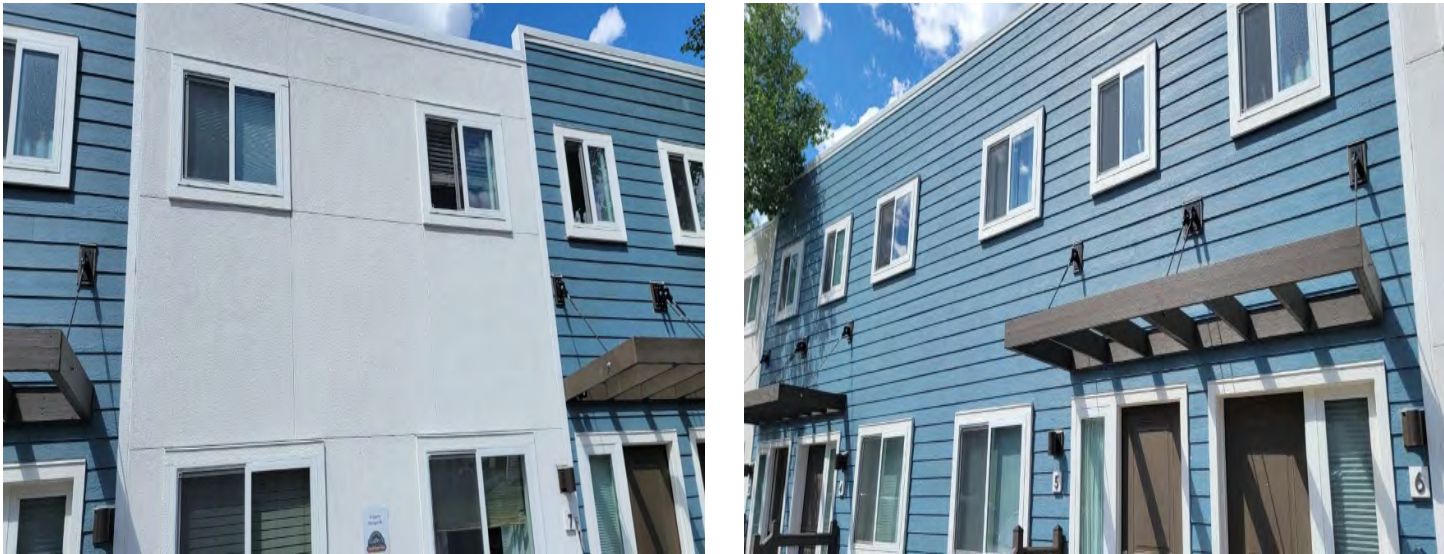
Building Ext Surfaces - Repaint

- All new siding and stucco were installed in 2019 and is in good condition. Minor fading was noted on southern exposed walls.
- We recommend that all exterior surfaces (body, trim, support joists, railings, soffits, snow guards, etc.) are painted every 5 - 8 years to protect the base materials and maintain an appropriate appearance.
- Proper prepping, and minor maintenance, should take with every painting cycle.
- Since association will be performing touch ups and routine maintenance every other year, we have extended the repainting cycle to 8 years

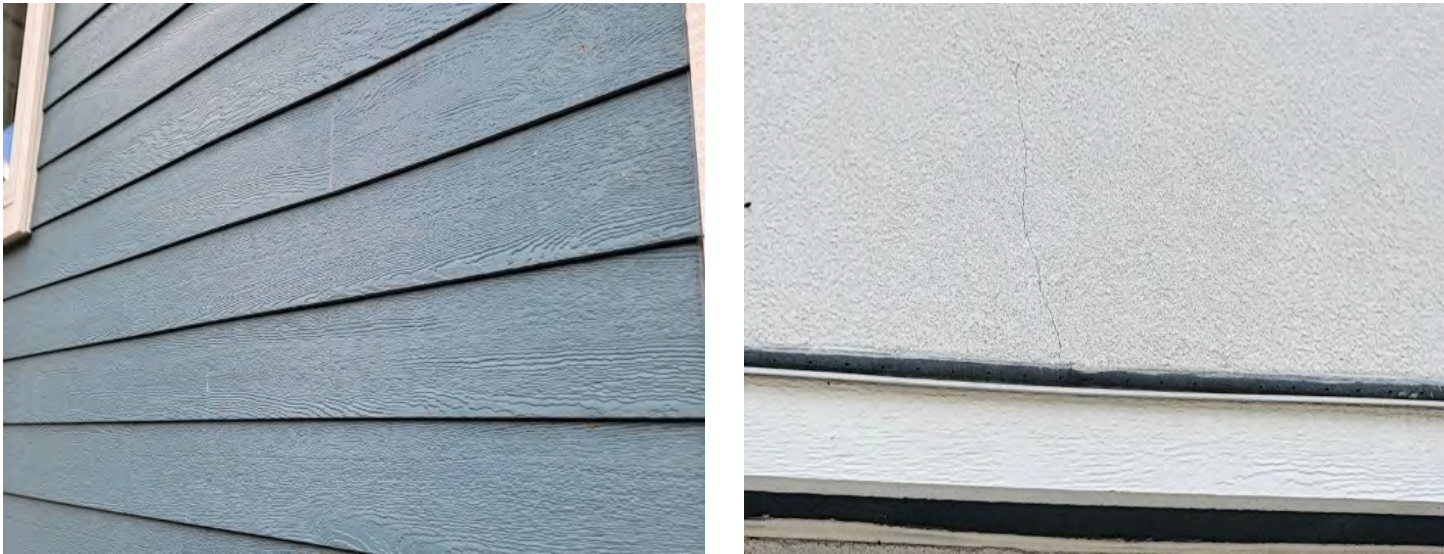
Wood/Stucco Siding - Repair

- Minor hairline cracks were observed in the stucco surfaces, but this is typical for this type of material. Lap siding (fiber cement) was in good condition with no issues noted.
- This material typically lasts 30 - 50 years, depending on how well it is maintained throughout the years.
- In order to keep up the appearance of the community and to ensure a maximum life of siding, we have established a Reserve allowance for inspections and repairs every painting cycle.
- As the material ages, the cost of future repairs may need to be increased in future Reserve Study updates

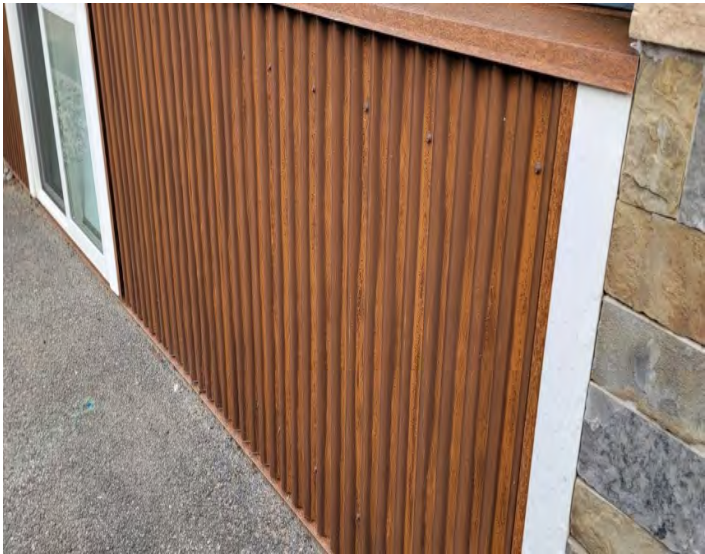
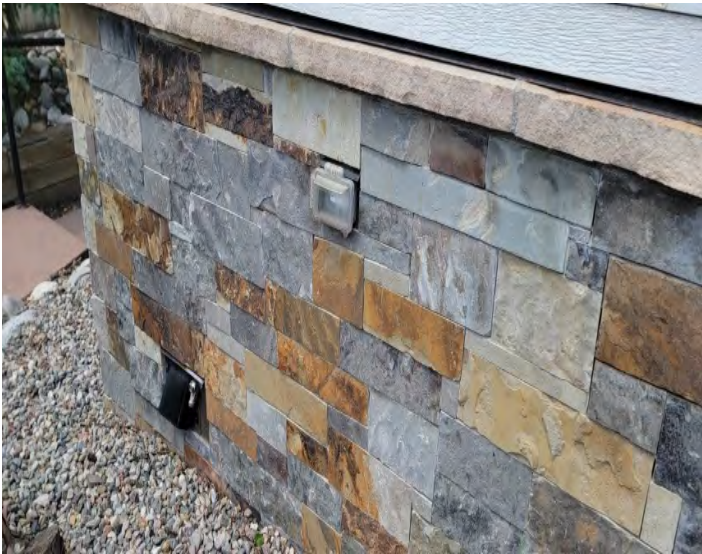
Stone/Metal Siding - Major Repairs

- Typically, this material has an extended life expectancy and complete replacement is unlikely.
- There are times where some stones will loosen and fall off, but this is unpredictable when and how much would occur.
- Repairs should be handled as a maintenance issue on an as needed basis.
- If it later turns out that frequent repairs are necessary, then funding could be added in future Reserve Study updates.

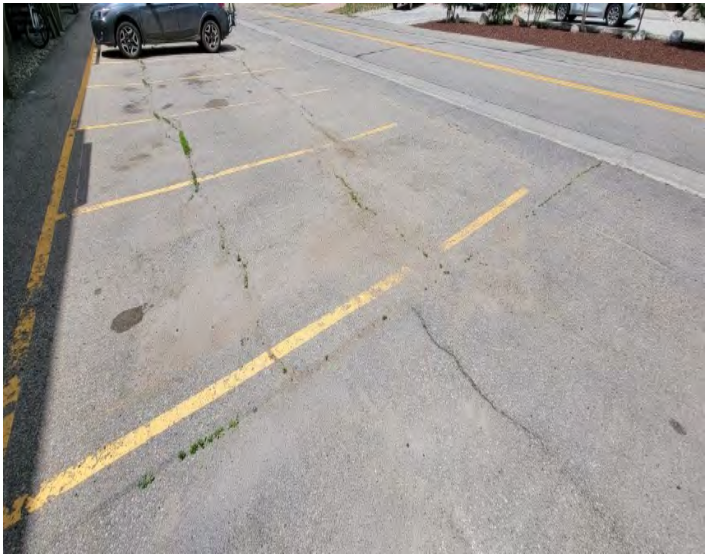
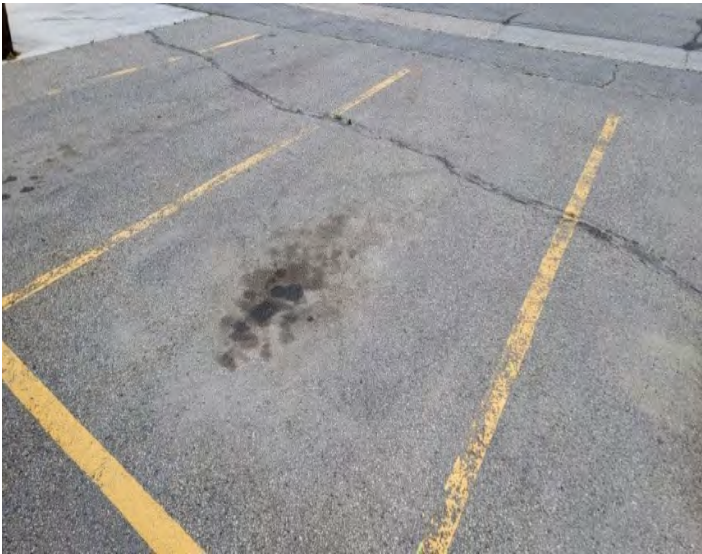
Asphalt - Major Overlay

- The average life expectancy for asphalt surfaces ranges between 25 - 35 years for surfaces that are maintained on a regular schedule.
- Maintenance includes crack fill and repairing small potholes annually as an operating expense.
- In addition, asphalt should be seal coated every 3 - 4 years, depending on the level of traffic and snow removing techniques.

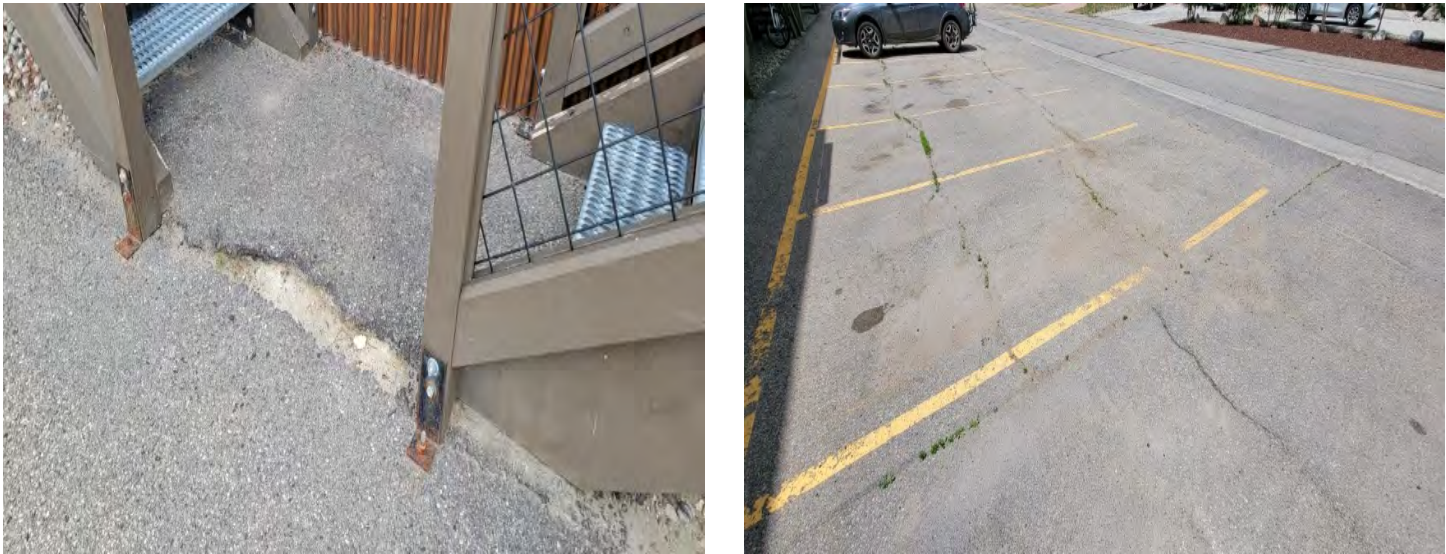
Asphalt - Surface Application

- This type of material is subject to heavy wear in this environment due to snow removal techniques. - Snow plows gradually remove small layers of asphalt every time plows are used.
- Sand and gravel acts as sand paper to the surface as cars drive over the surface.
- No matter what kind of removal is used, the asphalt layers diminish each year.
- In this environment, it is recommended that a seal coat is applied every 2 - 4 years, depending on the amount of traffic and the effects of the elements over the years.

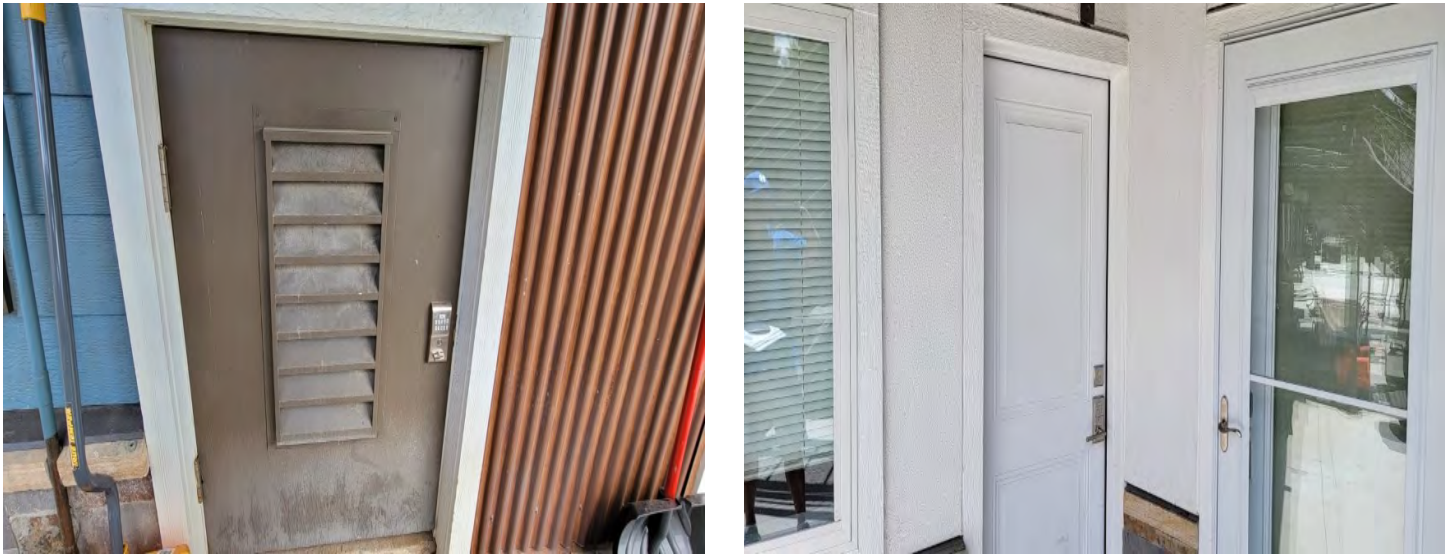
Comp #: 501      Doors - Replace

- Unit doors are the responsibility of the owners, so Reserve funding is not required for unit doors.
- The doors for the mechanical rooms are in poor condition, but are used minimally, so replace these doors as needed with operating funds.
- Due to the low cost and different levels of use of the common doors in building 410, doors should be replaced on an as needed basis with general operating funds.
- Therefore, separate Reserve funding is not required at this time for this component.

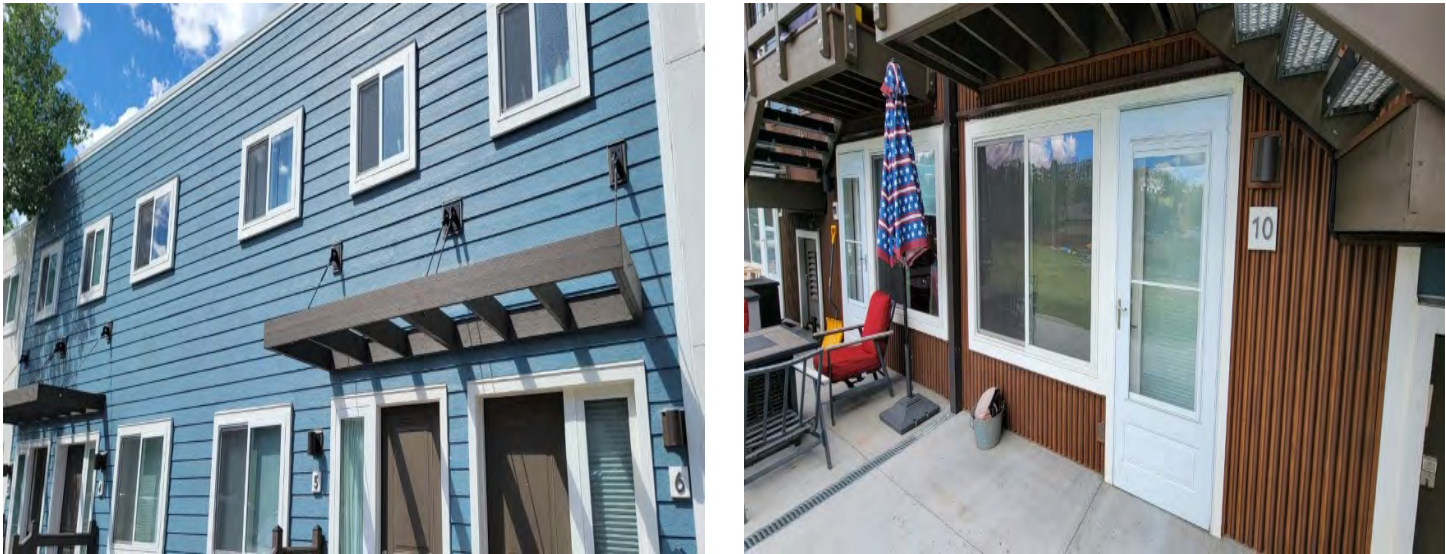
Windows - Replace

- All windows were replaced at the same time as the reconstruction in 2019
- Typically, windows are the responsibility of each individual owner.
- Therefore, separate Reserve funding is not required for this component at this time.

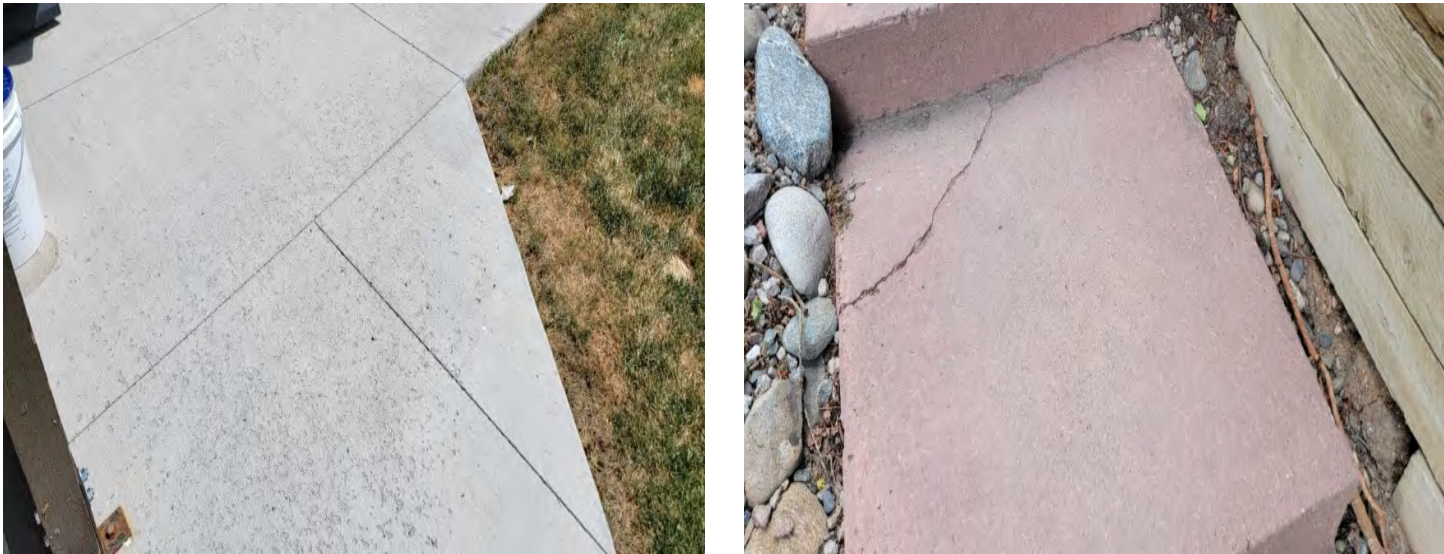
Concrete Flatwork - Partial Replace

- Observations:
- The majority of the concrete was replaced in 2019 and is in good to fair condition. There was some evidence of minor cracks and some spalling noted throughout the property.

- While it is unlikely that all concrete surfaces will fail at the same time and completely need replacement, it is likely that major repairs will be needed periodically.

- The dyed concrete (older sections) will be difficult to match when repairs or replacement is required. Therefore, we recommend replacing all of the colored concrete with standard concrete when required.

- We suggest establishing Reserve funding for periodic major repairs, as opposed to minor repairs annually.
  - Each time a contractor comes out to the property to fix an area, a "trip charge" is usually built into the repair bill.

- Therefore, by doing larger areas at the same time, the cost is cheaper on a per square footage basis.
  - This line item is for periodic major repairs and should not be misinterpreted as complete replacement.

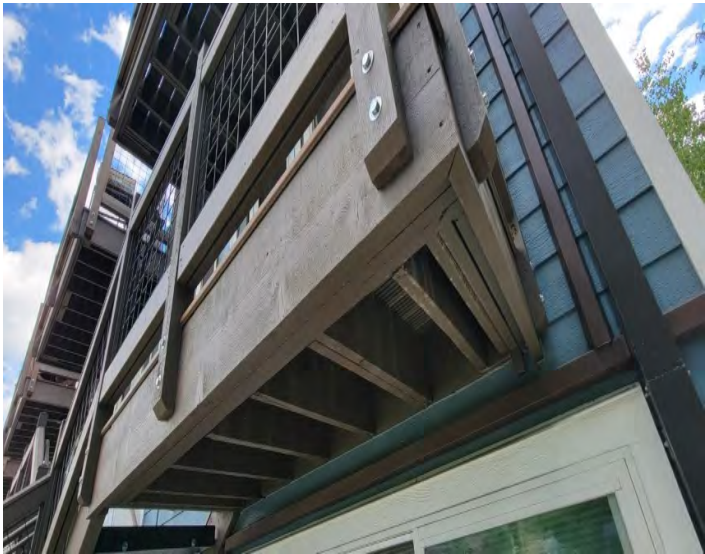
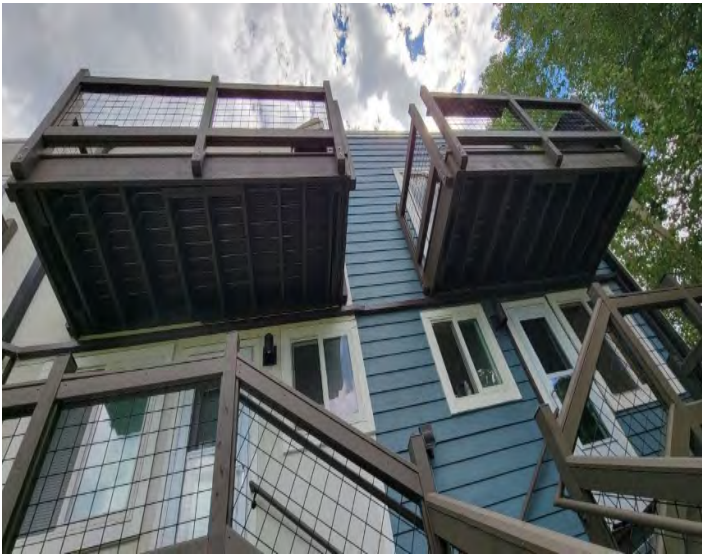
Unit Upper Level Decks - Replace

- All decks and rails were replaced in 2019 and are in good condition. No reported or observed problems noted at time of site visit.
- We recommend inspecting all decks every 2 - 3 years and make necessary repairs as an operating expense to maintain a safe environment.
- While the life expectancy established by the manufacturer is considered "lifetime", this material is also subject to scratching and deterioration that could warrant replacement within 25 - 30 years.
- For aesthetic purposes, we suggest establishing a life cycle of 30 years at this time.
- If it later turns out that the deterioration rate is not as we expected, then the life and remaining life can be adjusted in future Reserve Study updates.

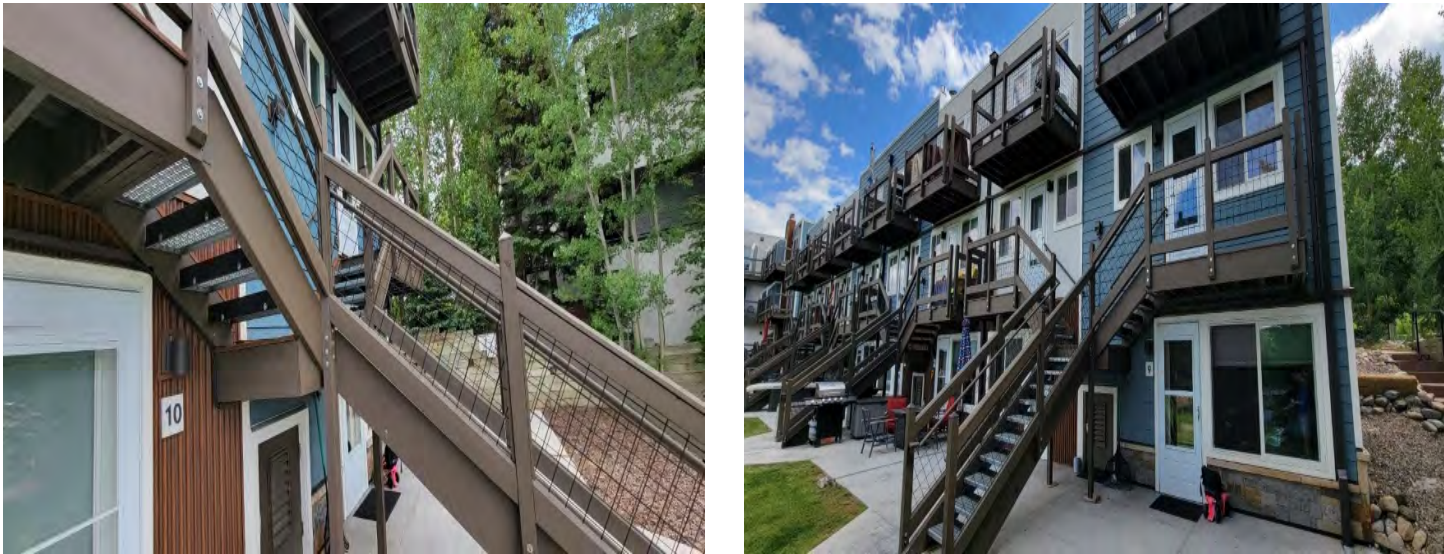
Stairway Systems - Major Repairs

- All stair systems were replaced in 2019 along with the reconstruction project.
- We recommend inspecting all decks every 2 - 3 years and make necessary repairs as an operating expense to maintain a safe environment.
- While the life expectancy established by the manufacturer is considered "lifetime", this material is also subject to scratching and deterioration that could warrant replacement within 25 - 30 years.
- For aesthetic purposes, we suggest establishing a life cycle of 30 years at this time.
- If it later turns out that the deterioration rate is not as we expected, then the life and remaining life can be adjusted in future Reserve Study updates.

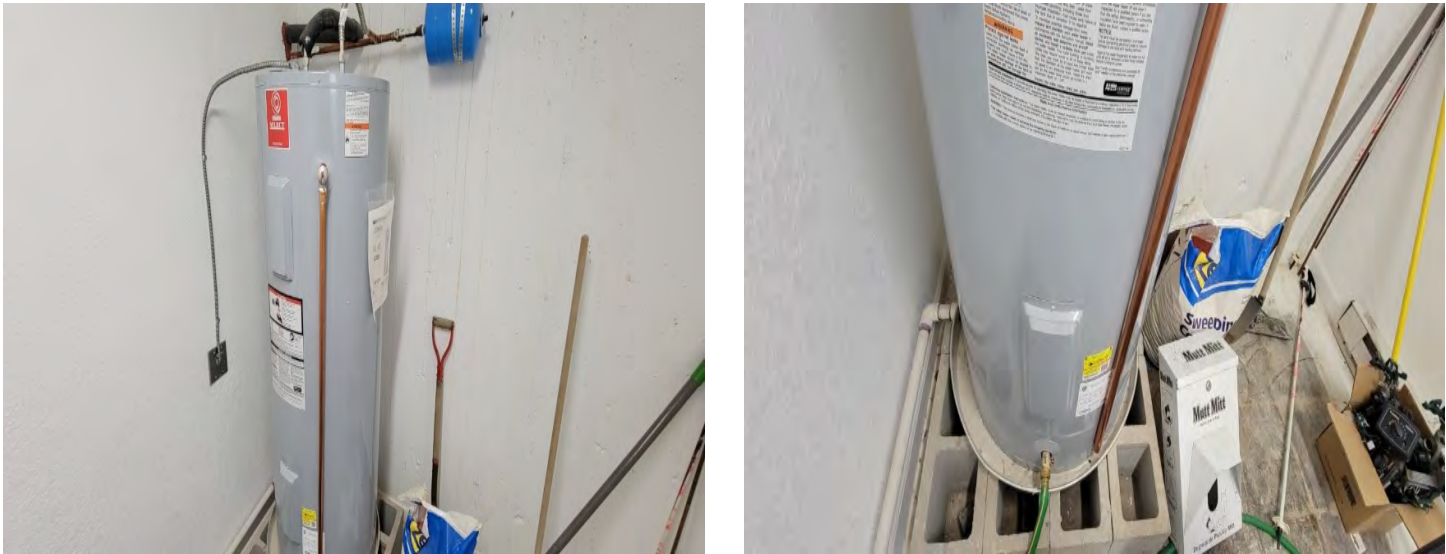
Water Heater - Replace (Laundry)

- Water heater was replaced in 2018 and appears to be working well. Joints and connections were in good shape and free from significant rusting and corrosion.
- Depending on the level of use and the quality of the water running through the system, expect a useful life of 12 - 15 years from water heaters with proper maintenance and care.

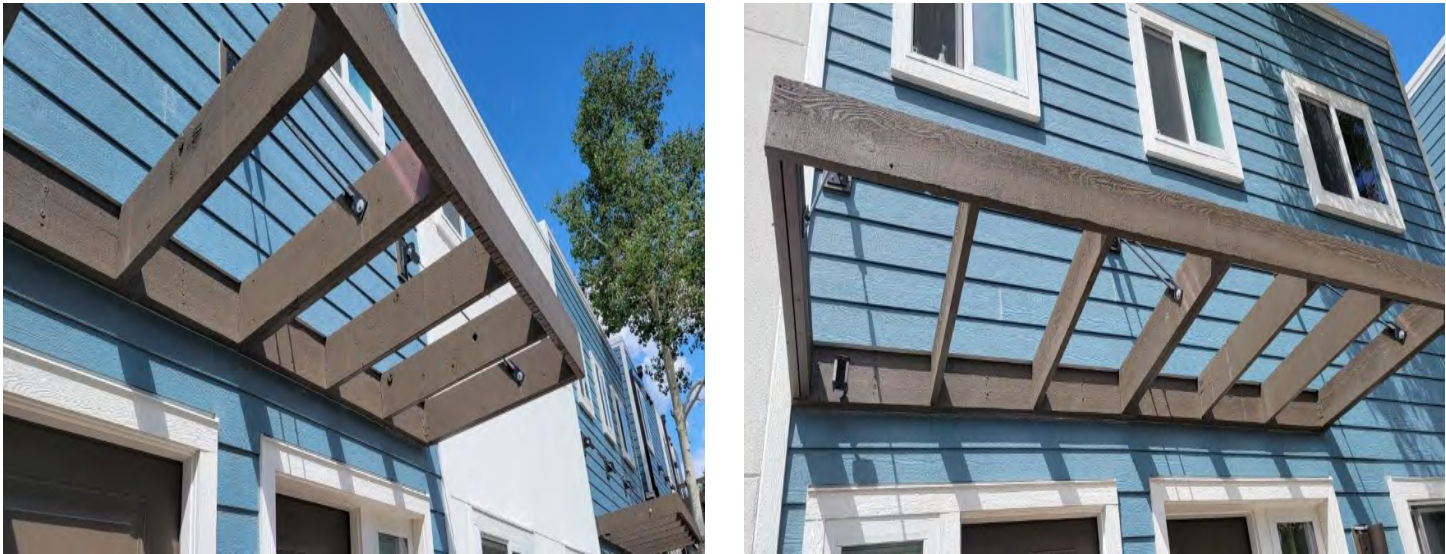
Wood Awnings - Replace

- Structures are well constructed and should have an extended life expectancy with proper maintenance and minimal exposure to elements
- Reserve funding not required at this time. treat repairs as part of building repairs prior to painting

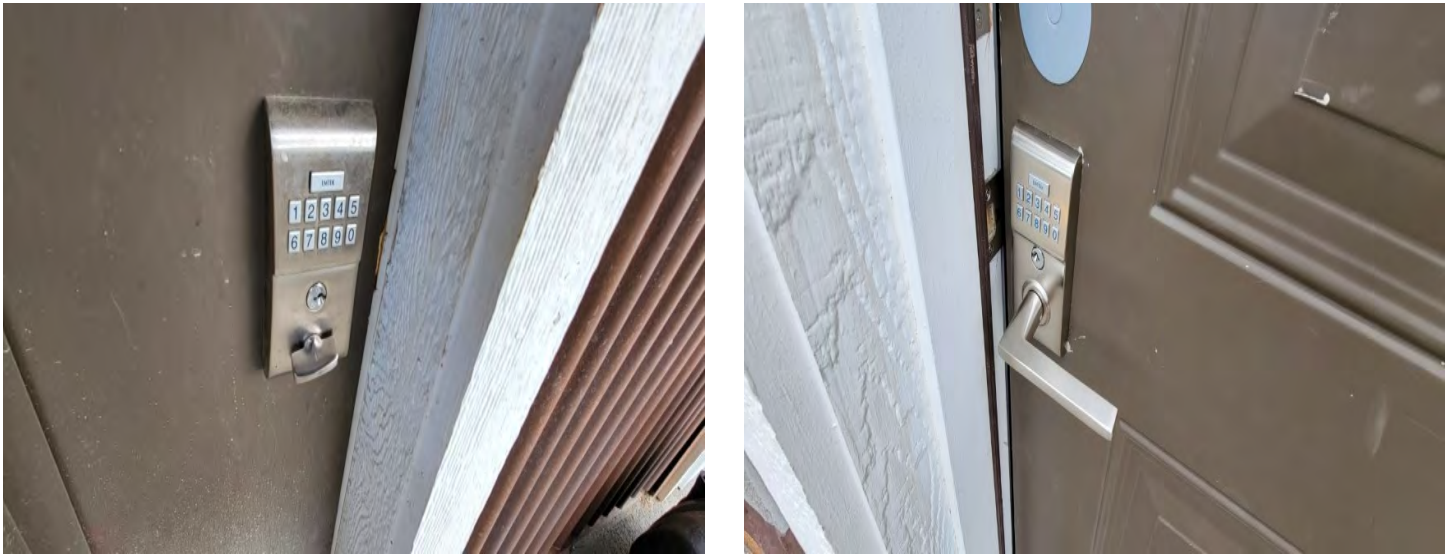
Comp #: 908      Electronic Door Locks - Replace

- Locks appeared to have been recently replaced.
- The average life expectancy for these ranges from 7 - 10 years. Since these are outside and exposed to elements, expect to replace on the shorter side of the normal cycle.
- Remaining life is based on the assumed age of the locks.

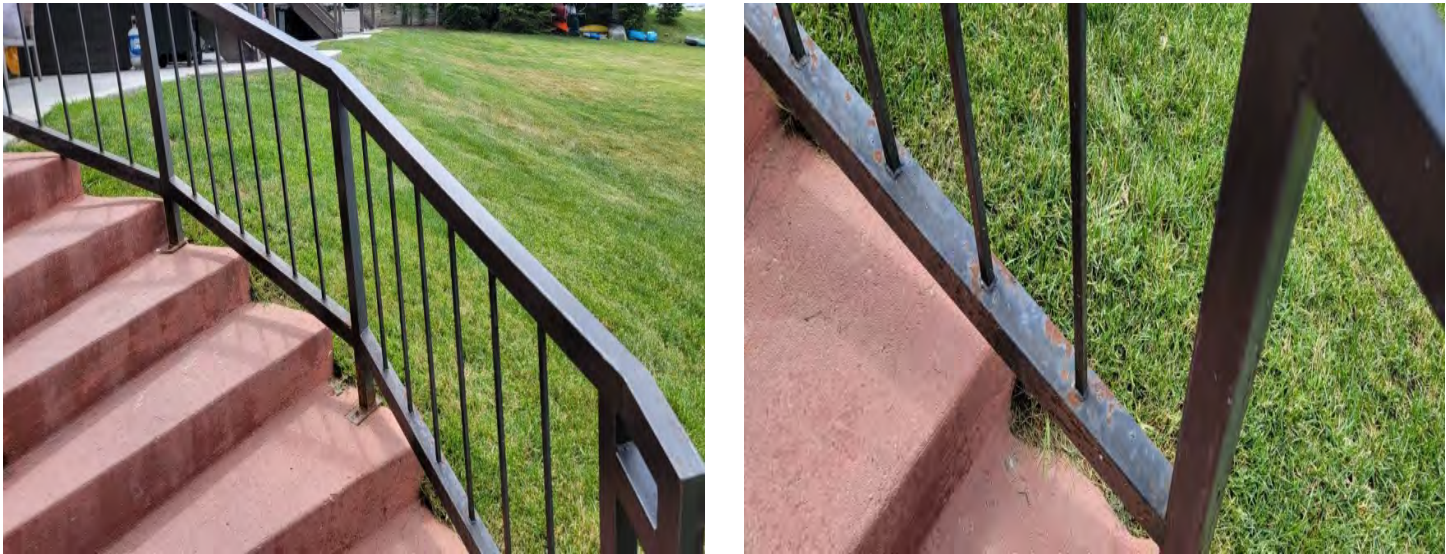
Metal Railing - Replace

- Painting should be done at the same time as building exterior surfaces for best cost estimate.
- Some surface rusting was noted. We recommend wire brushing the materials to rid the rust and repaint to protect the materials from further deterioration.
- Due to the small quantity, separate Reserve funding is not required for this component. Per client request, we added replacement cost for this railing in 5 years
- If it later turns out that deterioration exceeds our expectation, Reserve funding can be added in future report updates.

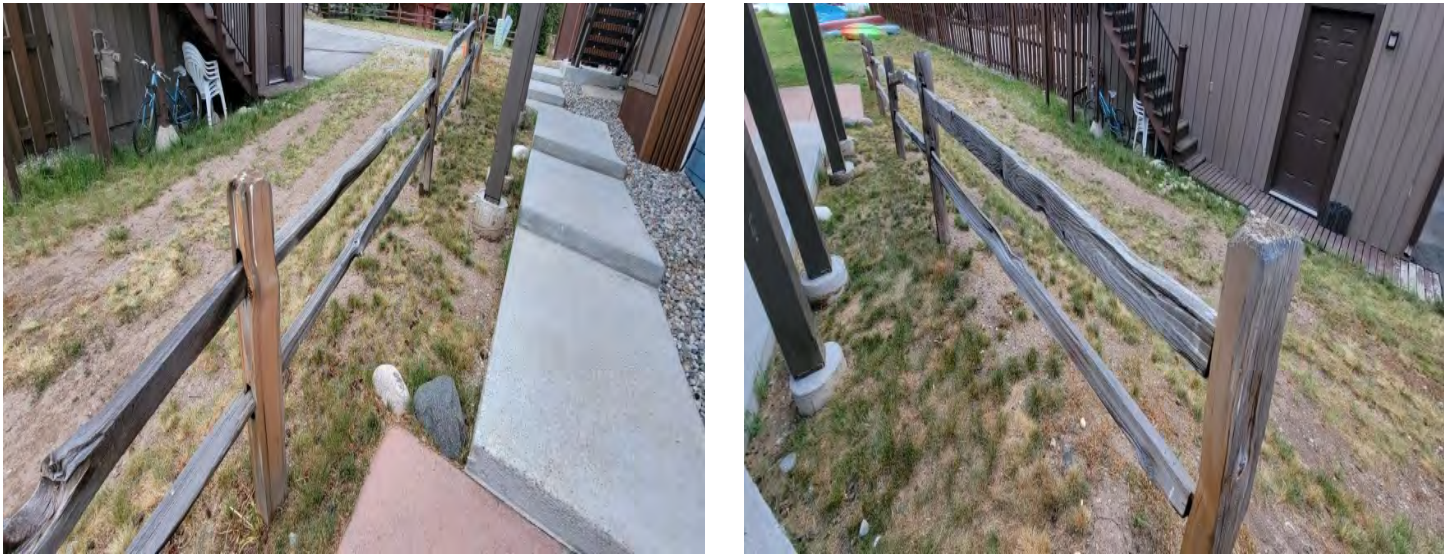
Split Rail Fencing/Rail - Replace

- Observations:
- A couple rails and posts have been recently replaced.
  - Due to small area, repairs and replacement of sections should take place with operating funds.
  - Therefore, at this time, separate reserve funding is not required for this component.

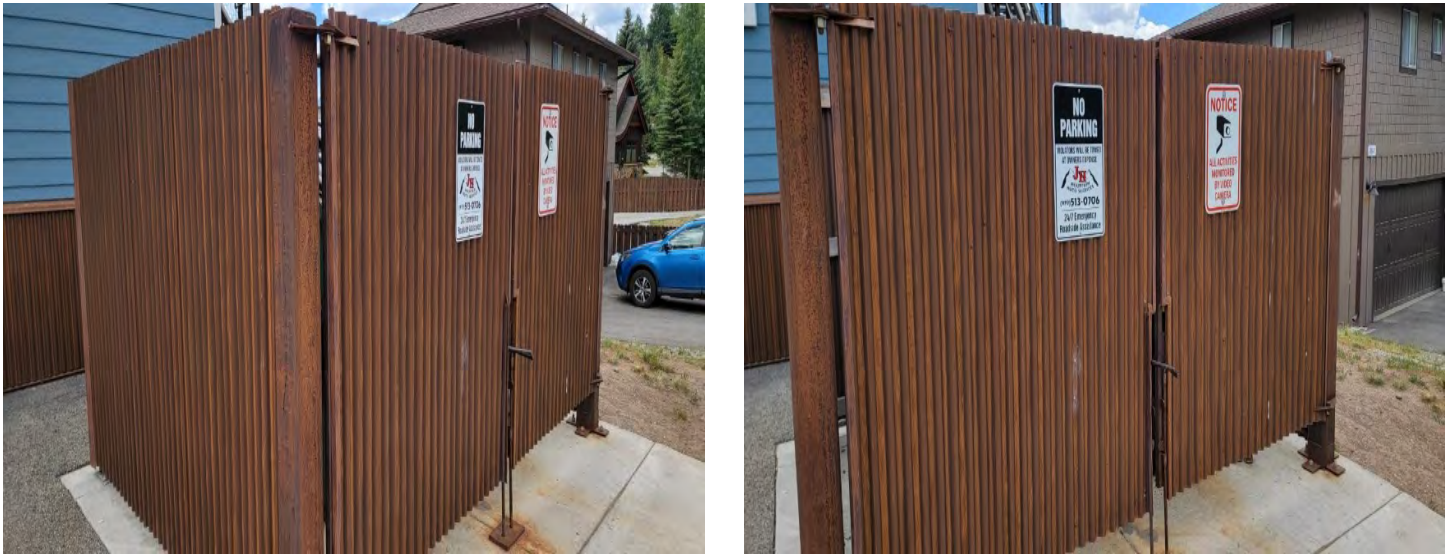
Comp #: 1010    Trash Enclosures - Replace

- Observations:
- Enclosure was reconstructed in 2019 with steel posts and corrugated metal siding.
  - These materials should have an extended life expectancy under normal conditions
  - Funding is not required at this time due to the quality of materials used.
  - In future Reserve Study updates, if conditions warrant replacement, add funding at that time

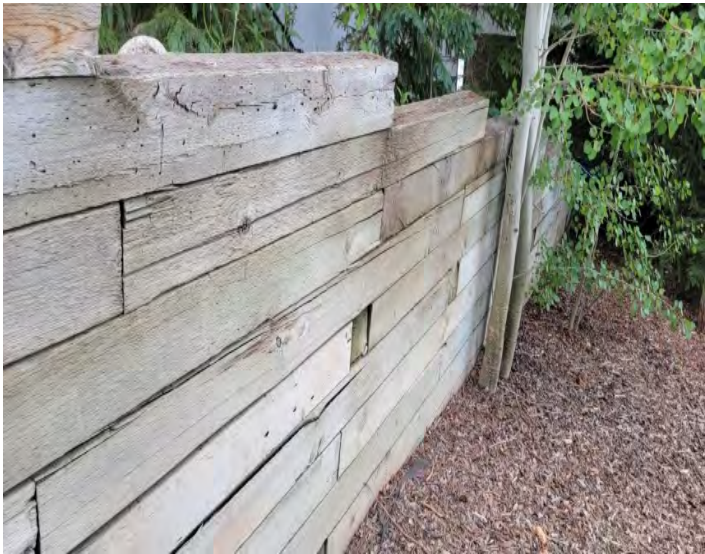
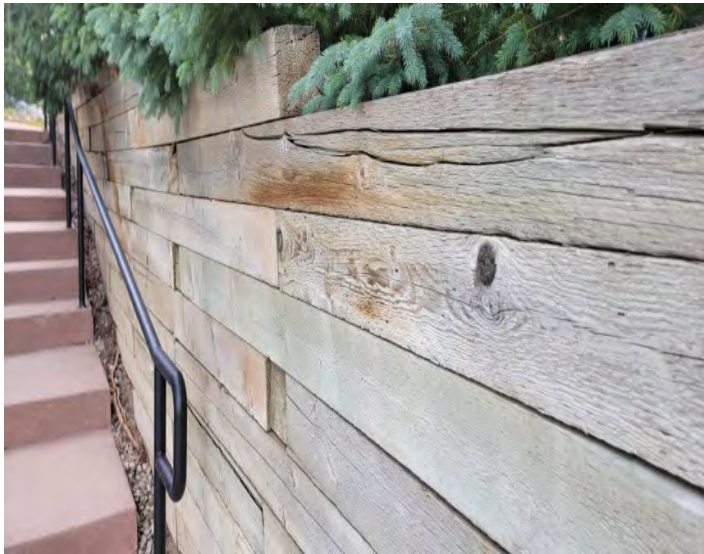
Comp #: 1011     Retaining Wall - Replace

- Observations:
- Generally, in most conditions, these walls have an overall life expectancy of 15 - 20 years.
  - However, with periodic repairs, the life of the wall can be extended.
  - The top timber tends to become the first piece to deteriorate and need to be replaced.
  - This type of wall also tends to be susceptible to movement and leaning.
  - When replacement is necessary, most associations are converting to block wall for longer life expectancy and less maintenance.
  - Per client request, replacement cost was increased to use block

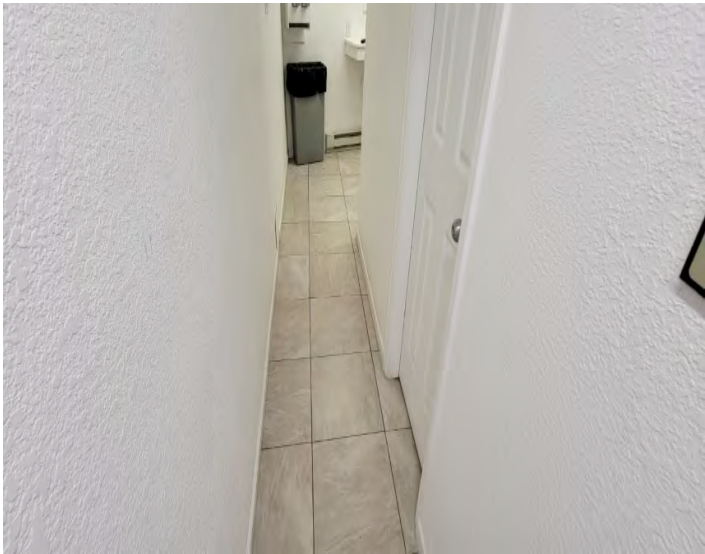
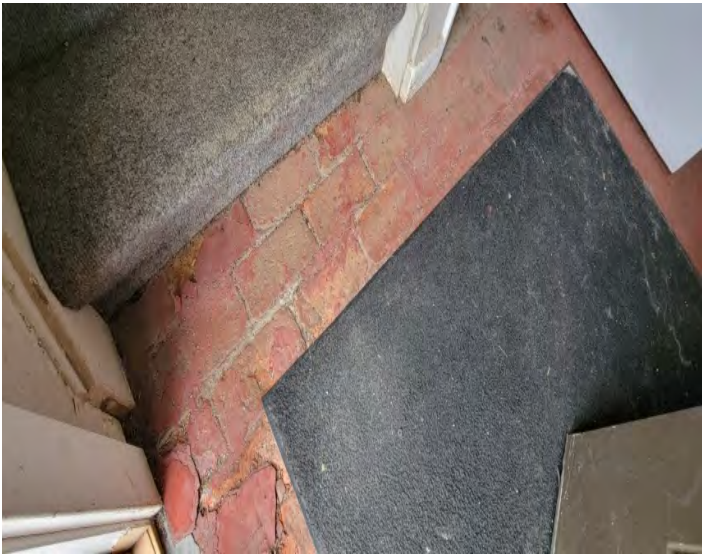
Comp #: 1414    Interior Areas - Update Allowance

- Laundry room and exercise room area has been updated and is in good condition. The old hot tub room was converted into an exercise room. The stairs to the upper level and brick entry is still dated and in poor condition.
- Expect to update these areas every 10 - 15 years to maintain appearance and keep up with changing decorative trends.
- We have included an allowance for the association to update these areas as determined by the Board

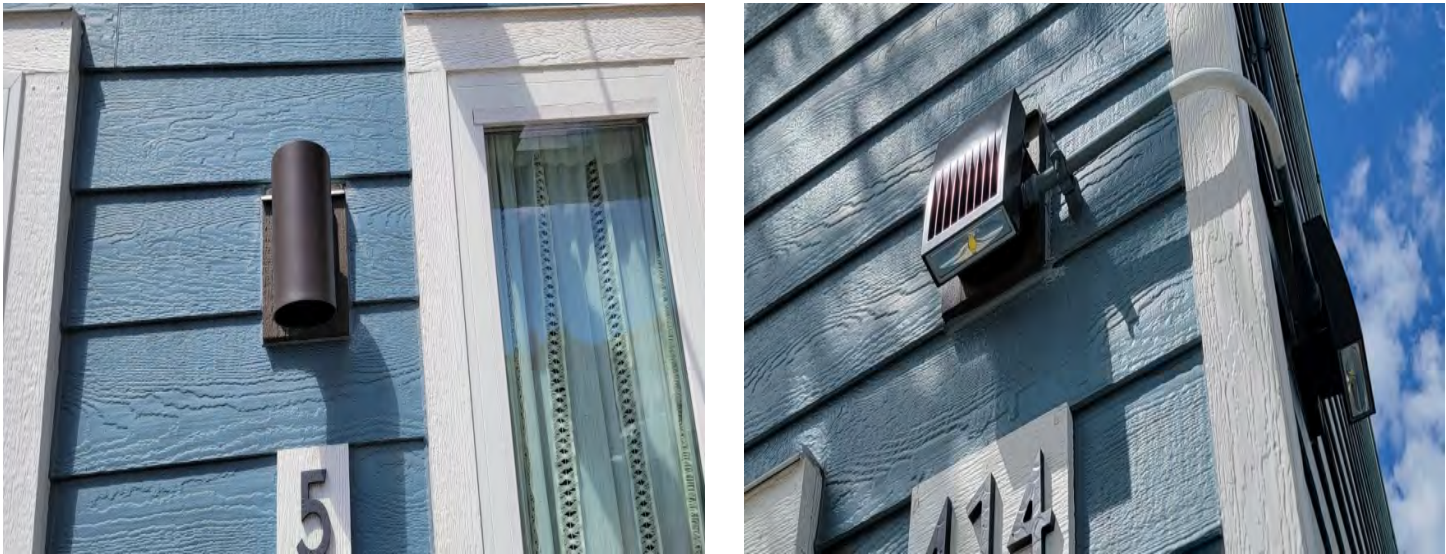
Exterior Wall Mount - Replace

- While replacement can occur on an as needed basis, it is our opinion and recommendation to replace all lights at the same time every 12 - 15 years to maintain a consistent appearance throughout the property.
- By replacing multiple fixtures, the association will be able to obtain a quantity discount for replacement and installation of the fixtures.
- This will also ensure a consistent appearance for the community by replacing all at the same time.

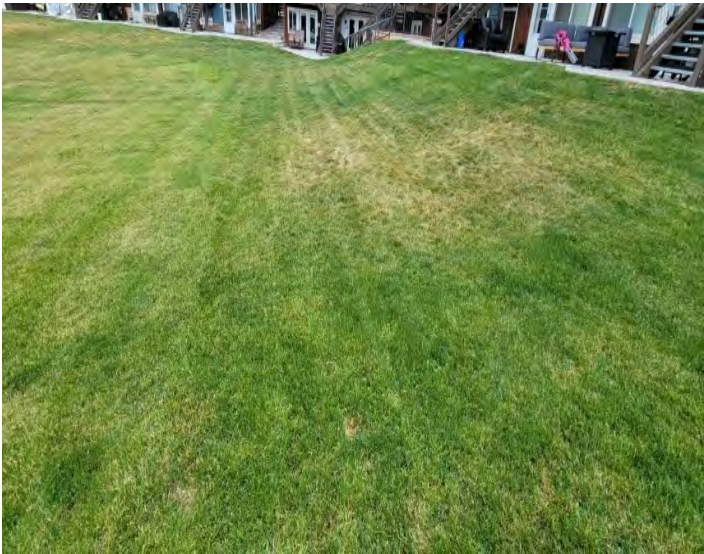
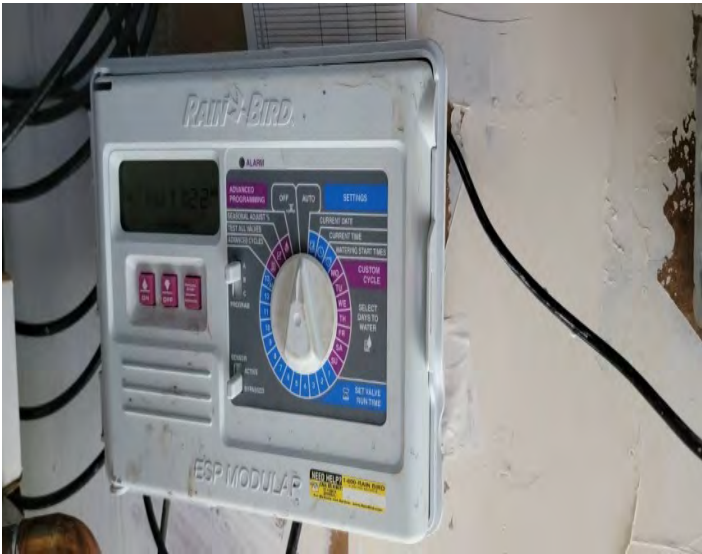
Irrigation System - Major Repairs

- At this time, there is no expectancy to completely replace the system and Reserve funding is not recommended.
- We recommend the association establish a line item in the general operating budget for annual repairs to necessary components of the system (broken lines, sprinkler heads, valves, backflow preventers, controller, etc).
