# PRELIMINARY INVESTIGATION REPORT

## Lake Forest, Sprinkler System Water Loss

Representing: Lake Forest HOA  
Location: 1620 Lakeview Terrace, Unit B304, Frisco, Colorado  
Date of Loss: November 27, 2023  
AEI Project No.: 16020

AEI Project No.: 16020

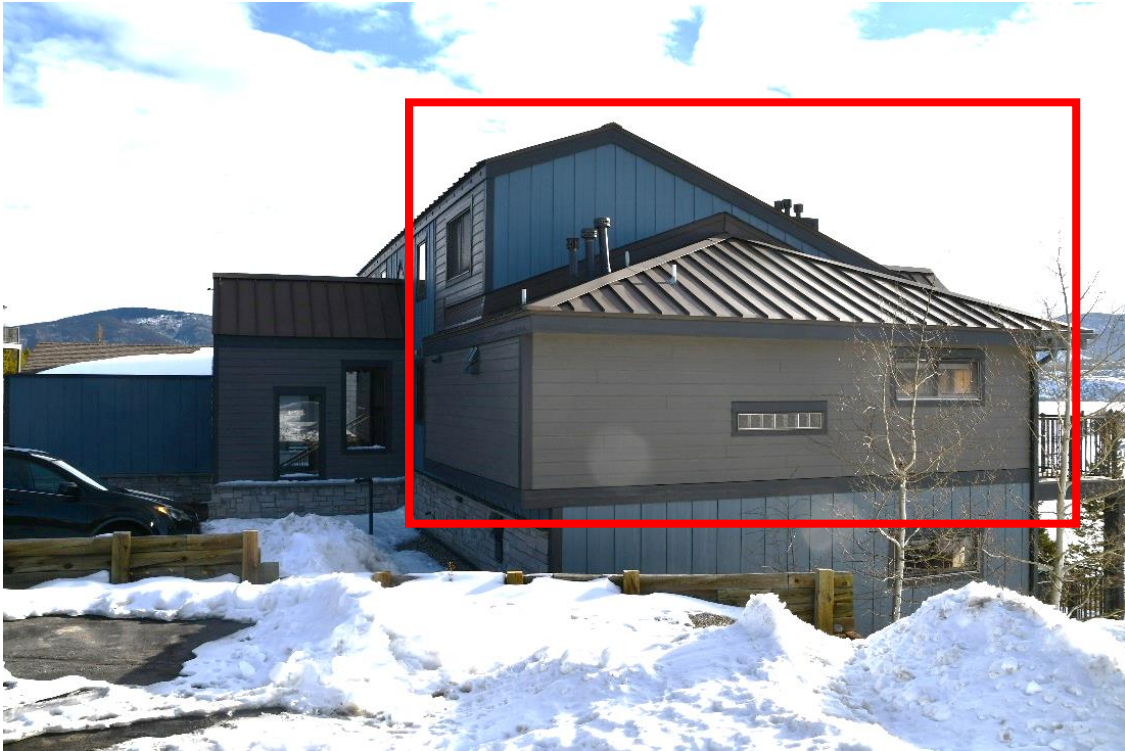
**Figure 1. Unit 304B exterior (16020\_CBS\_1-003).**

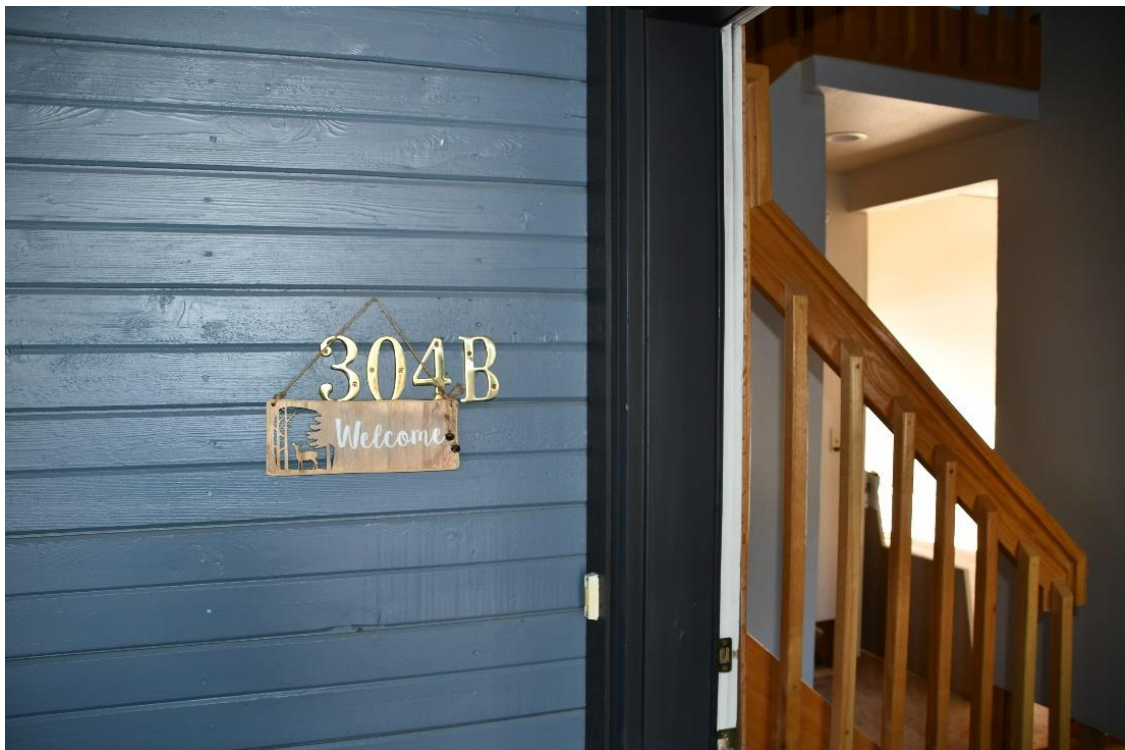
**Figure 2. Entrance to Unit 304B (16020\_CBS\_1-011).**

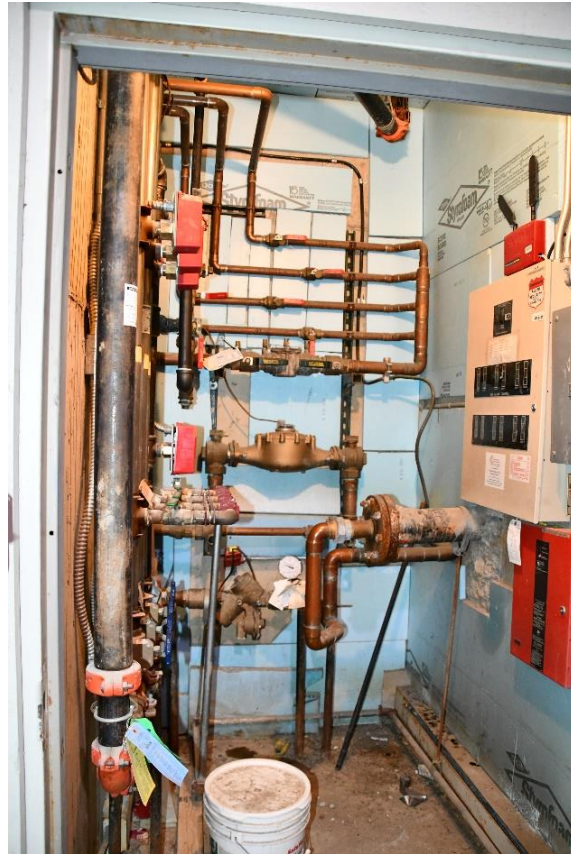
**Figure 3. Sprinkler riser room (16020\_CBS\_1-132).**

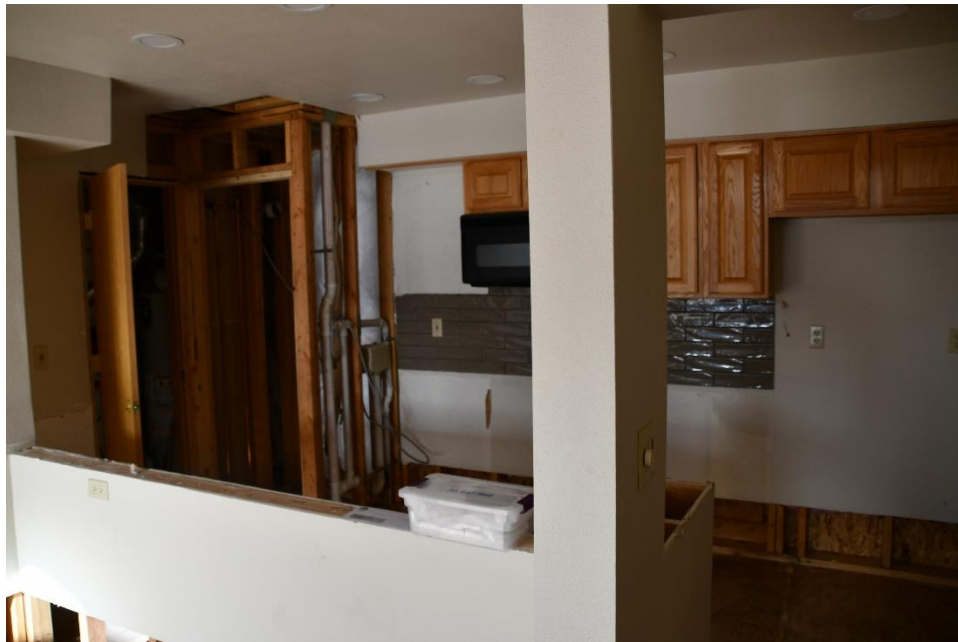
**Figure 4. Interior of Unit 304B, kitchen area (16020\_CBS\_1-016).**

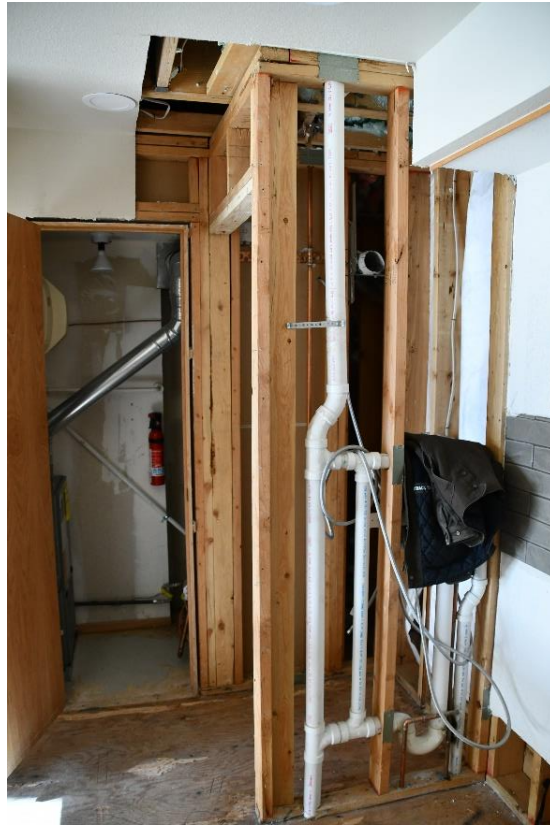
**Figure 5. Unit 304B, kitchen area looking west towards mechanical room and built out wall for the refrigerator (16020\_CBS\_1-018).**

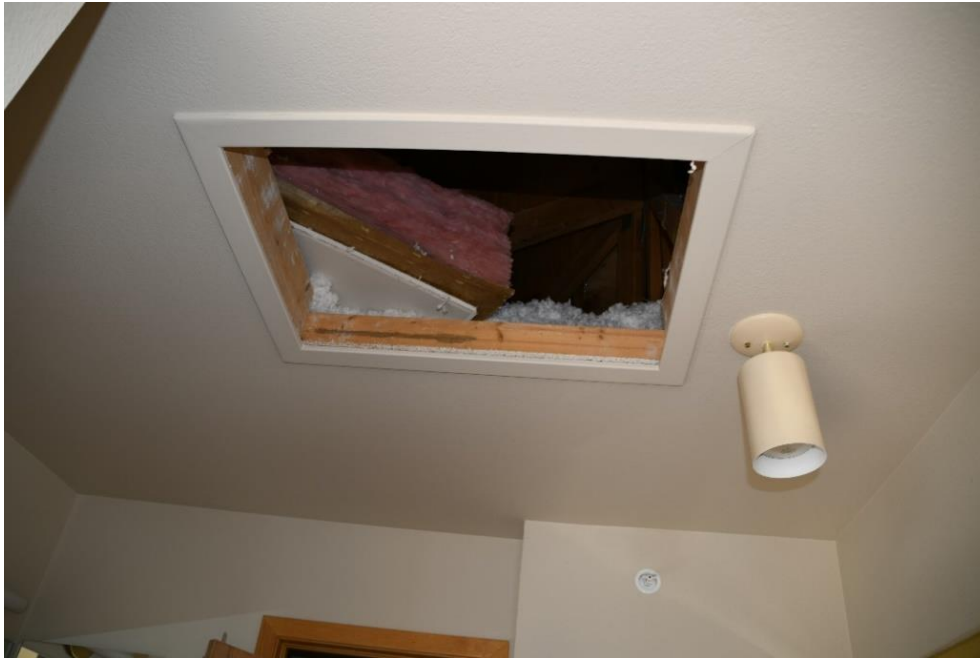
The attic over the west bedroom was entered via an access panel in the ceiling, as illustrated in Figure 13. White loose fill cellulose insulation was observed in the attic, as shown in Figure 14. The depth of the

**Figure 13. Attic access panel in west bedroom (16020\_CBS\_1-071).**

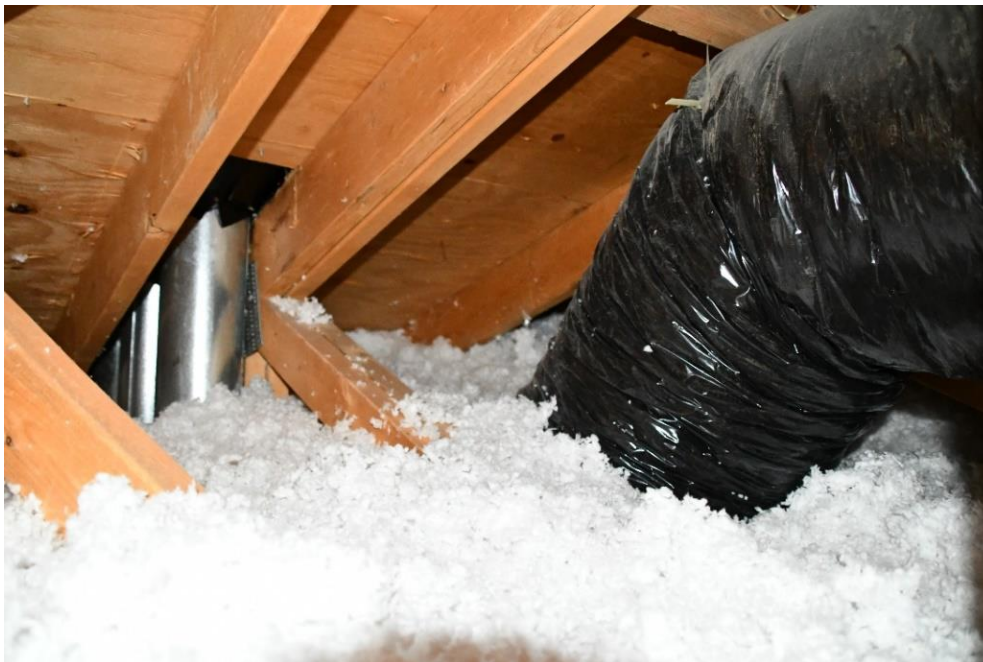
**Figure 14. Looking north into the attic from the access panel (16020\_CBS\_1-078).**

The attempt to install a cardboard tent over the black-steel sprinkler pipe did not take into account the R-value of insulation needed to protect the pipe from freezing. The pipe was approximately 10-inches above the sheetrock ceiling. The cardboard tent was, at its highest point, approximately 12-inches above the sheetrock ceiling. The measured depth of the white loose-fill insulation in the attic was approximately 14-inches in depth throughout the attic. Based on these measurements and observed conditions in the

attic, there were approximately 2-inches of insulation covering the peak of the cardboard tent. Considerably more insulation, depth-wise, was needed to protect the subject pipe from freezing. The subject sprinkler piping was inadequately protected from freezing, which likely resulted in the formation of an ice block within the pipe, leading to the failure of the sprinkler pipe.

1. Add additional insulation over the cardboard tent installed in the attic over the kitchen, as well as installing a small louver in the ceiling to allow warm air to enter the cavity created by the cardboard tent. This method would only be effective if additional insulation were installed over the cardboard tent.
2. Bring the black-steel pipe into the heated envelope of the unit. Although NFPA 13R indicates that pipe installed under insulation is considered to be below the ceiling, improper insulation depth negates the thermal protection of the pipe. The sprinkler pipe could be relocated into the unit and installed where the ceiling and the wall meet. A small soffit could be constructed around the pipe, concealing the pipe, as it follows a path to the area over the refrigerator. A side wall sprinkler could be installed for the mechanical room from the same run of pipe.

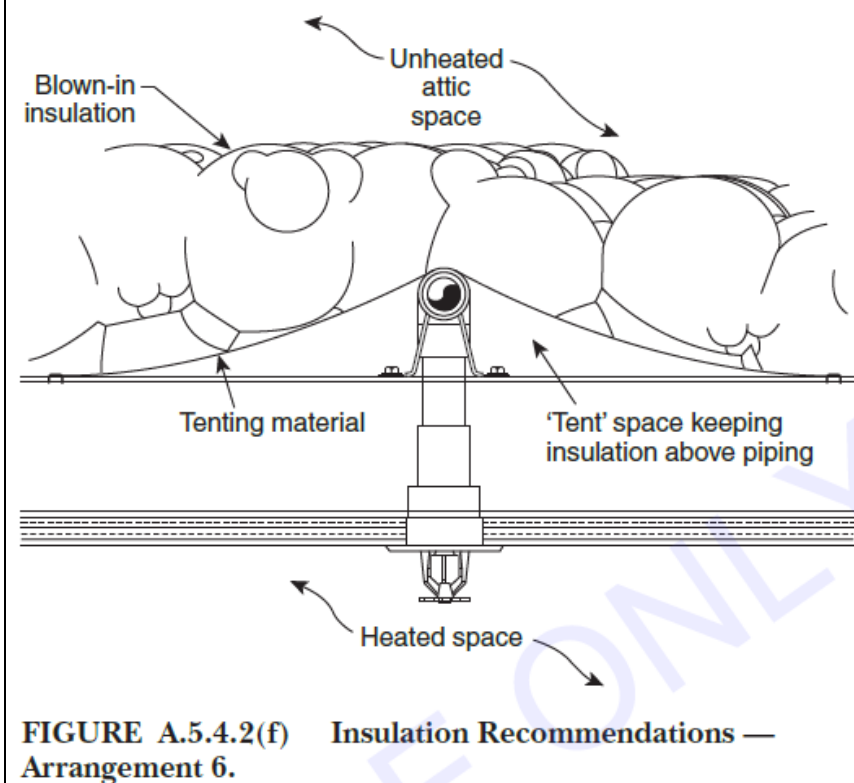
Per NFPA 13R, where a sprinkler system cannot be adequately heated at/or above 40°F, it shall be protected by 1 of 5 different methods, as shown in Figure 26. NFPA 13R states that pipe covered by insulation is considered to be part of the area below the ceiling, also shown in Figure 26. Additionally, Figure 26 shows one of six examples of how to protect pipe with insulation.

**A.5.4.2** Piping covered by insulation, as shown in Figure A.5.4.2(a) through Figure A.5.4.2(f), is considered part of the area below the ceiling and not part of the unheated attic area.

**Figure 26. Excerpts from the 2019 Edition of NFPA 13R with one method of insulating shown.**
