Property: Lake Forest
Lake View Terrace-Frisco, CO

Service: Full Reserve Study

FRISCO, COLORADO

Site Inspection 5/25/21
INITIAL DRAFT submitted: 6/8/21
FINAL REPORT Submitted 6/21/21

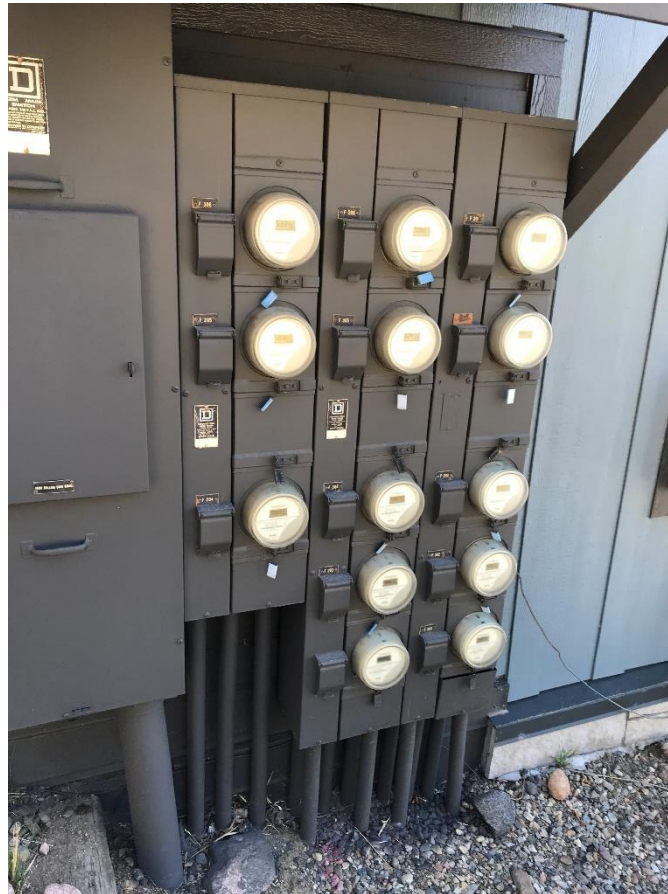
Electric meters

Electrical & natural gas unit meters are mounted on outside of each building in a covered area. The site landscaping appears to be in good condition with mature trees and vegetation. The grass is well maintained. There is a park area adjacent to the clubhouse and barbecue grills on the site available to residents.

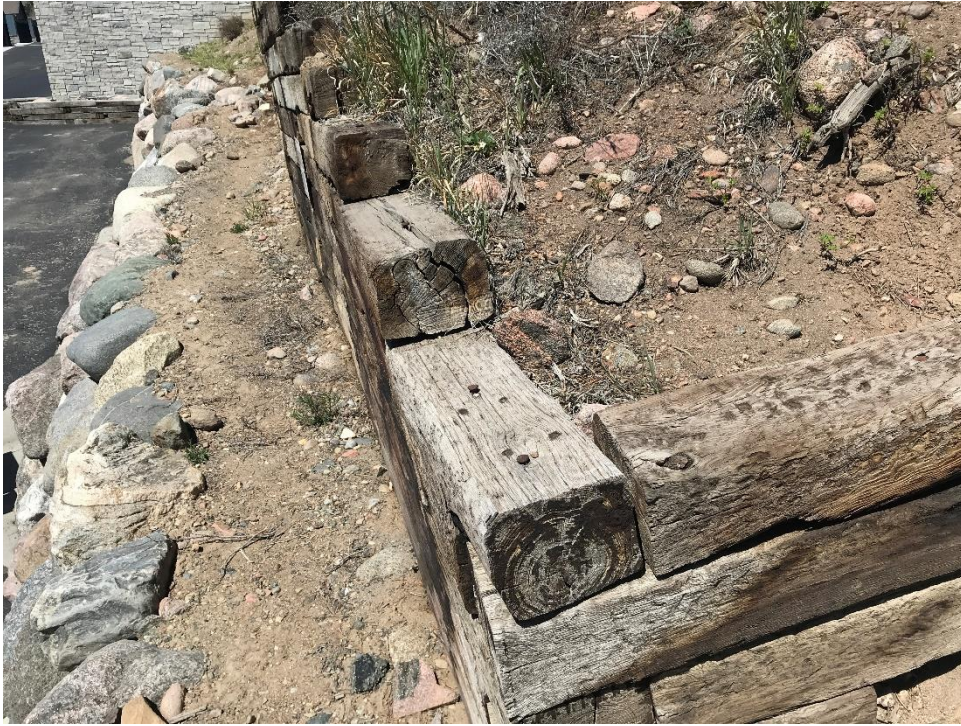
PHOTOGRAPH 5

Location: North side of property behind E & F buildings
 EUL-35 years
 RUL- 3 years
 SUMMARY- Wall has not shifted significantly since 2017. FEZ is monitoring wall movement in multiple locations with horizontal measurements to the building wall.
 REPAIRS- Year 3 -major repair and stabilization. Year 10 50% wall replacement.

- Item #10 Rock Retaining Wall
