Regarding: Reserve Study Final Version

# Yacht Club Condominiums, Inc. 144 Gold Run Cir. Dillon, CO. 80435

## FINAL VERSION

Report Period – 05/01/23 – 04/30/24

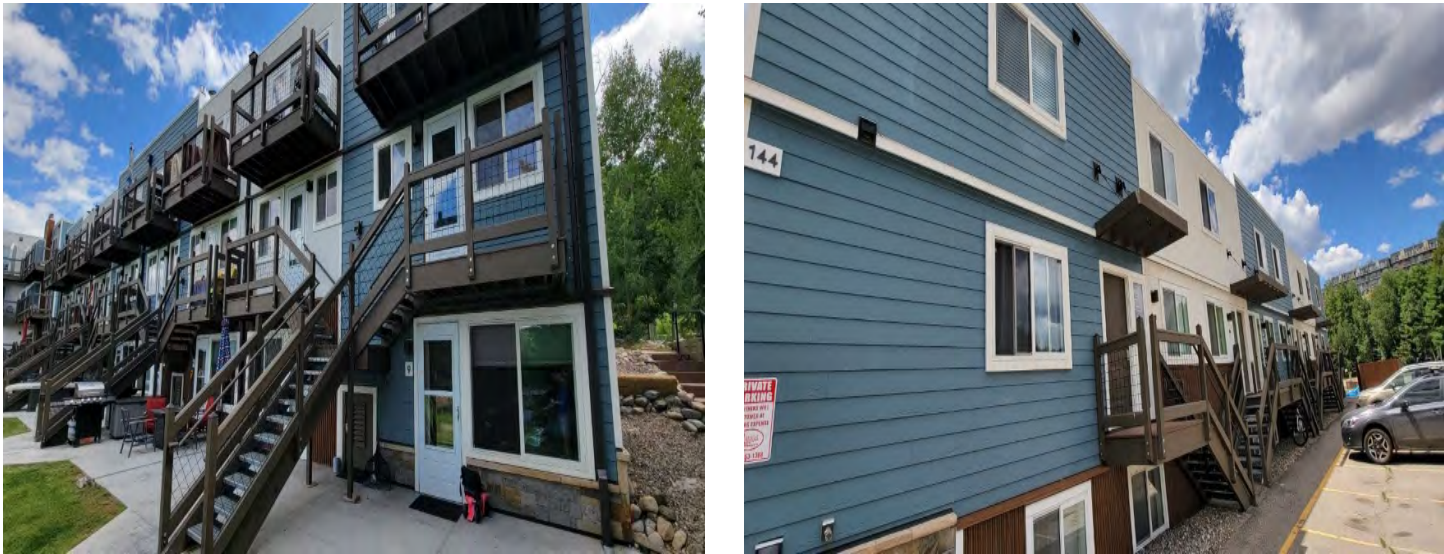
Comp #: 206

Building Ext Surfaces - Touch Up/Maintenance

Observations:  
-Per client request, we have added a line item for touch ups and maintenance every other year.

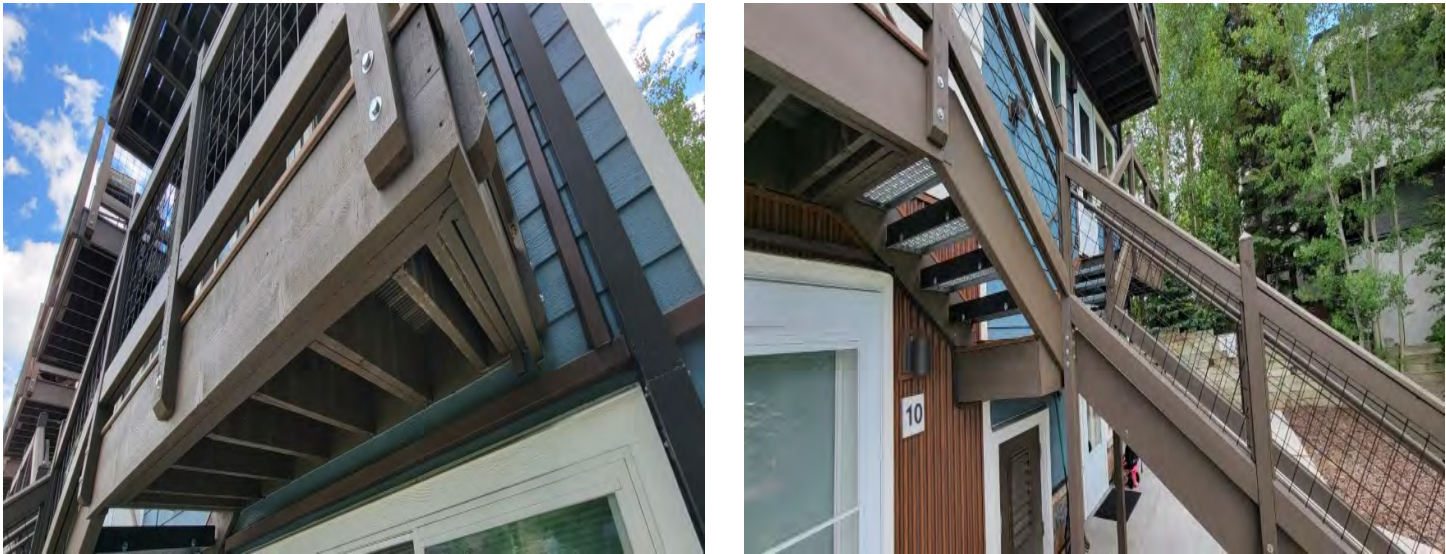
Comp #: 606

Unit Decks/Stairways - Inspect/Repair

- Per client request, an allowance has been added to the Reserve Study for periodic inspections and repairs, along with routine maintenance, which would include tightening any loose bolts, repairing any deteriorated rails, etc.
- It is difficult to determine an exact cost on a long-term budget basis, but this allowance can be adjusted in future Reserve Study updates as a history of maintenance, inspections, and repairs are conducted.

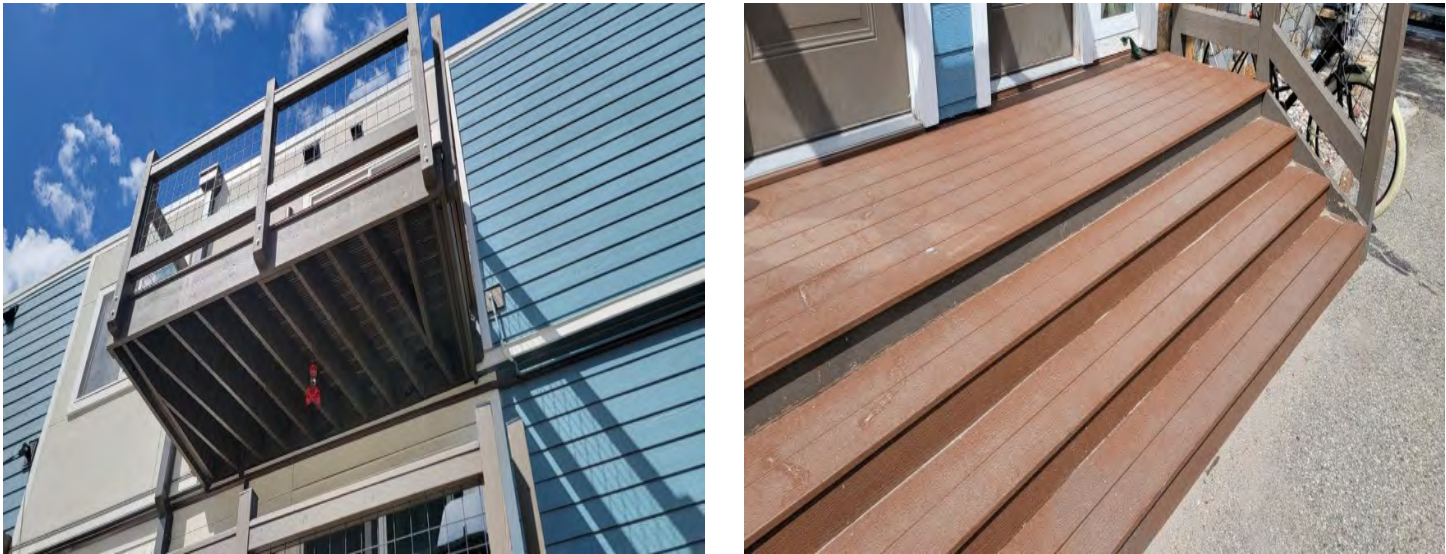
Comp #: 607

Unit Front Decks - Replace

- Since all decks and rails are similar in design, we recommend replacing all at same time so the appearance is consistent throughout the entire property.
- All decks were replaced in 2019 along with the exterior remodel project. However, it was reported the joists are still original and may require periodic repairs
- We recommend inspecting all decks at least once a year and make necessary repairs as an operating expense to maintain a safe environment.

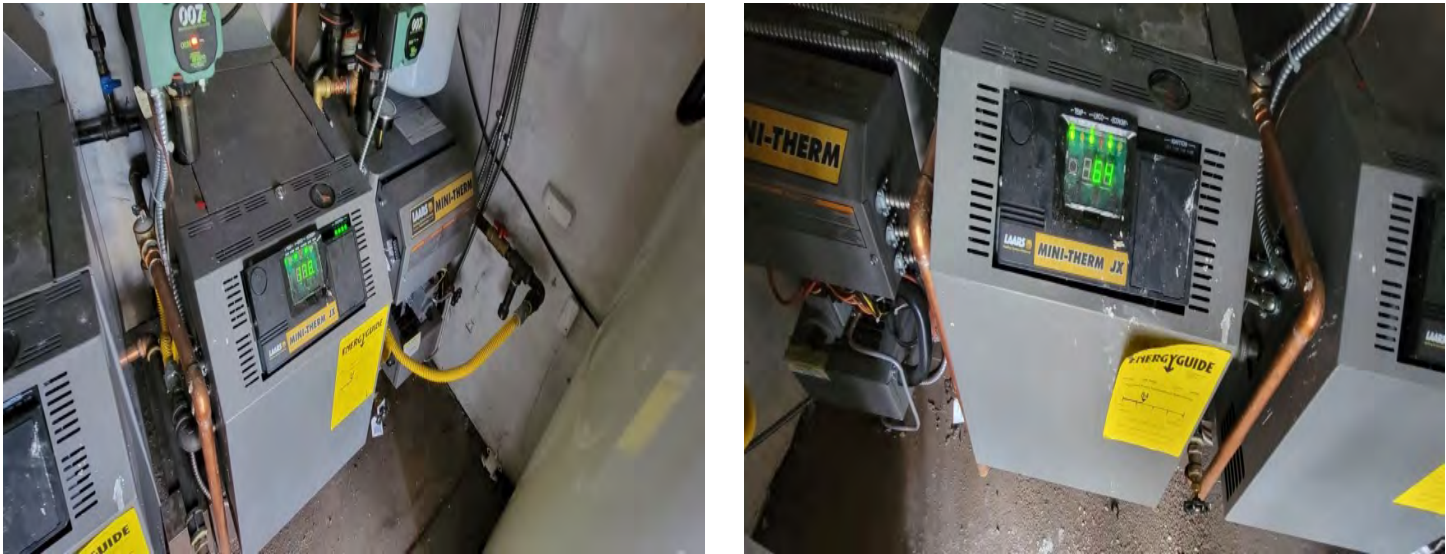
Comp #: 702

Boilers - Replace

- Observations:
- It was reported that all boilers will be the responsibility of the owner and not the association.
  - Therefore, Reserve funding is not required for this component

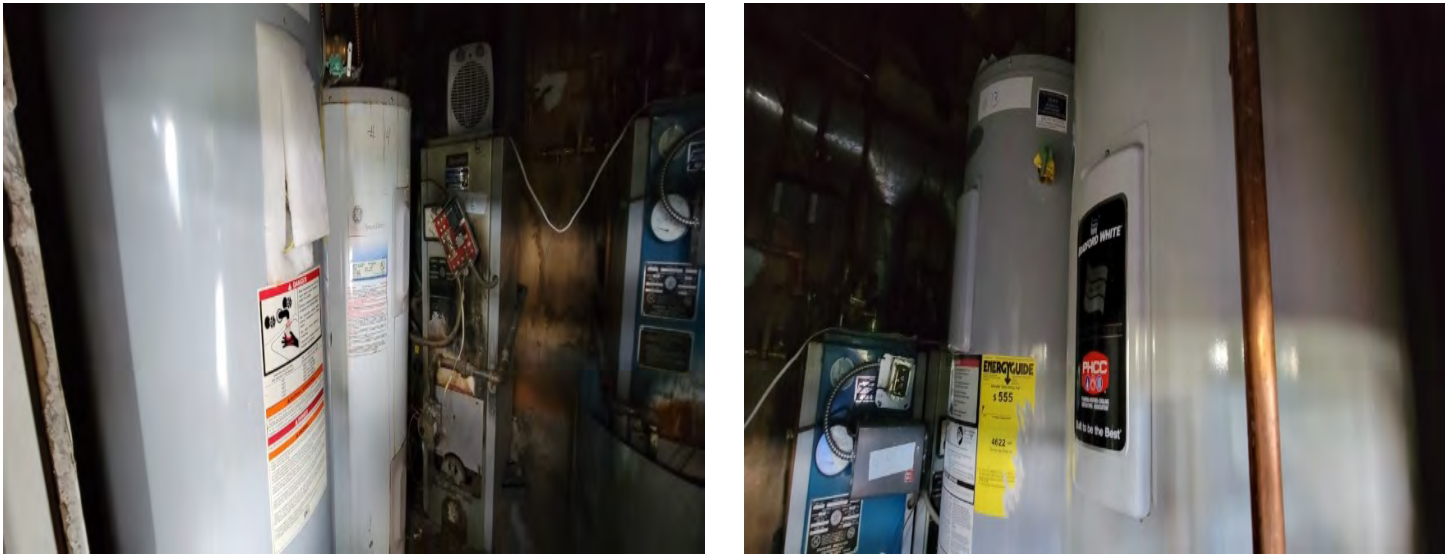
Comp #: 703

Water Heater - Replace

- It was reported that all water heaters will be the responsibility of the owner and not the association.
- Therefore, Reserve funding is not required for this component

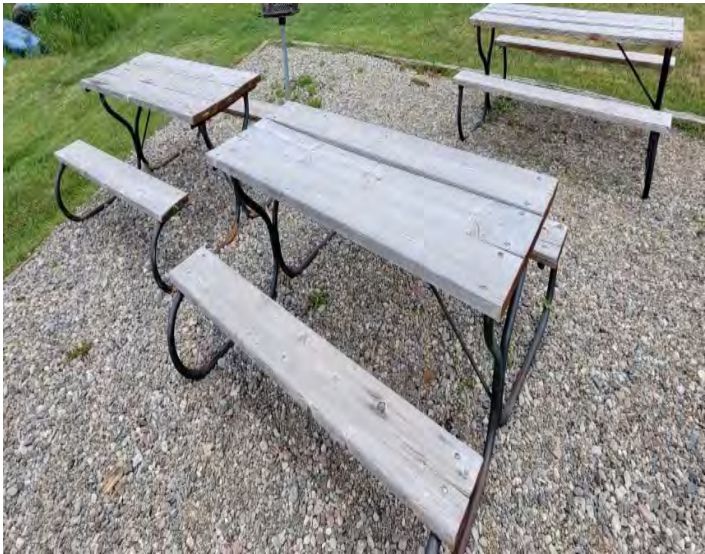
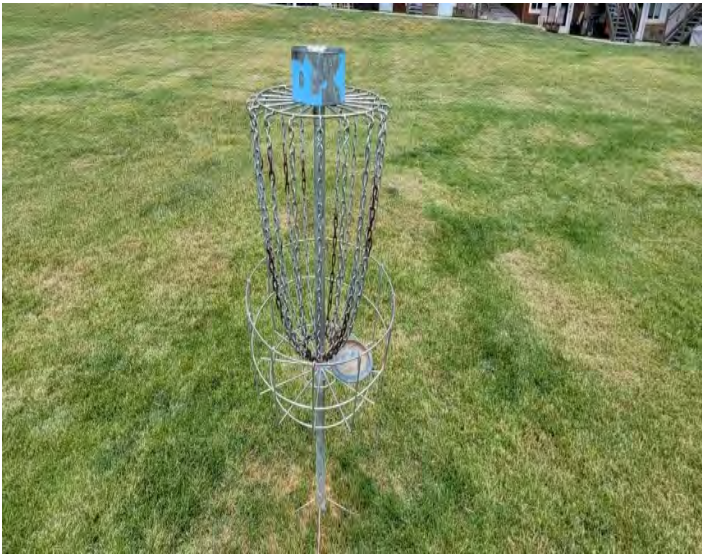
Comp #: 1306

Park Equipment - Replace

- Replace on an individual basis as needed with general operating funds.

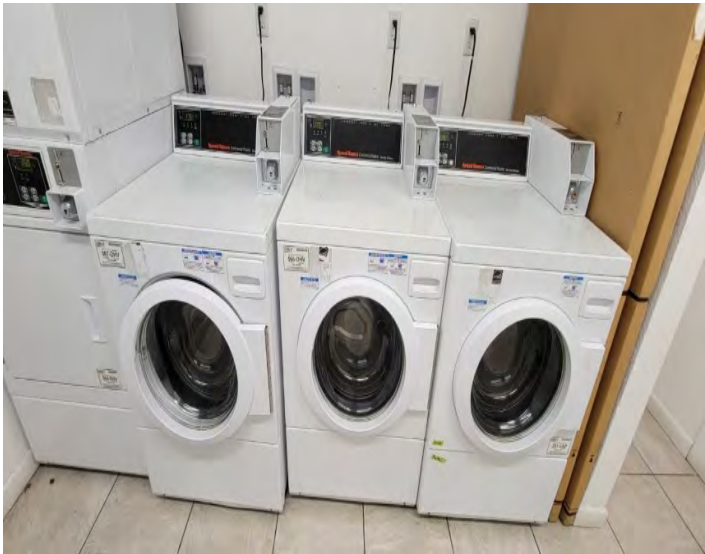
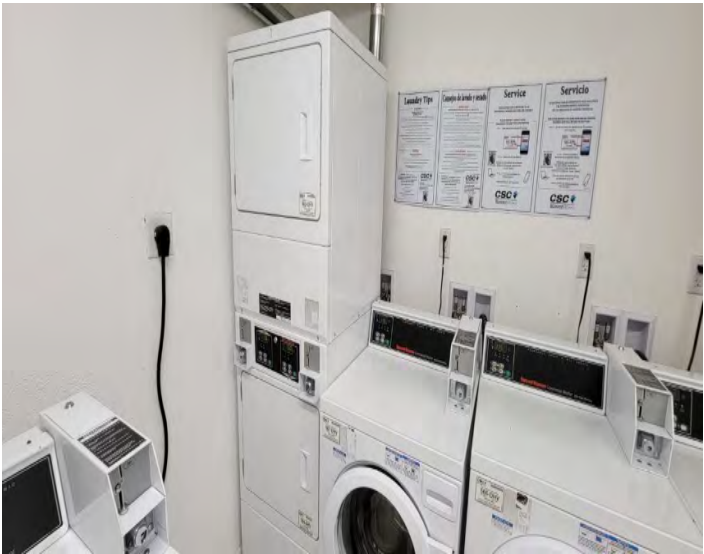
Comp #: 1401

Laundry Equipment - Replace

- Equipment is leased through a separate company (CSC).
- As a result, since the association does not own this equipment, then Reserve funding is not required at this time.

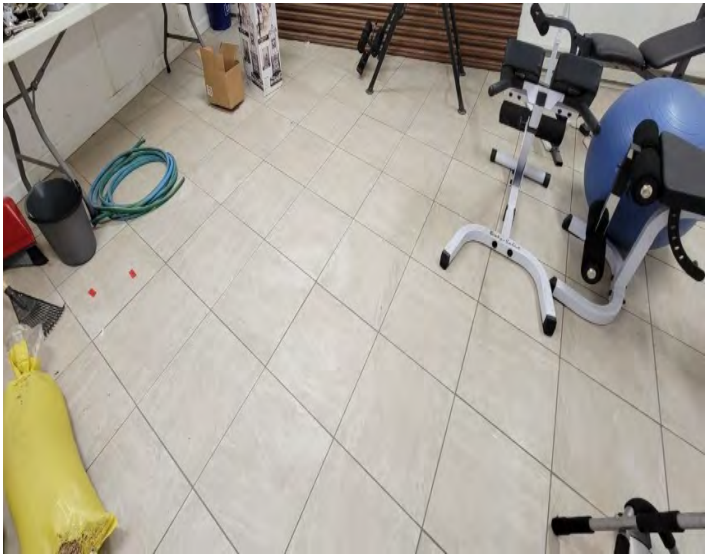
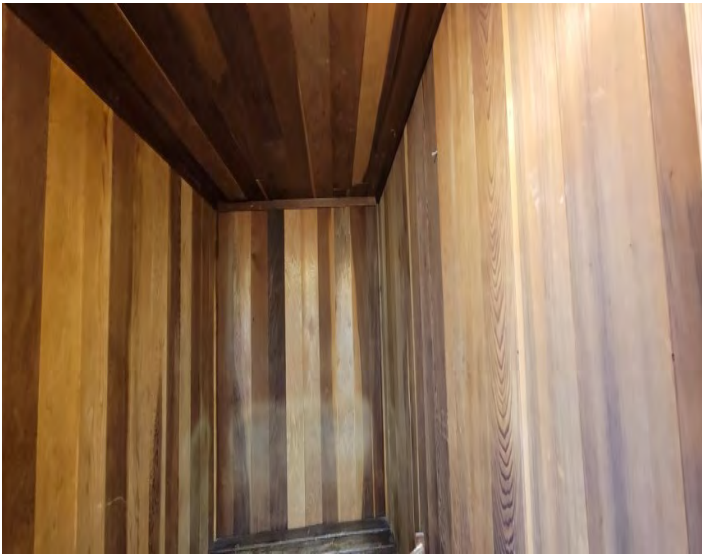
Comp #: 1409

Lower Level Room Area - Refurbish

- This area used to contain the spa and currently contains a sauna that is not used.
- Board has requested to include funding to repurpose this area within the next 5 years
- The exact cost of repurposing this area will depend on the final design and what will be installed.
- This allowance is an agreed upon number between the current Board and ARS during a phone call to discuss the report
